June 13, 2024

Perdido Sun Condominium
13753 Perdido Key Drive
Pensacola, FL 32507

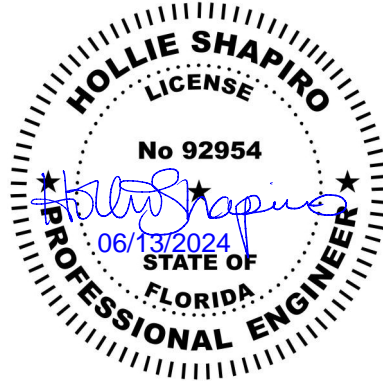
RECOMMENDED FOR PHASE 2? NO

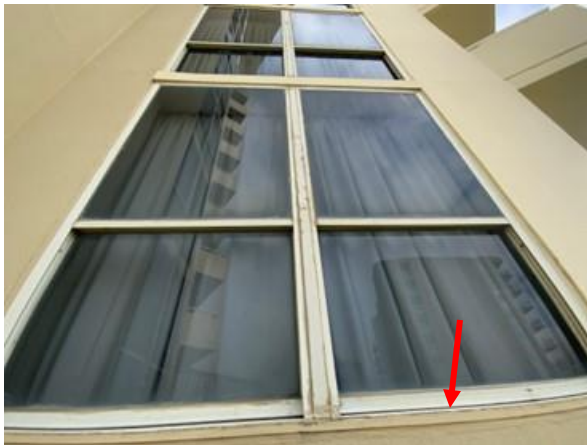
Photo 2
South Elevation – Overall view of windows, deteriorated sealants observed – Typical.

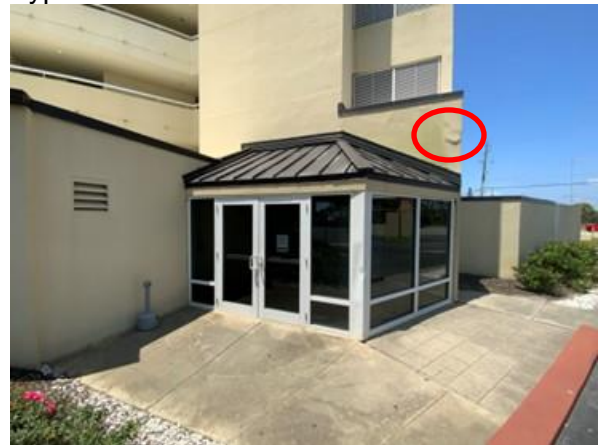
Photo 5
North Elevation – View of blistered wall coating – Isolated.

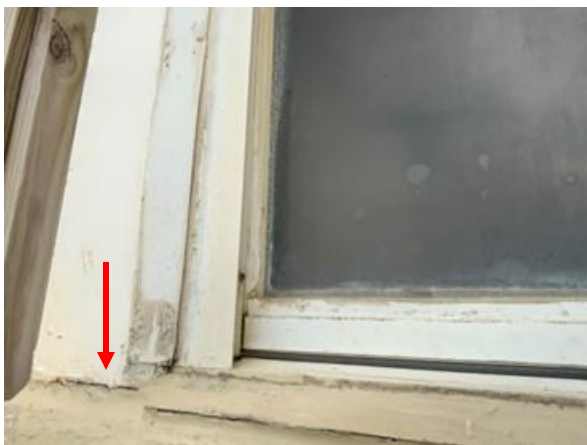
Photo 3
South Elevation – Overall view of windows, deteriorated sealants observed – Typical.

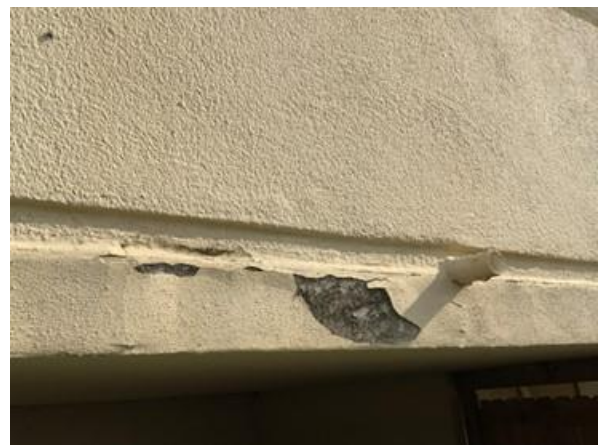
Photo 6
South Elevation – View of delaminated wall coating near balcony slab edge– Isolated.

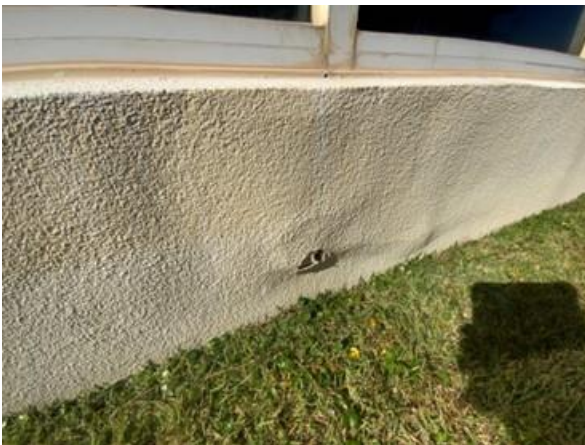
Photo 8
East Elevation – View of water damaged EIFS wall cladding – Isolated.

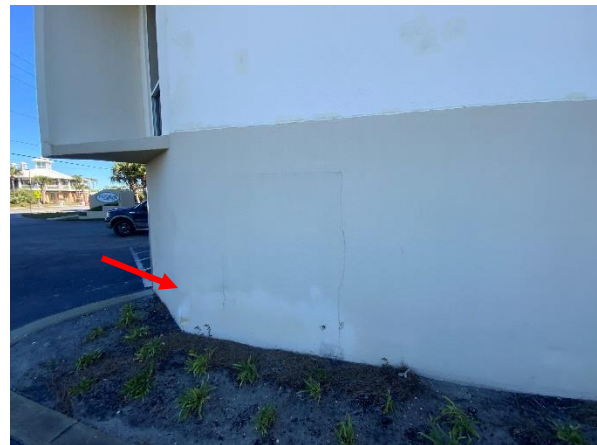
Photo 11
West Elevation - View of cracked and delaminated EIFS cladding – Isolated.

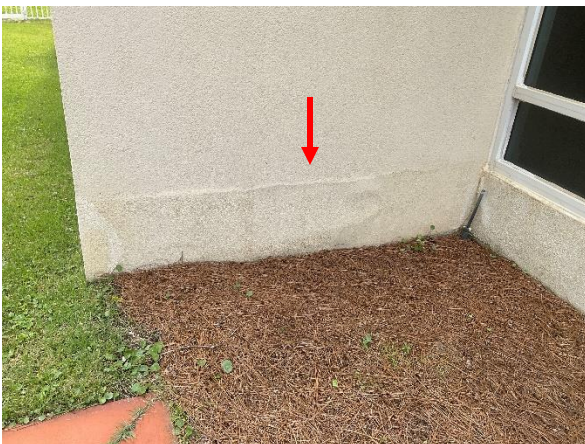
Photo 9
East Elevation – View of delaminated EIFS wall cladding – Isolated.

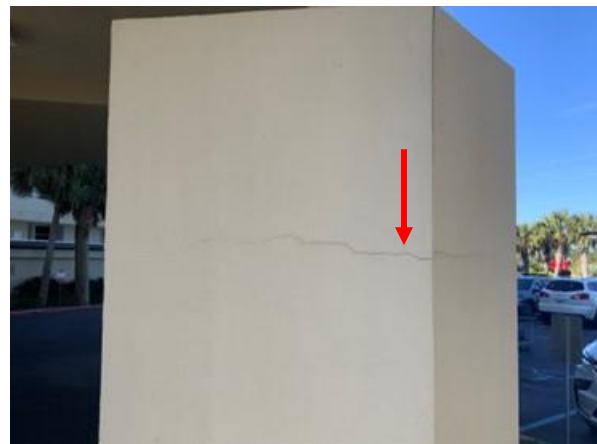
Photo 12
North Elevation - View of cracking in portecochere column – Isolated.

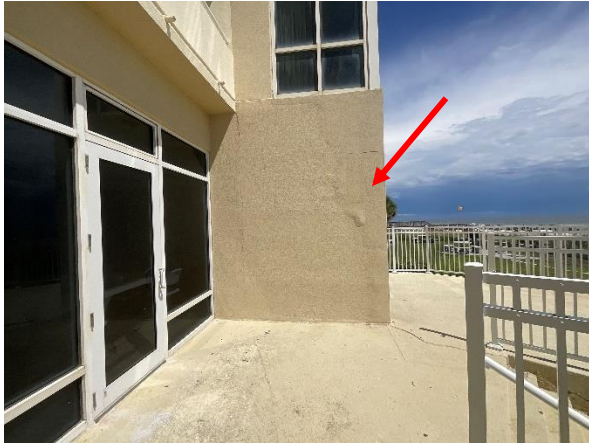
Photo 13
South Elevation - View of cracked and delaminated stucco cladding – Isolated.

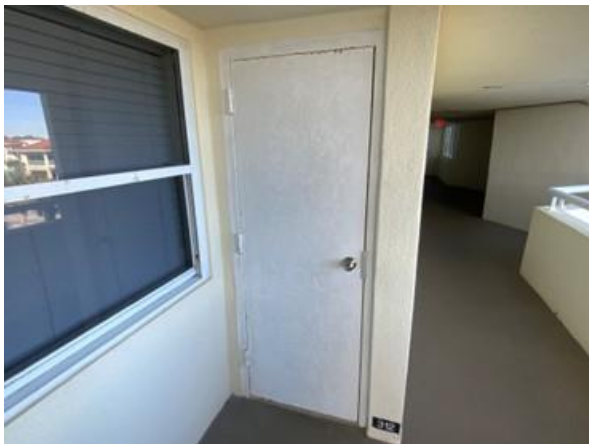
Photo 14
North Elevation – Common Walkway – View of minor corrosion at storage door.

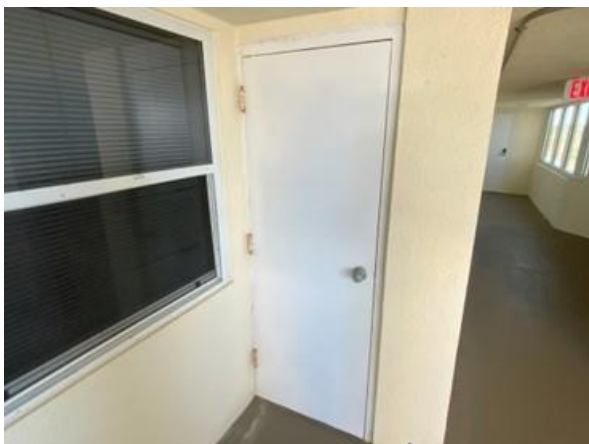
Photo 15
North Elevation – Common Walkway – View of minor corrosion at storage door.
