LOCATION: PERDIDO SUN

QUARTERLY PMP INSPECTION

Date & Quarter Performed Q2: 5/28/2025

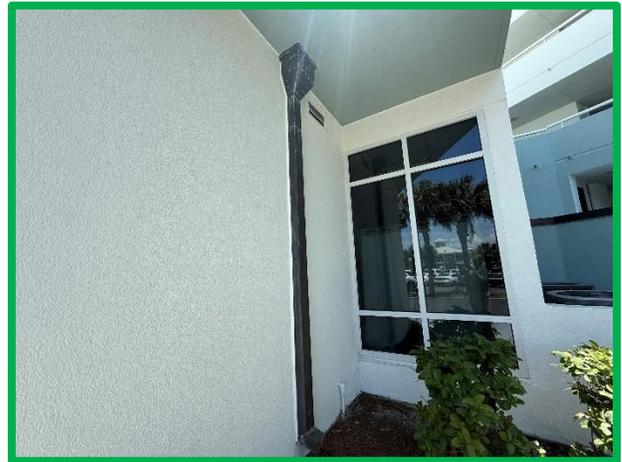
Photo 10
North Elevation – New coatings and windows
in overall good condition.

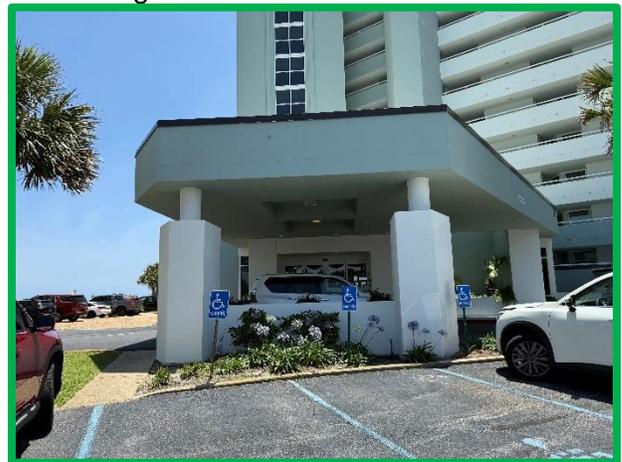
Photo 11
North Elevation – New coatings and windows
in overall good condition.

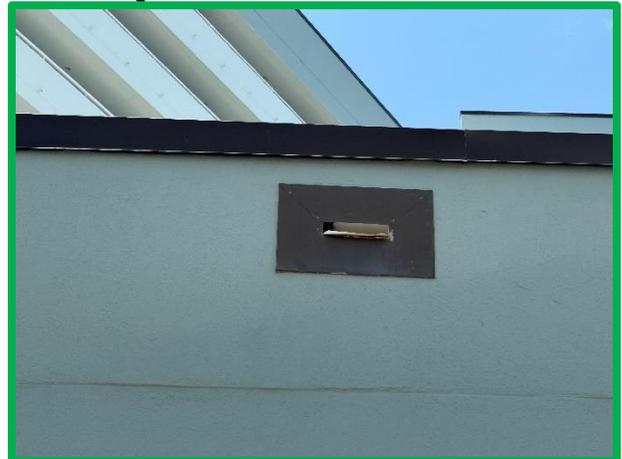
Photo 12
North Elevation – New coatings and windows
in overall good condition.

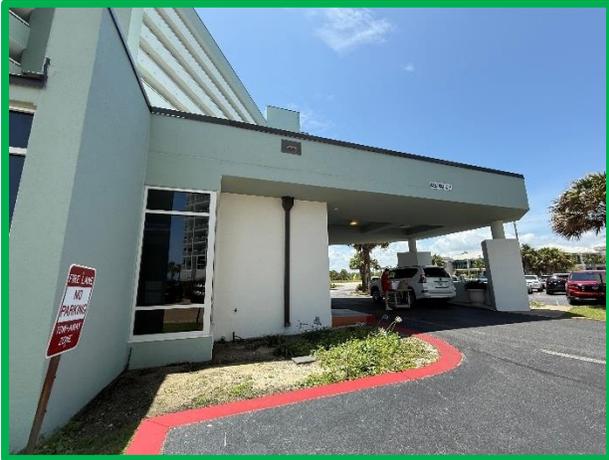
Photo 13
North Elevation – New coatings and windows in overall good condition.

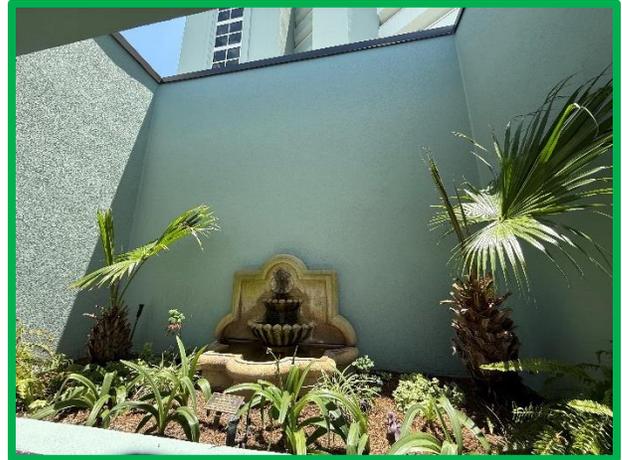
Photo 16
North Elevation – New coatings and windows in overall good condition.

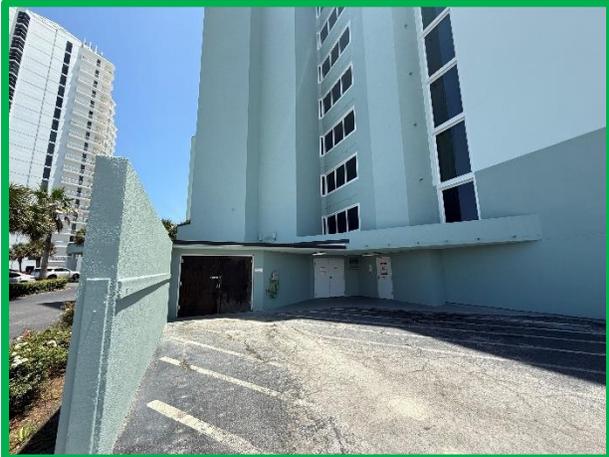
Photo 14
North Elevation – New coatings and windows in overall good condition.

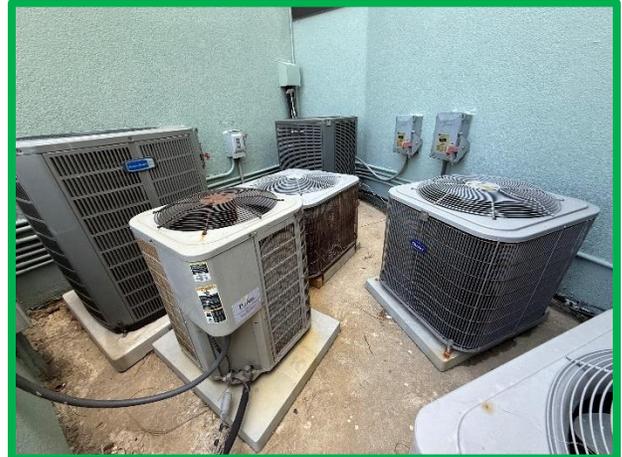
Photo 17
North Elevation – New coatings and windows in overall good condition.

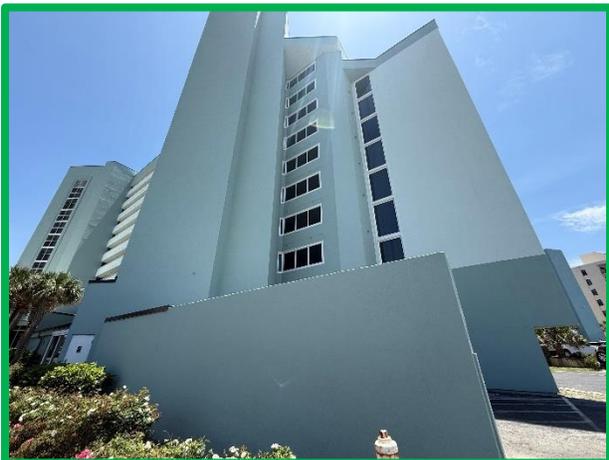
Photo 15
North Elevation – New coatings and windows in overall good condition.

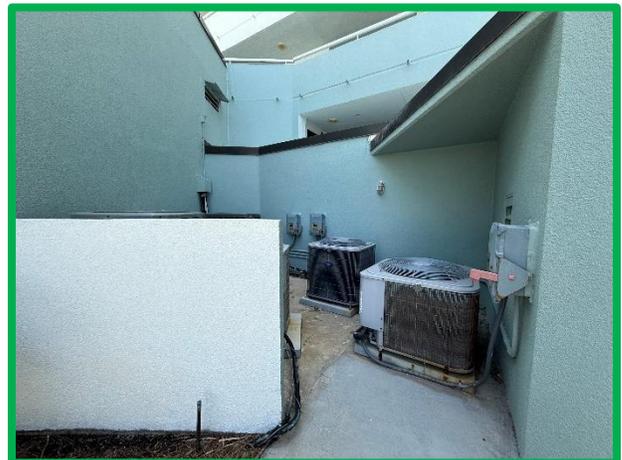
Photo 18
North Elevation – New coatings and windows in overall good condition.

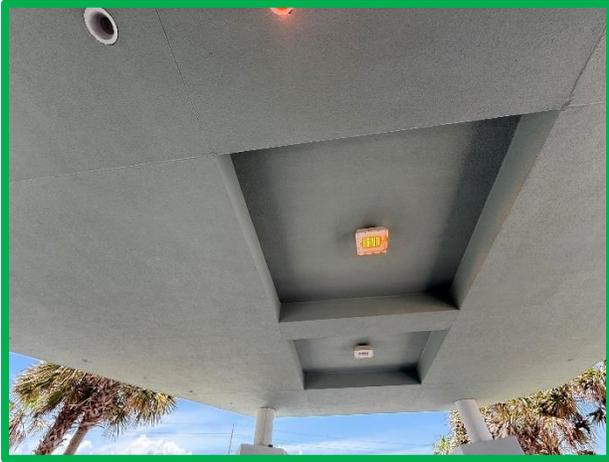
Photo 19
North Elevation – New coatings in overall good condition.

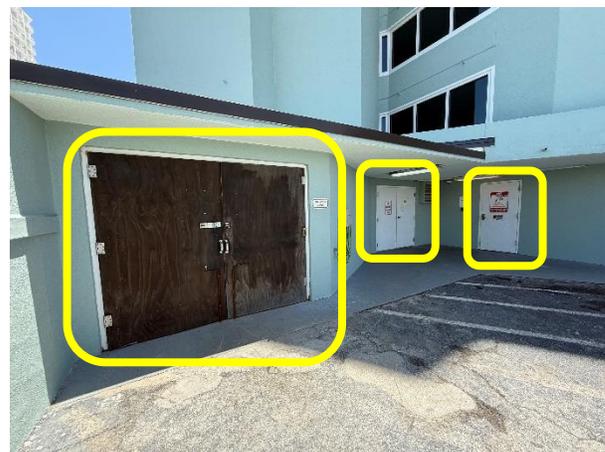
Photo 48
North Elevation – Steel door frames with minor-to-moderate corrosion present on door hardware and frames.

5/7/2024	Annual Wall	1.4.5	Repair the deterioration and corrosion on the steel door frames of the ground floor maintenance rooms located at the Northwest corner of the building.
5/28/2025	Annual Wall	3.1.1	Northwest Corner – Repair further corrosion on steel door frames and hardware.
5/28/2025	Annual Wall	3.1.2	South Elevation – Replace missing perimeter sealant between door frame and cladding at single maintenance closet door.
5/28/2025	Annual Wall	3.1.3	Common Walkways – Replace missing dryer vent louver at Unit 1100. Replace damaged dryer vent louver at Unit 700.
5/28/2025	Annual Wall	3.1.4	Common Walkways – Remediate corrosion at metal storage doors, stairwell doors, and mechanical room doors.

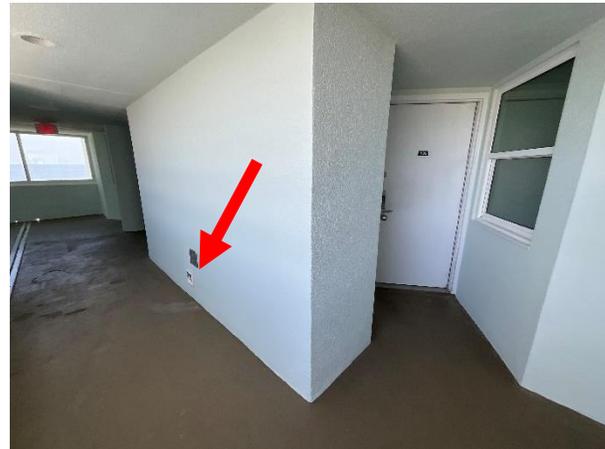
Isolated: Dryer Vent Damaged / missing at Units 1100, 500, and 700. Typical: Corroded Fasteners at Dryer Vents on All Floors.

Photo 58
North Elevation – Common Walkways – Floor 11 – Unit 1102 – Missing dryer vent louver.

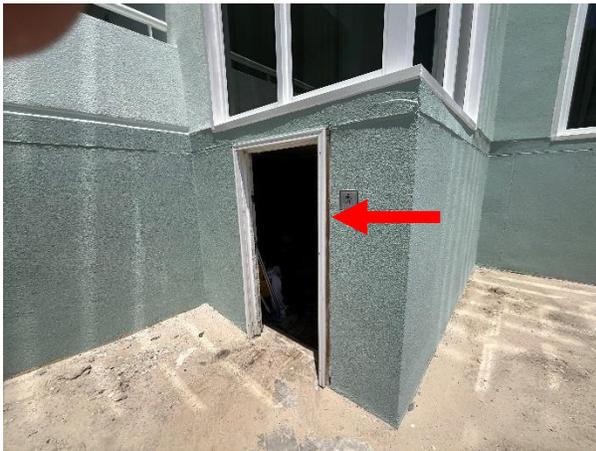
Photo 56
South Elevation – Missing perimeter sealant between door frame and stucco cladding.

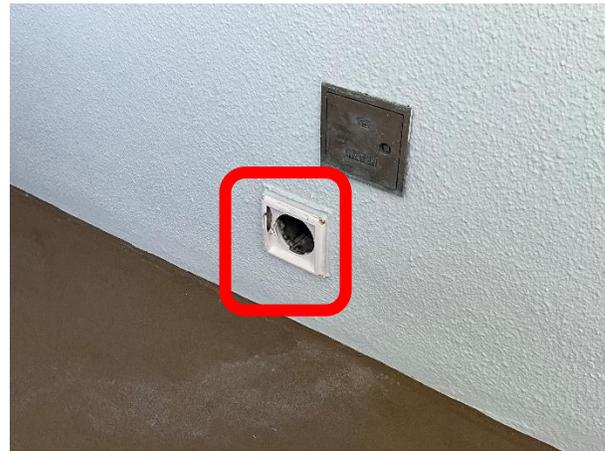
Photo 59
North Elevation – Common Walkways – Floor 11 – Unit 1102 – Missing dryer vent louver.

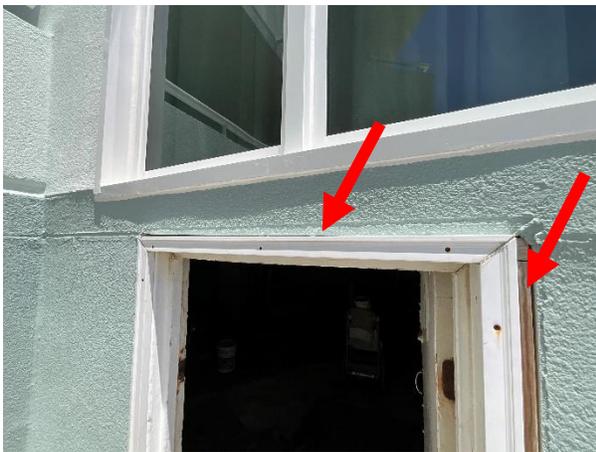
Photo 57
South Elevation – Missing perimeter sealant between door frame and stucco cladding.

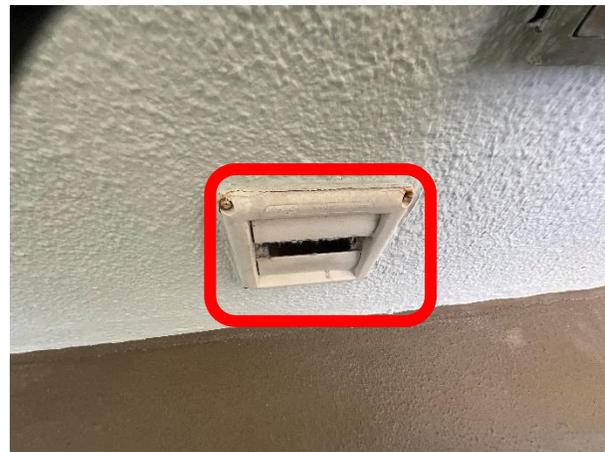
Photo 60
North Elevation – Common Walkways – Floor 7 – Unit 702 – Damaged dryer vent louver.

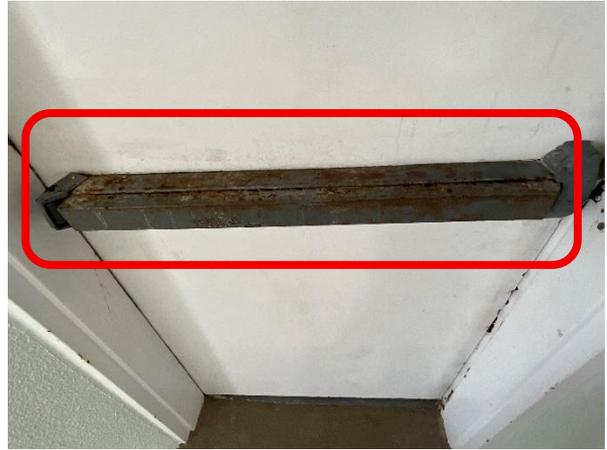
Photo 64
North Elevation – Common Walkways – Floor 11 – Corrosion present at door hardware.

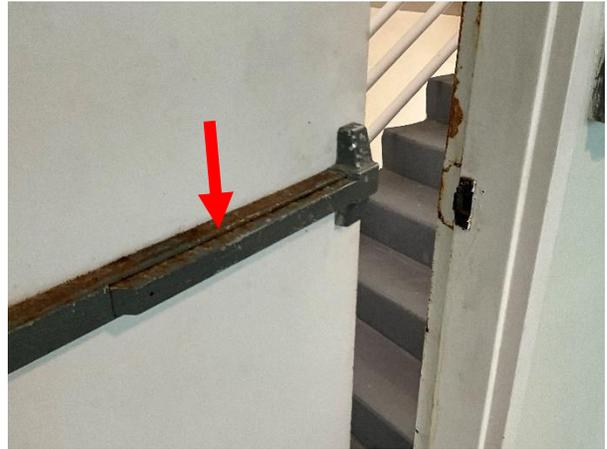
Photo 65
North Elevation – Common Walkways – Floor 7 – Corrosion present at door hardware.

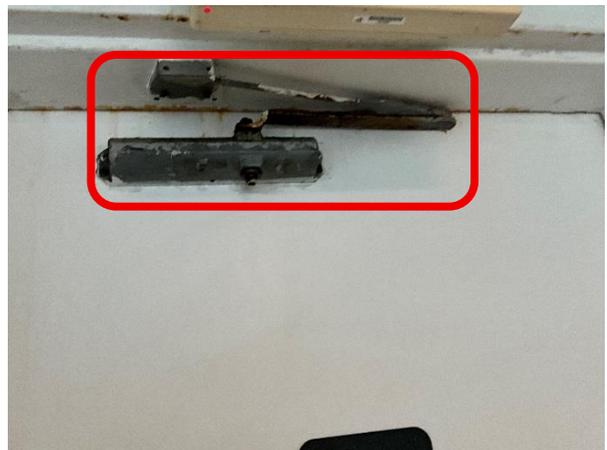
Photo 66
North Elevation – Common Walkways – Floor 7 – Corrosion present at door hardware.

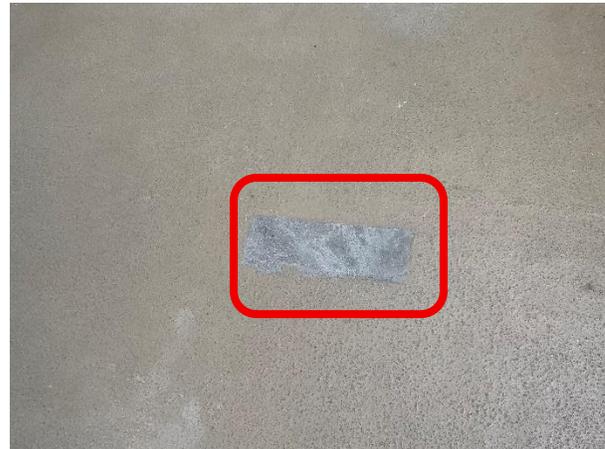
Photo 76
North Elevation – Common Walkways – Floor 4 – Isolated damaged deck coating.

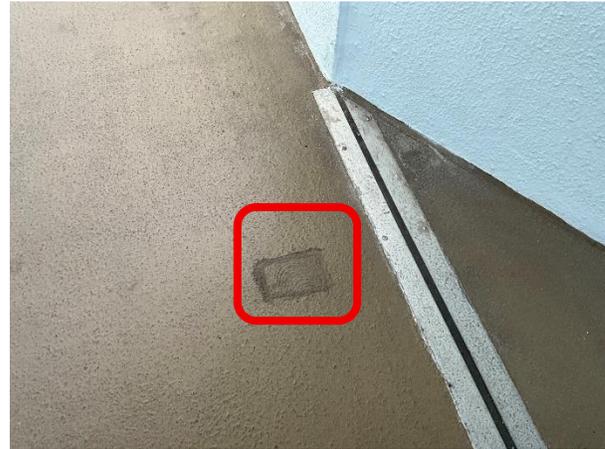
Photo 77
North Elevation – Common Walkways – Floor 4 – Isolated damaged deck coating.

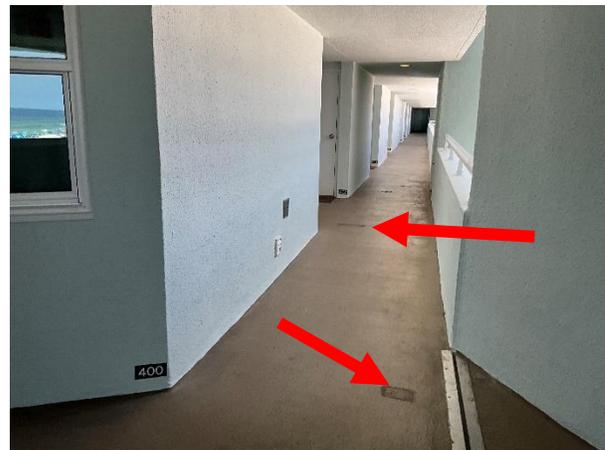
Photo 78
North Elevation – Common Walkways – Floor 4 – Isolated damaged deck coating.

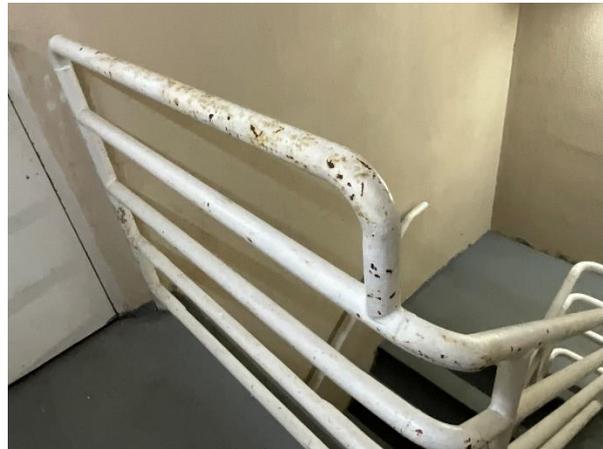
Photo 82
East Stairwell – Floor 11 – Chipped and bubbled railing paint.

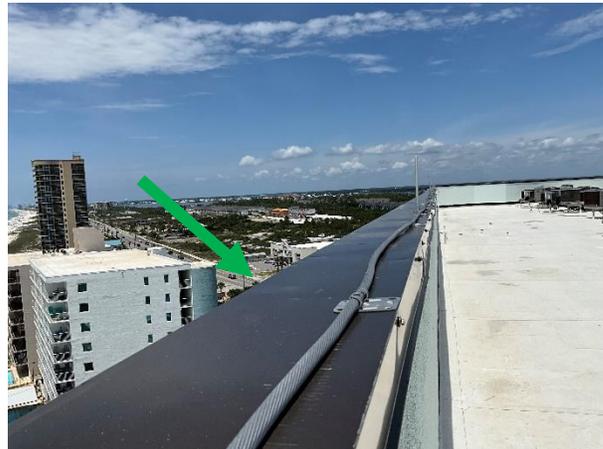
Photo 88
Low-Slope Roof – Coping in overall good condition.

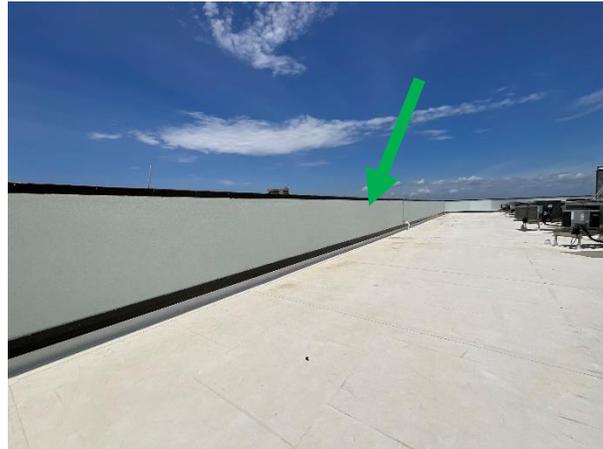
Photo 89
Low-Slope Roof – Parapet wall in overall good condition.

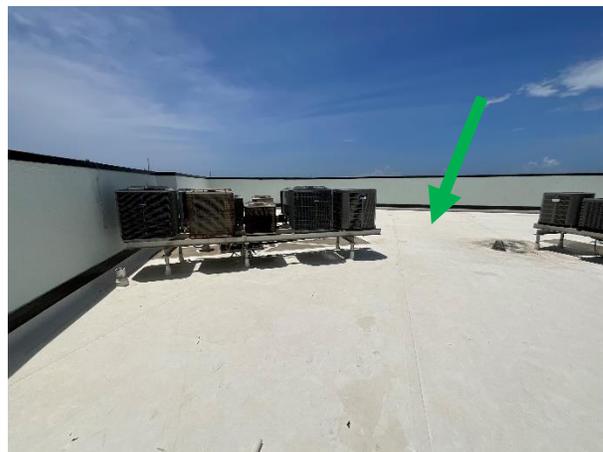
Photo 90
Low-Slope Roof – Single-ply membrane in overall good condition.

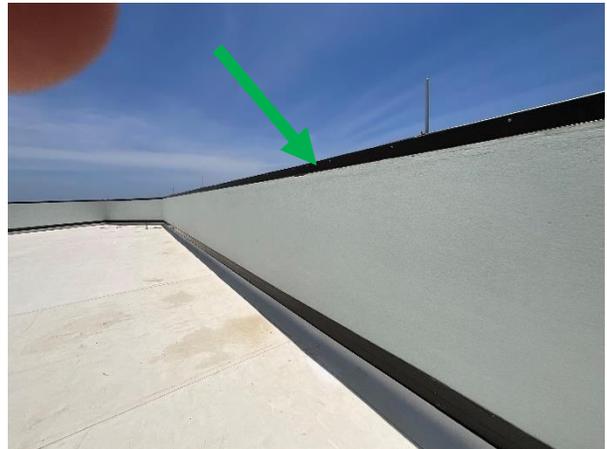
Photo 94
Low-Slope Roof – Parapet wall in good condition with no cracking or damage present.

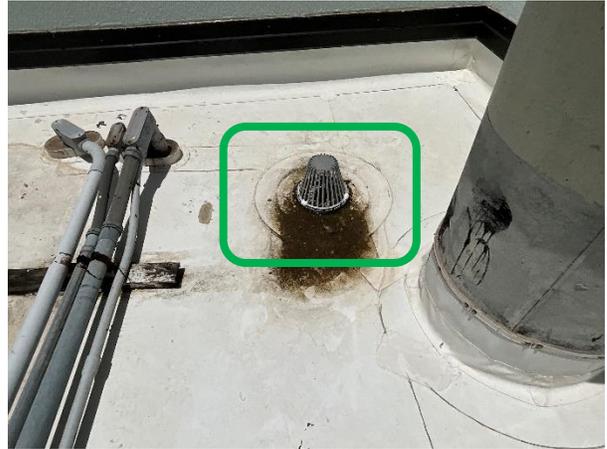
Photo 95
Low-Slope Roof – Drain cover installed at western most drain.

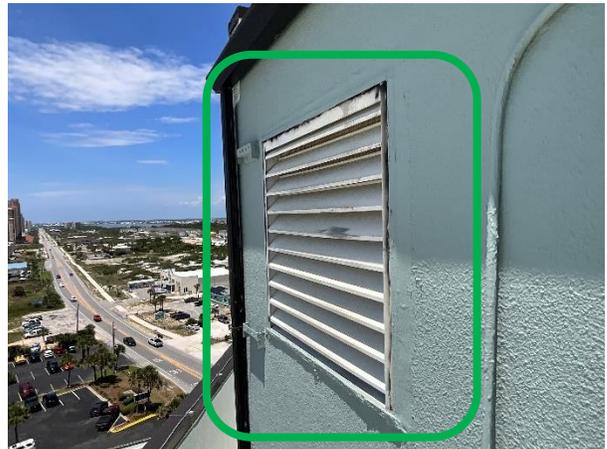
Photo 96
Low-Slope Roof – View of louver perimeter sealed to the cladding with protective coating applied.

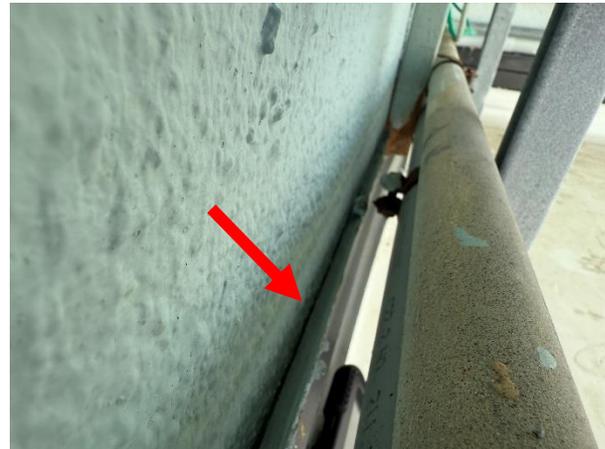
Photo 100
Low-Slope Roof – Missing sealant at metal flashing interface.

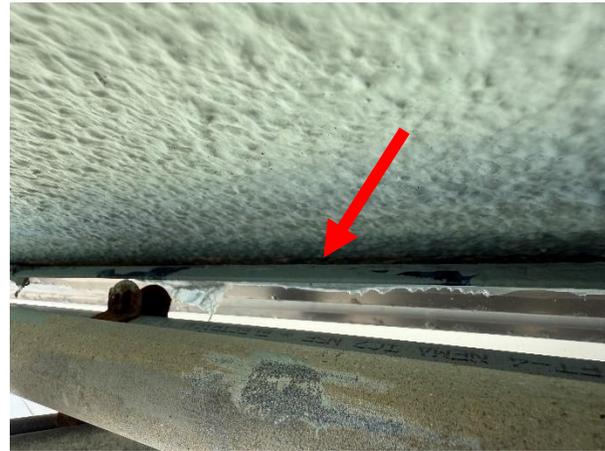
Photo 101
Low-Slope Roof – Missing sealant at metal flashing interface.

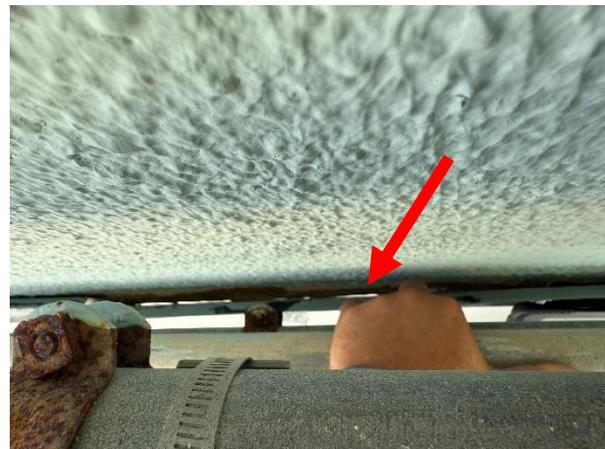
Photo 102
Low-Slope Roof – Missing sealant at metal flashing interface.

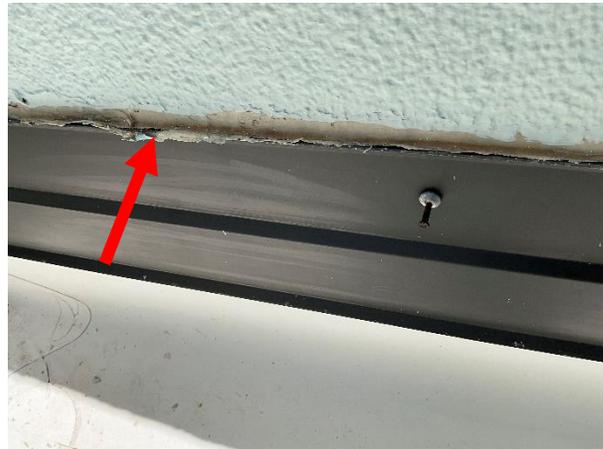
Photo 106
Low-Slope Roof – Sealant at metal flashing interface applied over exposed plastic film.

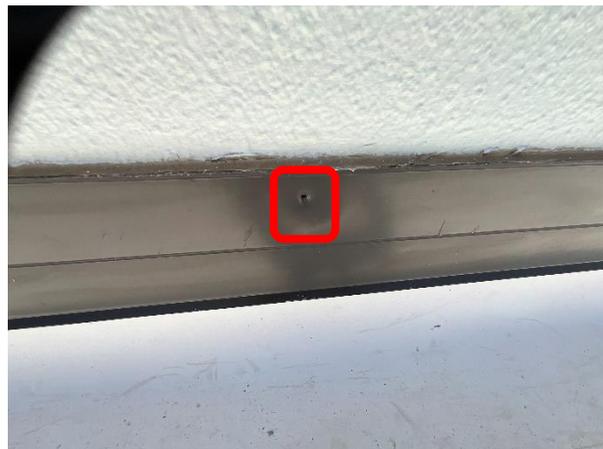
Photo 107
Low-Slope Roof – Hole present due to missing fastener.

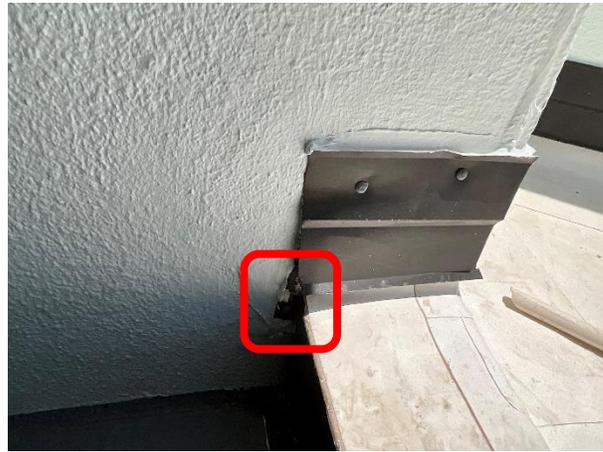
Photo 112
Low-Slope Roof – Loose and unbonded membrane at alcove.

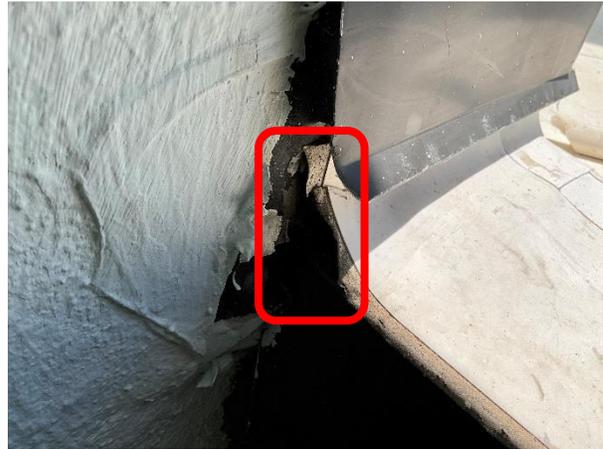
Photo 113
Low-Slope Roof – Loose and unbonded membrane at alcove.

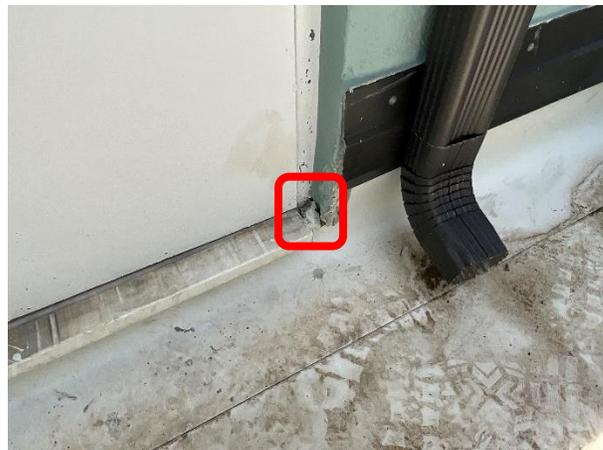
Photo 114
Low-Slope Roof – Loose and unbonded membrane at Northeast elevator equipment door.

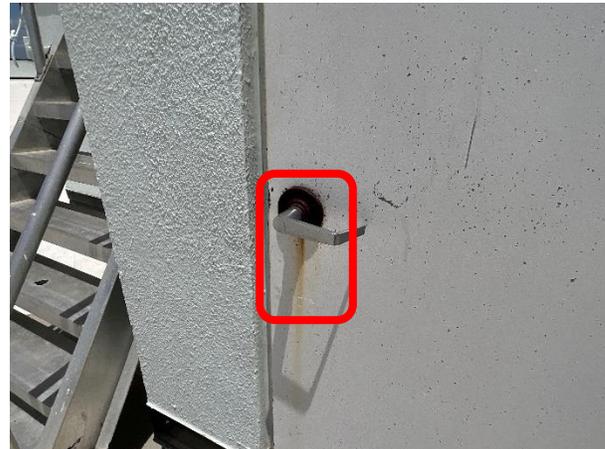
Photo 118
Low-Slope Roof – Moderate corrosion on hardware of roof access door.

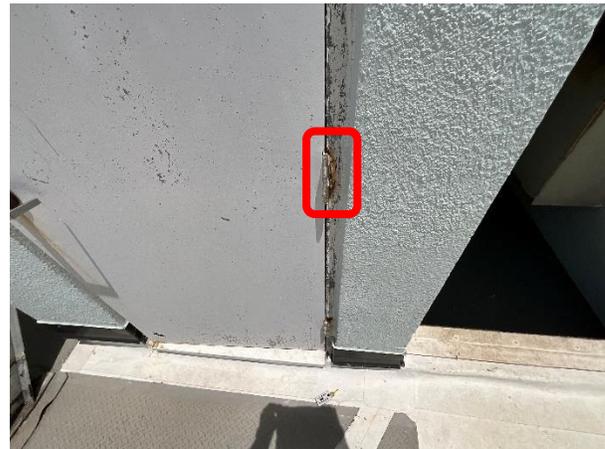
Photo 119
Low-Slope Roof – Minor corrosion on hardware of roof access door.

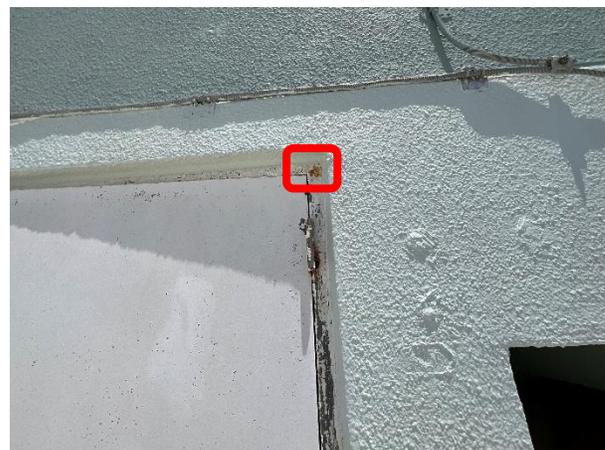
Photo 120
Low-Slope Roof – Minor corrosion on frame of roof access door.
