# BECI Field Report

**Perdido Sun**  
13753 Perdido Key Dr.  
Pensacola, FL 32507

FIELD REPORT NO: **PRDDSN007**

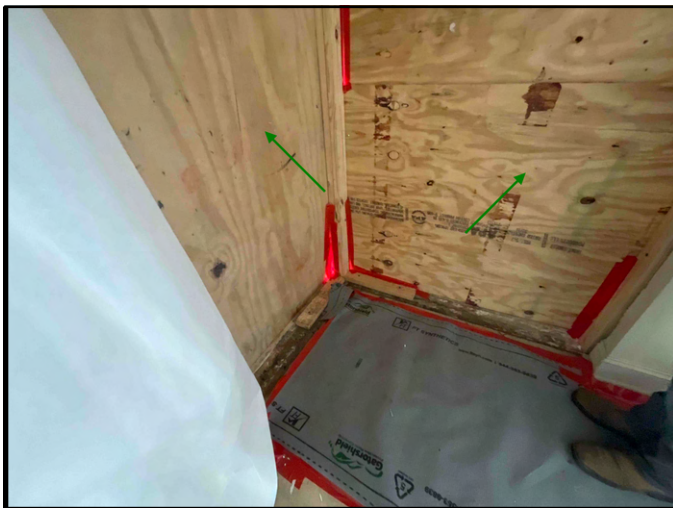
- 7.2 In the Ground Floor Lobby, we observed that the existing storefront window had been removed (Reference Figure 1). At the head of the rough opening, wooden bucking was existing with a concrete slab at the sill. The existing exterior stucco was slightly raised above the concrete slab and it was discussed that C/Sharpe would cut the stucco flush with the concrete slab. The FastFlash, Fluid-Applied Flashing and Waterproofing, would be applied at the rough opening, extending onto the cut portion of stucco. Additionally, we noted that plywood had been installed on the exterior side of the storefront window removal to protect the interior during replacement (Reference Figure 2). The team discussed the sill waterproofing detail and discussed that per the EFCO installation instructions, the two (2) exterior sides of the sill pan would be embedded in sealant. To avoid sealing up the weep holes, the exterior sealant joint would be installed from the metal flashing to the bottom lip of the frame. BECI drew a detail in the field to represent the new waterproofing directives for the sill of the new storefront window (Reference Figure 3).

**FIGURE 1 - Ground Floor Lobby - View of existing storefront window removed - Work in Progress.**

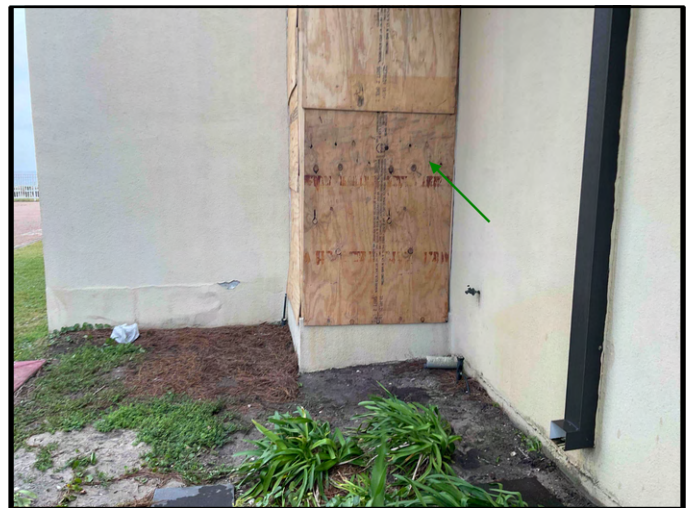
**FIGURE 2 - Ground Floor Lobby - View of plywood installed at exterior side of existing storefront window removal - Work in Progress.**

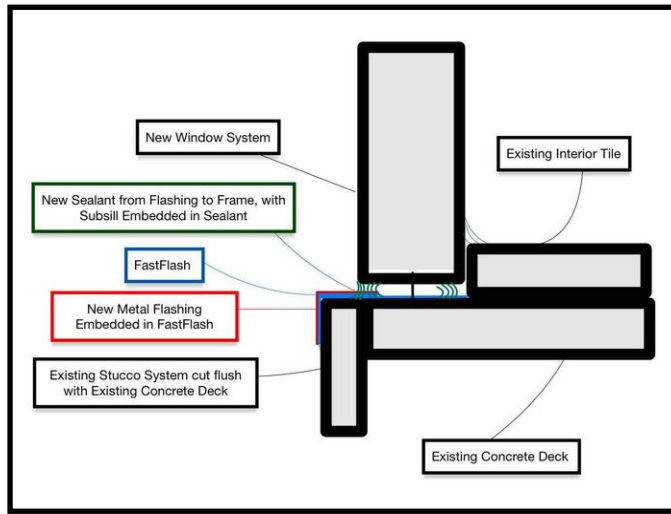
**FIGURE 3 - BECI Detail drawn on-site for new EFCO Storefront Window Waterproofing.**

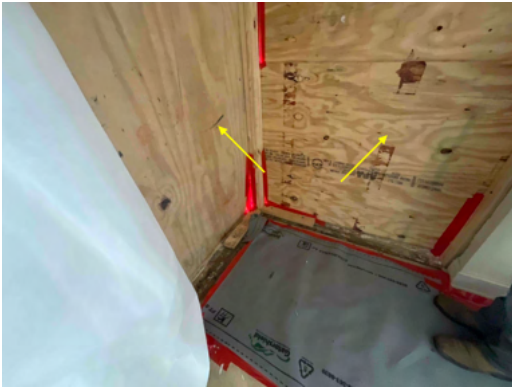
**Photo 1**

Ground Floor Lobby - View of existing storefront window removed - Work in Progress.

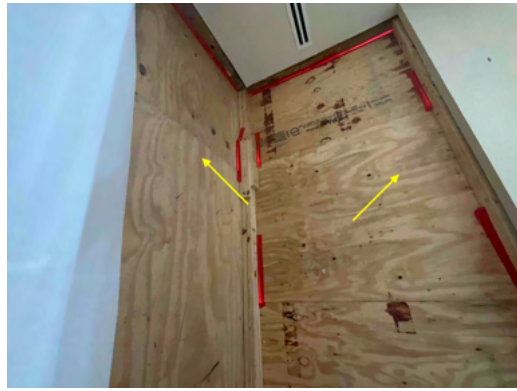
**Photo 2**

Ground Floor Lobby - View of existing storefront window removed - Work in Progress.

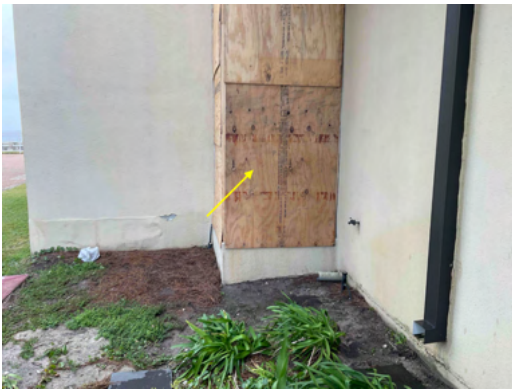
**Photo 3**

Ground Floor Lobby - View of plywood installed at exterior side of existing storefront window removal - Work in Progress.

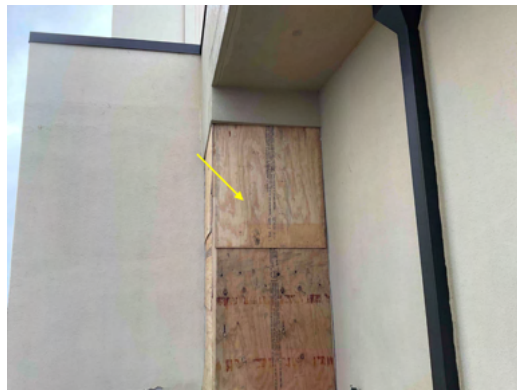
**Photo 4**

Ground Floor Lobby - View of plywood installed at exterior side of existing storefront window removal - Work in Progress.

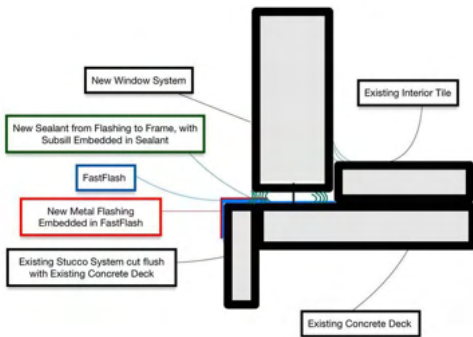
**Photo 5**

BECI Detail drawn on-site for new EFCO Storefront Window Waterproofing.

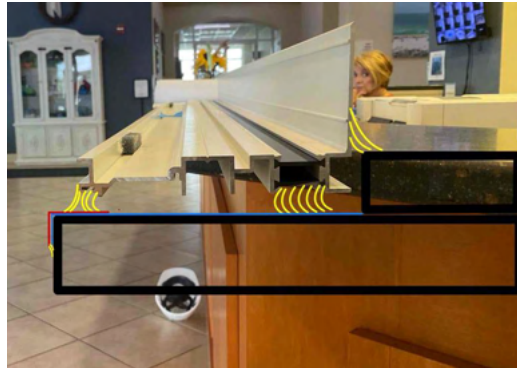
**Photo 6**

BECI Detail drawn on-site for new EFCO Storefront Window Waterproofing.
