BECI Field Report

Perdido Sun
13753 Perdido Key Dr.
Pensacola, FL 32507

FIELD REPORT NO: **PRDDSN018**
CONSULTANTS PROJECT NO: **P140741899**

Window Mock-Ups at Unit 200

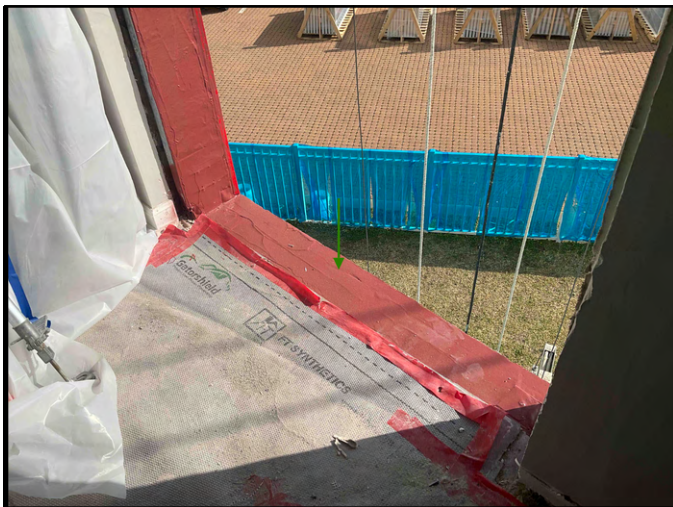
- 18.2 During our visit to Unit No. 200, we observed three (3) EFCO Series 2701 Fixed Window mock-up installations at varying stages of progress. At the Eastmost bedroom storefront window mock-up, the rough opening was noted to have Prosoco FastFlash waterproofing applied following framing repairs at the jambs. At the head, a 1x untreated wood bucking had been installed to adjust the opening height of the window and new FastFlash had been applied to maintain continuous waterproofing. The rough opening height appeared to be approximately 95-3/4 inches which complied with the Engineered Shop Drawings provided by Glass Systems of Alabama. This adjustment helps ensure proper alignment of the head and sill joints during the installation of the EFCO Series 2701 Fixed Window.

FIGURE 1 - Unit No. 200 - View of new FastFlash waterproofing installed at rough opening.

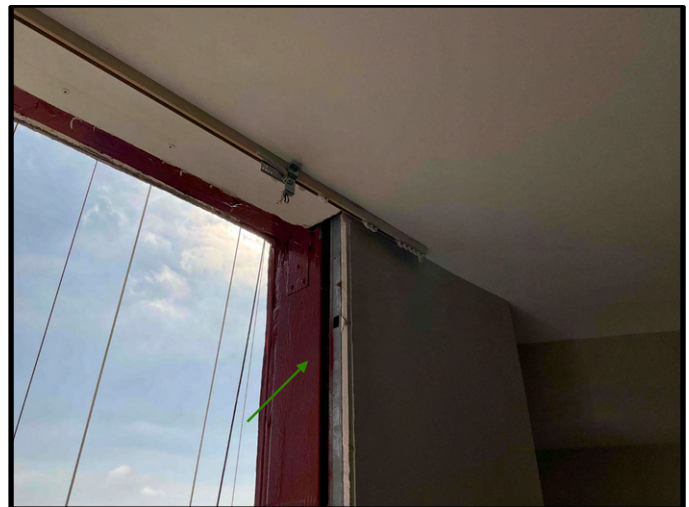
FIGURE 2 - Unit No. 200 - View of new FastFlash waterproofing installed at rough opening. Additional lumber to be installed at head of opening.

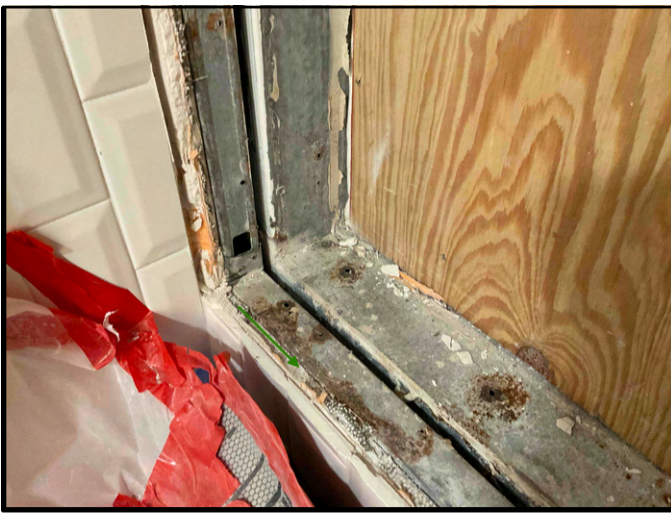
- 18.2.1 At the bathroom windows, the perimeter tile around the rough opening was removed, exposing the framing for further inspection. The framing at the head-to-northmost jamb appeared to be connected using metal channels and accessories. As per the Scope of Work, the next steps will be to apply new FastFlash waterproofing at the rough opening after the necessary preparations are completed, such as mechanical cleaning and treatment at the existing metal framing. We observed that protective measures had been installed to safeguard the surrounding areas during the construction process. We will continue to monitor developments to ensure adherence to the EFCO Series 2701 installation requirements and BECI's Waterproofing Details.

FIGURE 3 - Unit No. 200 - View of existing tile removed from rough opening.

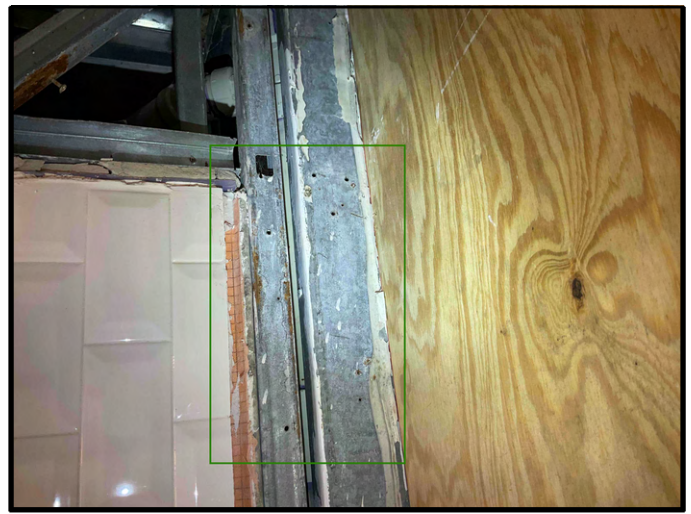
FIGURE 4 - Unit No. 200 - View of existing tile removed from rough opening.

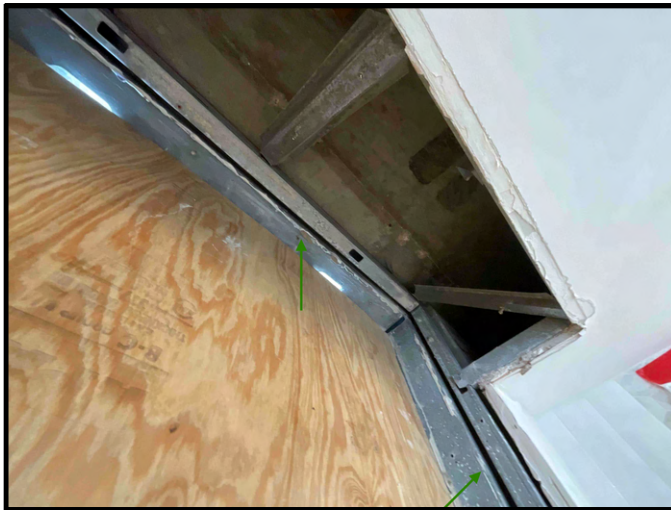
FIGURE 5 - Unit No. 200 - View of existing tile removed from rough opening.

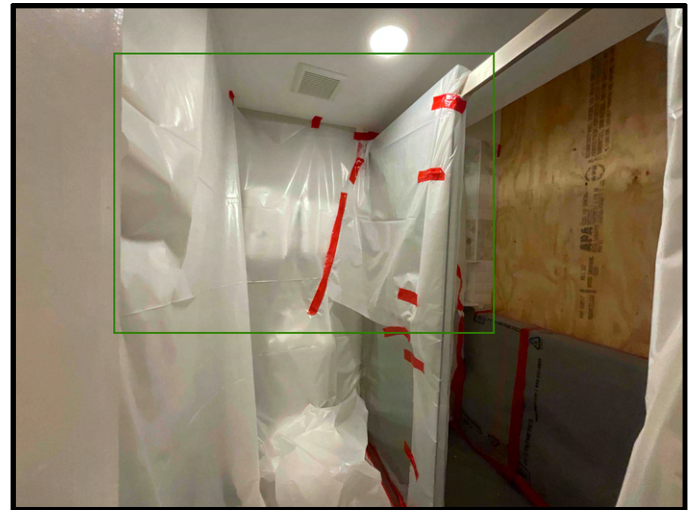
FIGURE 6 - Unit No. 200 - View of protection installed at bathroom.

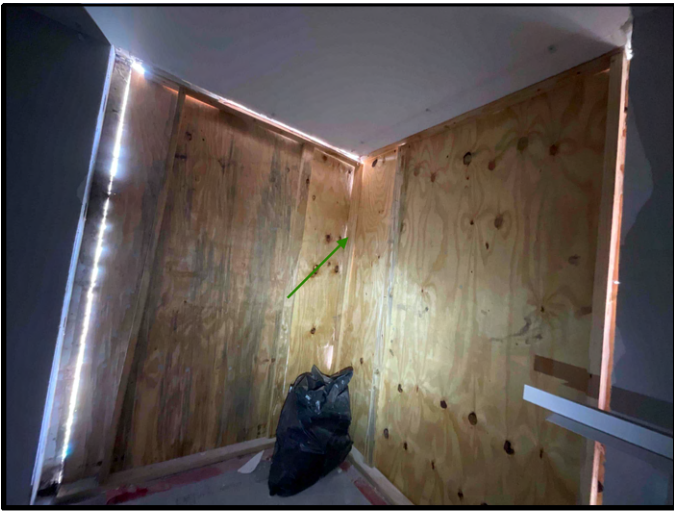
- 18.2.2 The South Corner windows presented two distinct jamb conditions. At the Eastmost jamb, the EIFS band at the edge of the concrete slab required the metal-framed jamb to be adjusted inward by approximately 2 inches to meet the required anchorage distance from the slab edge as indicated in the shop drawings. This adjustment had already been made in accordance with the detail provided by BECI in RFI #3. At the Westmost jamb, a wooden bucking was observed, consisting of two (2) 2"x4"s attached to a metal stud, with a previously installed 1x piece of lumber already removed. BECI provided detailed guidance for addressing these jamb conditions and advised that C/Sharpe consult with EFCO to confirm that the wooden substrate is suitable for current window anchorage provided in the Engineering Stamped Shop Drawings.

FIGURE 7 - Unit No. 200 - View of corner window removed.

18.2.2 12/31/2024	12/31/24 - C/Sharpe is to address the jamb conditions in accordance with the detail provided by BECI in RFI #3 and C/Sharpe is to consult with EFCO to confirm that the wooden substrate is suitable for current window anchorage provided in the Engineering Stamped Shop Drawings.	New - 12/31/2024	N/A

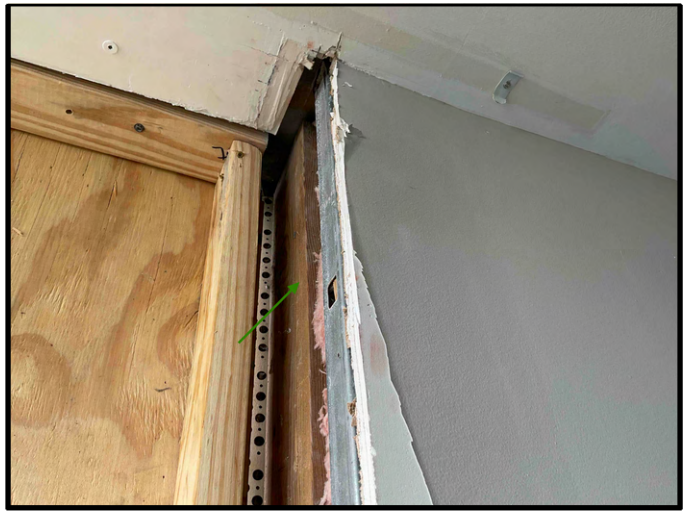
FIGURE 8 - Unit No. 200 - View of wood bucking at West Jamb.

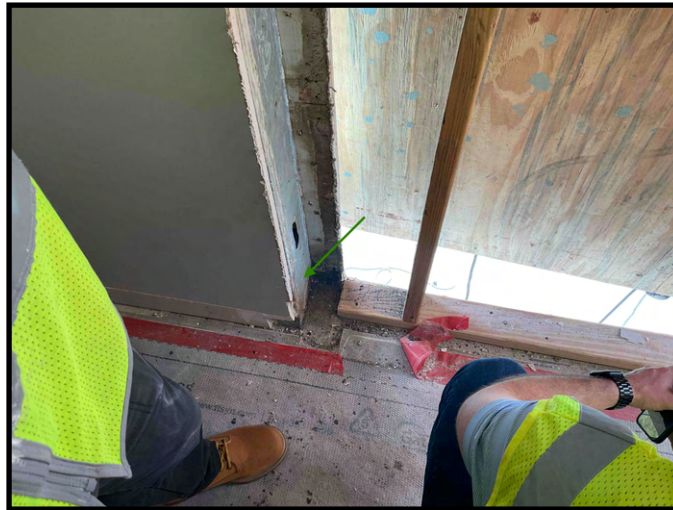
FIGURE 9 - Unit No. 200 - View of metal framing moved inwards for window installation.

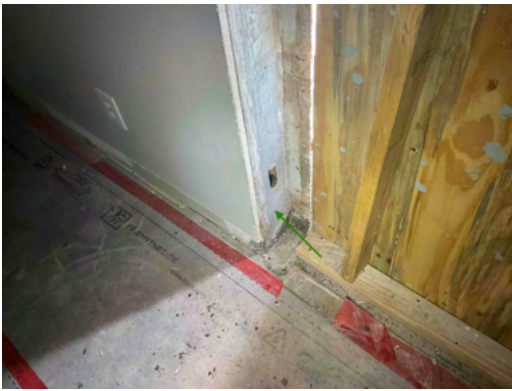
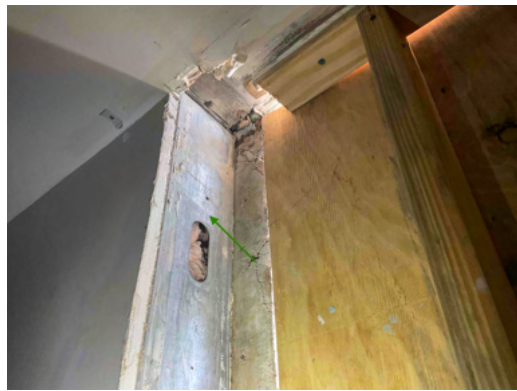
Photo 3
Unit No. 200 - View of metal framing moved inwards for window installation.

Photo 4
Unit No. 200 - View of metal framing moved inwards for window installation.

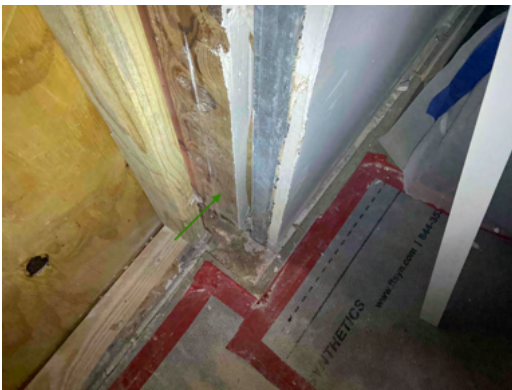
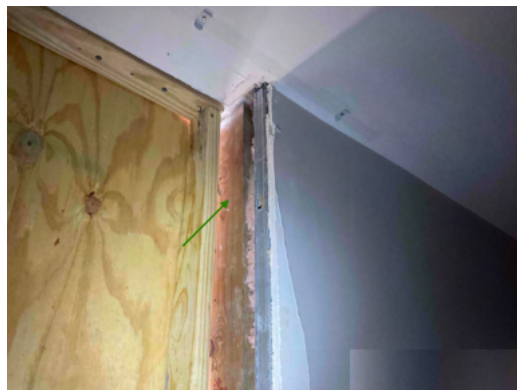
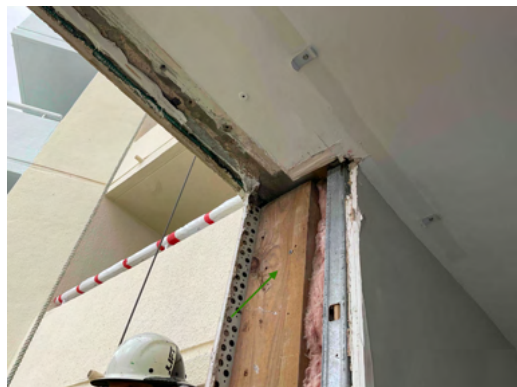
Photo 5
Unit No. 200 - View of wood bucking at West Jamb.

Photo 6
Unit No. 200 - View of wood bucking at West Jamb.

Photo 18
Unit No. 200 - View of wood bucking at West Jamb.

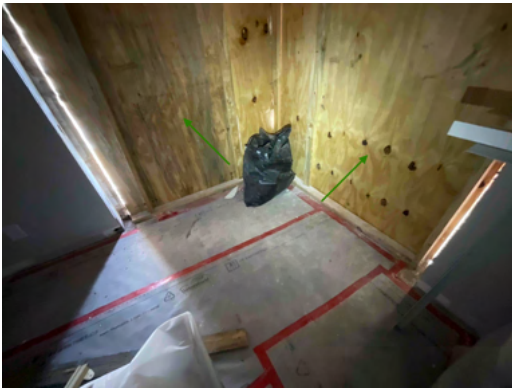
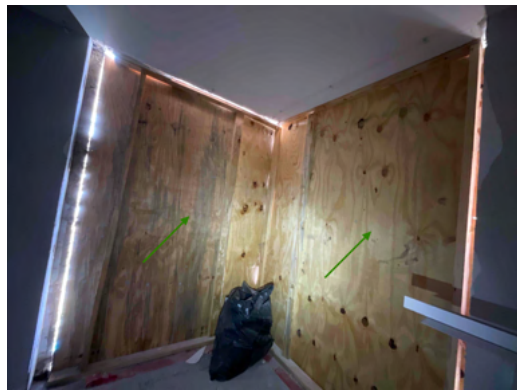
Photo 7
Unit No. 200 - View of corner window removed.

Photo 8
Unit No. 200 - View of corner window removed.

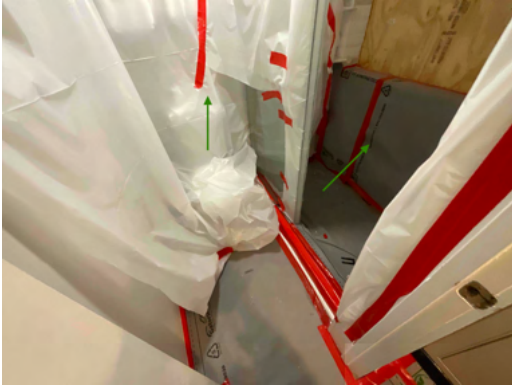
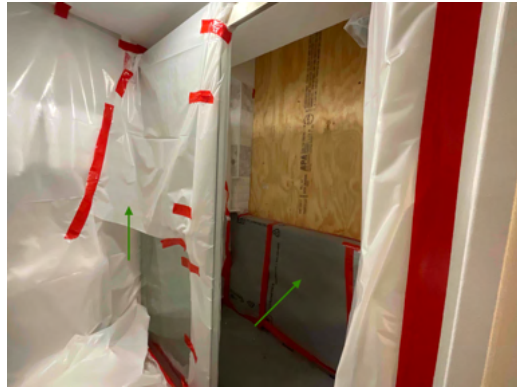
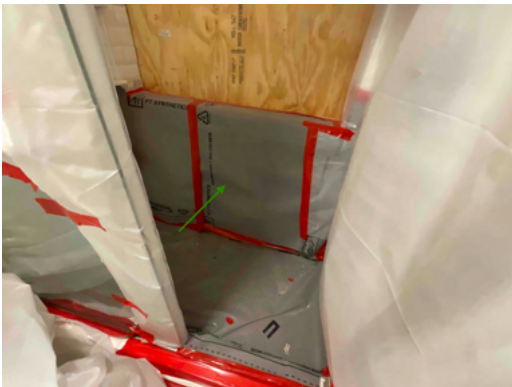
Photo 9
Unit No. 200 - View of protection installed at bathroom.

Photo 10
Unit No. 200 - View of protection installed at bathroom.

Photo 11
Unit No. 200 - View of protection installed at bathroom.

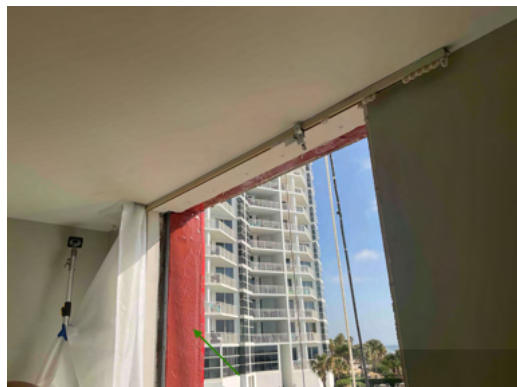
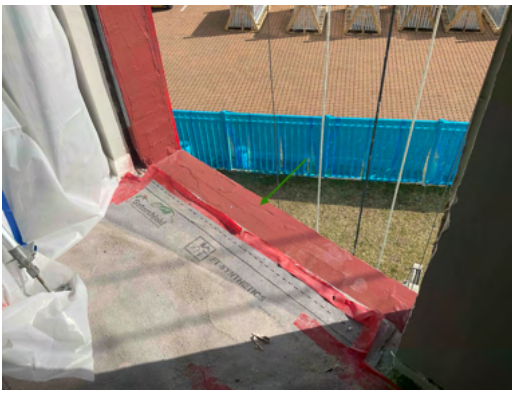
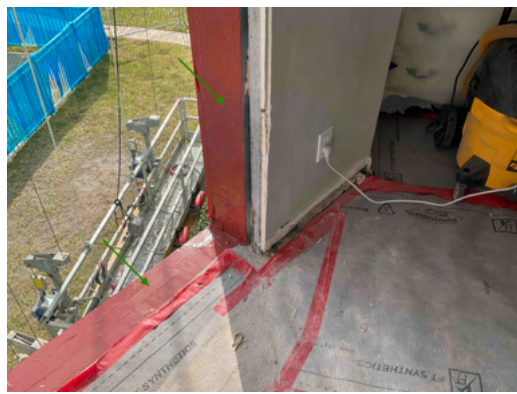
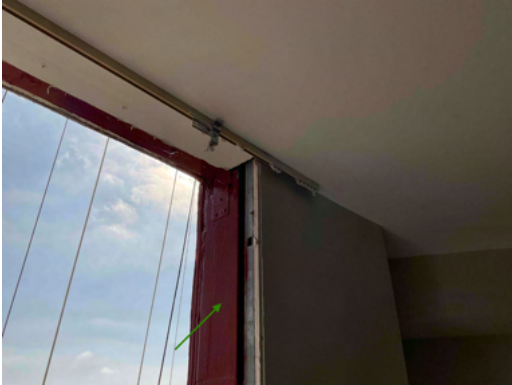
Photo 12
Unit No. 200 - View of new FastFlash waterproofing installed at rough opening.

Photo 13
Unit No. 200 - View of new FastFlash waterproofing installed at rough opening.

Photo 14
Unit No. 200 - View of new FastFlash waterproofing installed at rough opening.

Photo 15
Unit No. 200 - View of new FastFlash waterproofing installed at rough opening.

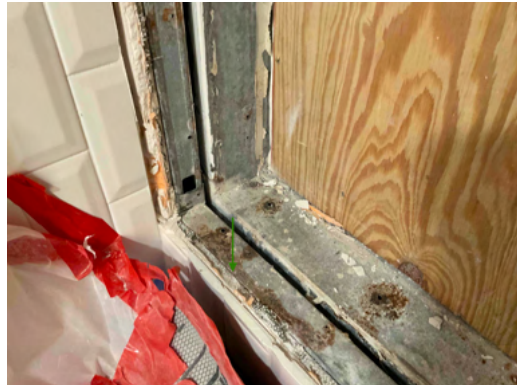
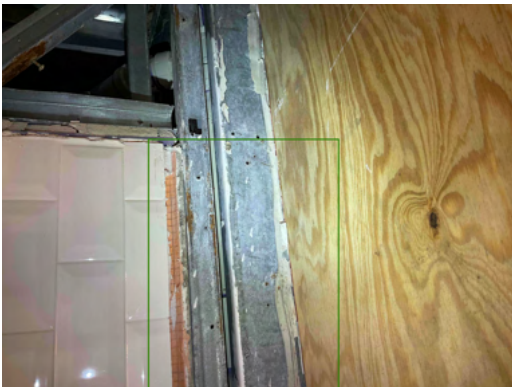
Photo 16
Unit No. 200 - View of existing tile removed from rough opening.

Photo 17
Unit No. 200 - View of existing tile removed from rough opening.

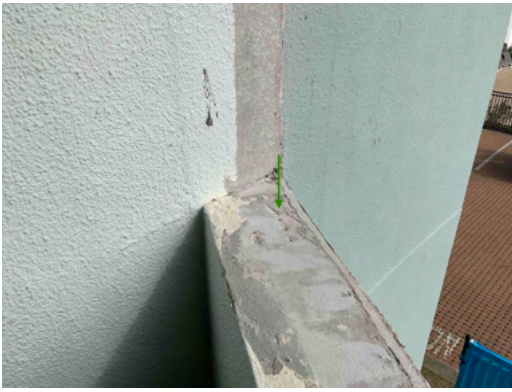
Photo 19
2nd Floor - View of concrete sill before waterproofing application.

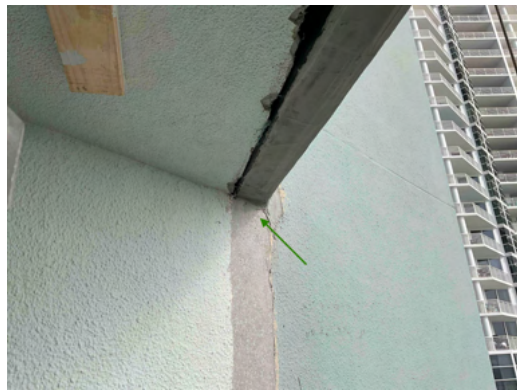
Photo 20
2nd Floor - View of stucco finish applied at new header framing.

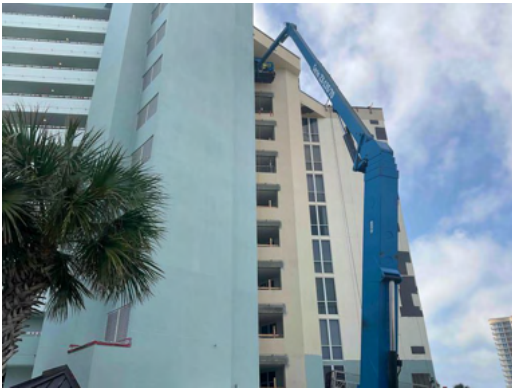
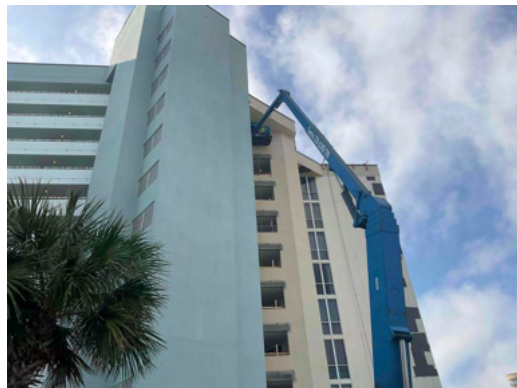
Photo 21
North Elevation - View of crew members applying new stucco at new header framing - Work in Progress.

Photo 22
North Elevation - View of crew members applying new stucco at new header framing - Work in Progress.

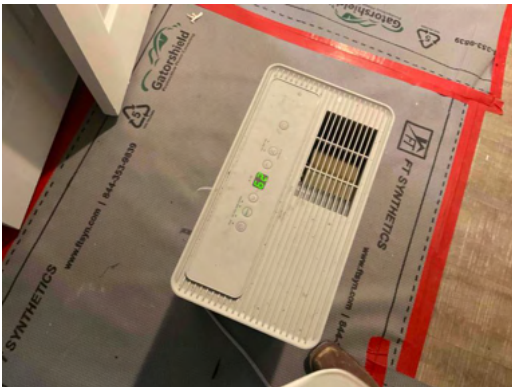
Photo 23
Unit No. 200 - View of dehumidifier running inside unit during window replacement.

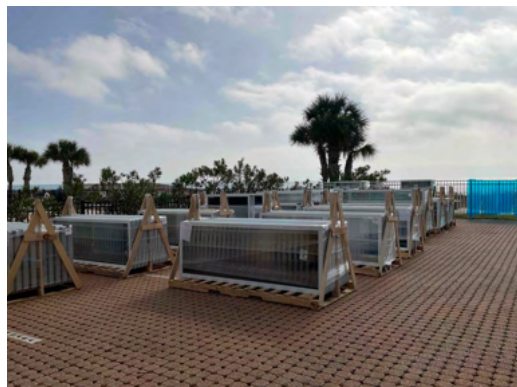
Photo 24
East Elevation - View of new EFCO windows stored on-site.

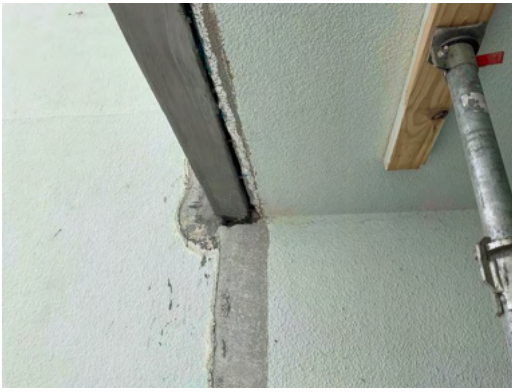
Photo 25

2nd Floor - View of stucco finish installation in progress at new window header framing.

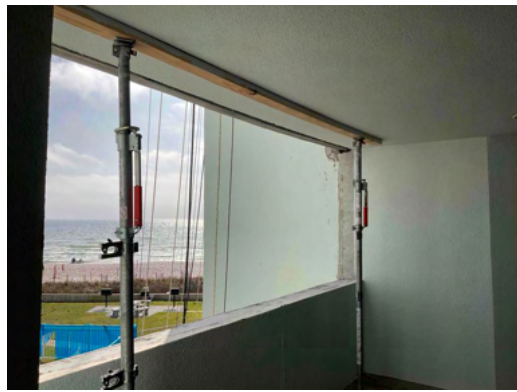
Photo 26

2nd Floor - View of stucco finish installation in progress at new window header framing.
