BECI Annual Roof Survey Report

Project:
Perdido Sun Condominiums
13753 Perdido Key Dr
Pensacola, FL 32507

REPORT YEAR: **2025**

CONSULTANT'S PROJECT NO: P01157

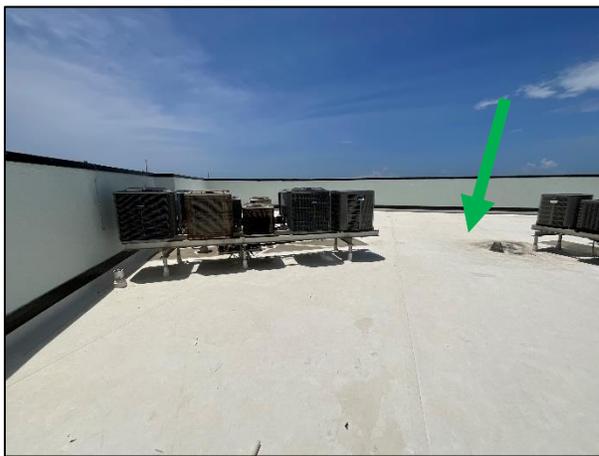
Figure 1 – Low-Slope Roof – Single-ply membrane in overall good condition.

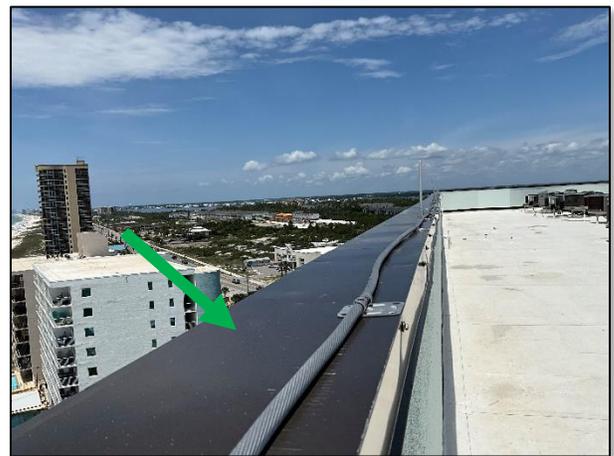
Figure 2 – Low-Slope Roof – Coping in overall good condition.

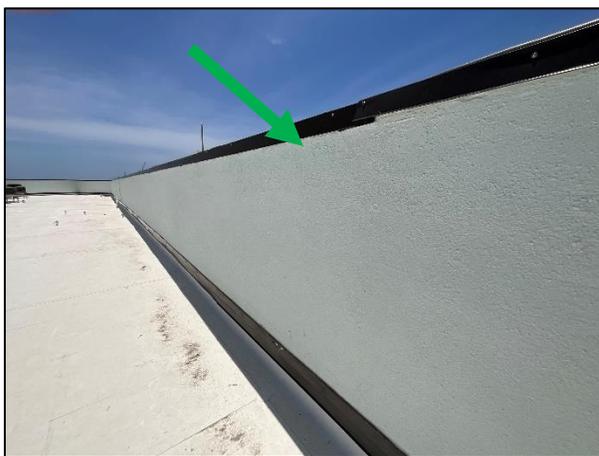
Figure 3 – Low-Slope Roof – Parapet wall in good condition with no cracking or damage present

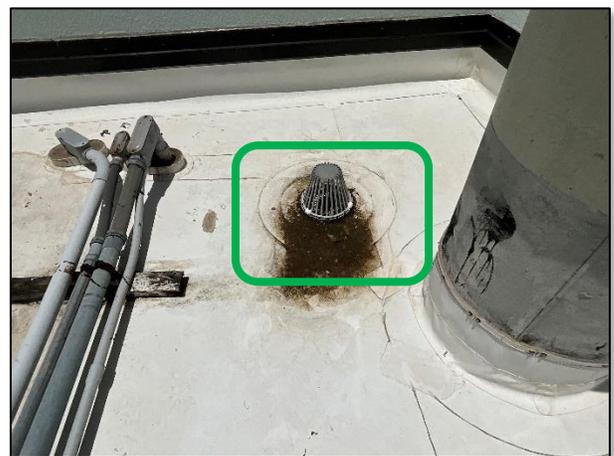
Figure 4 – Low-Slope Roof – Drain cover installed at western most drain.

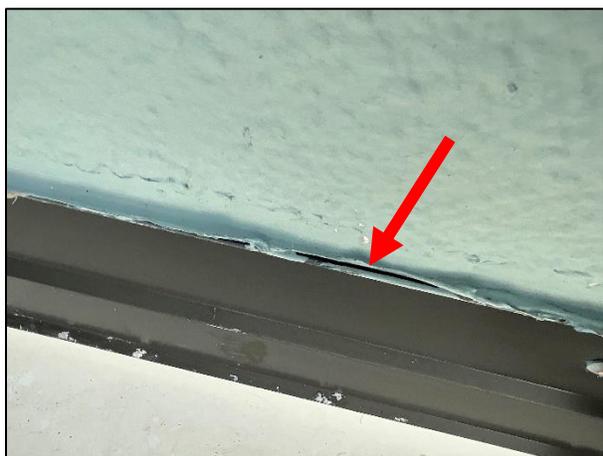
- 3.1.1 We observed the interface sealant between the metal flashing and adjacent knee wall to be in visibly deteriorated condition. The sealant installed between the metal flashing and parapet wall is compromised and should be completely removed and replaced utilizing proper surface preparation methods. It was evident that the sealant application consisted of a superficial skim coat over the previously deteriorated material (Reference Figure 5 and Photo Exhibit Nos. 13 and 14). We observed isolated voids throughout the sealant. At the Northwest mechanical room overhang, we observed the sealant to be missing from the metal flashing interface completely (Reference Photo Exhibit Nos. 15 through 18). Additionally, we noted that the protective plastic film had not been removed from the metal flashing prior to sealant application, creating an unsuitable surface for adhesion (Reference Figure 6 and Photo Exhibit Nos. 19 through 21). We observed multiple missing fasteners at several locations along the metal flashing (Reference Photo Exhibit No. 22). All of the aforementioned factors compromise the integrity of the flashing system and increase its' susceptibility to moisture infiltration. *We recommend that the interface sealant between the metal flashing and wall be removed and reapplied continuously. Upon application, a compatible coating system should be applied over the sealant. Additionally, all missing fasteners are to be replaced.*

Figure 5 – Low-Slope Roof – Superficial skim coat applied over previously deteriorated material.

1.4.4	Investigate and repair blistering of coating at the North parapet wall	Observed Corrected	Repaired
2025 Annual Roof Survey Report (Current)			
3.1.1	Remove and reapply the interface sealant between the metal flashing continuously. Upon application, a compatible coating system should be applied over the sealant. Additionally, all missing fasteners are to be replaced.	New

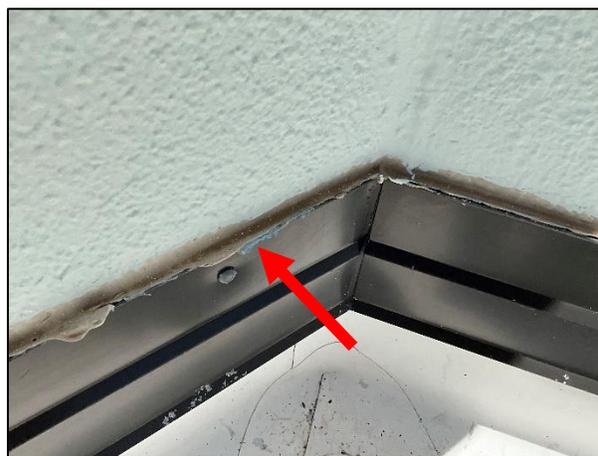
Figure 6 – Low-Slope Roof – Sealant at metal flashing interface applied over exposed plastic film.

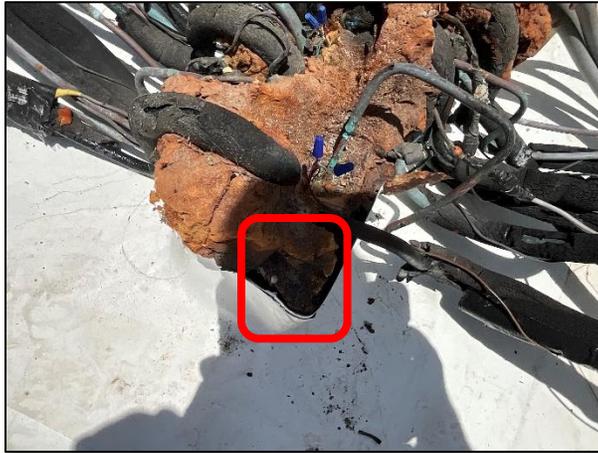
- 3.1.2 At the penetration point around AC conduit lines, the waterproofing membrane detailing was notably deficient. The membrane was not adequately sealed around the conduit entries (Reference Figure 7 and Photo Exhibit Nos. 23 and 24). This allows a clear pathways for water entry into the roofing system. These penetration points are covered with retrofit metal covers; however, wind-driven rain and condensation can enter the roof system at these locations. *We recommend sealing the waterproofing membrane at these locations.*

Figure 7 – Low-Slope Roof – Typical void around AC conduit.

3.1.2	Seal the waterproofing membrane at all penetration points around AC conduit lines.	New	
3.1.3	Seal the corners of the threshold at the roof access door.	New

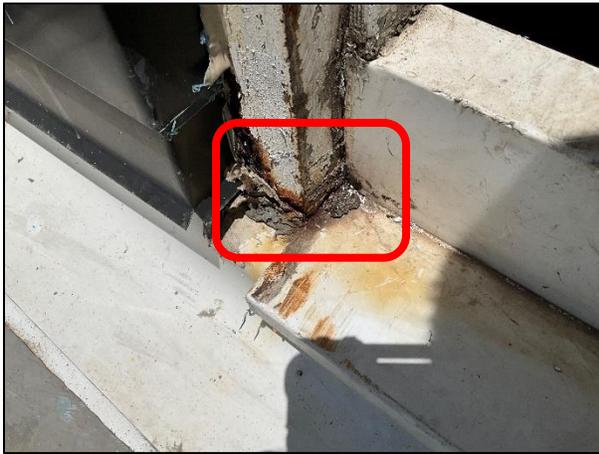
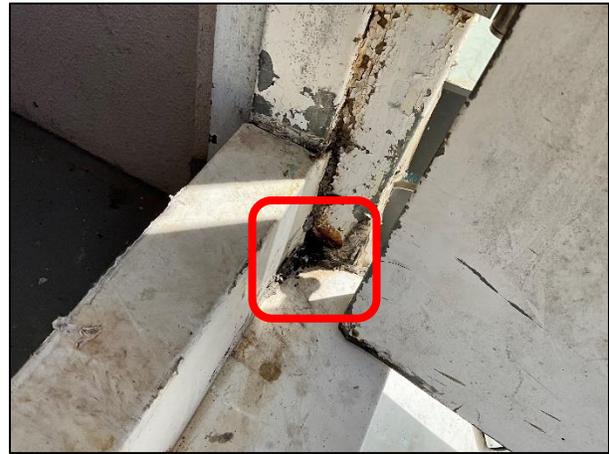
- 3.1.3 The threshold at the roof access door was found to be in poor condition, with visible signs of deterioration that could allow water entry into the rood system during heavy wind-driven rain conditions (Reference Figures 8 and 9 and Photo Exhibit Nos. 25 and 26). *We recommend sealing the corners of the threshold at this location.*

Figure 8 – Low-Slope Roof – Sealant at roof access door threshold in poor condition.

Figure 9 – Low-Slope Roof – Sealant at roof access door threshold in poor condition.

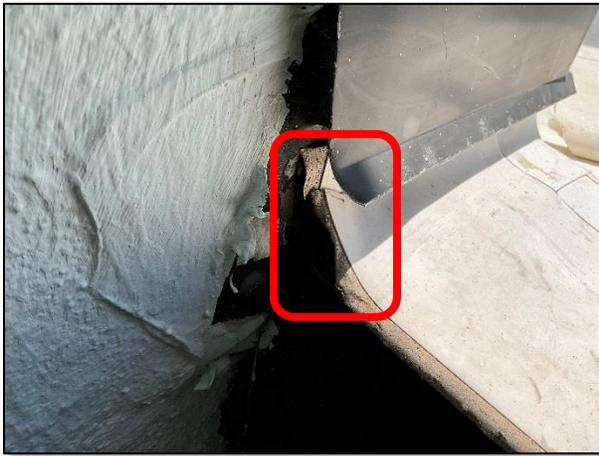
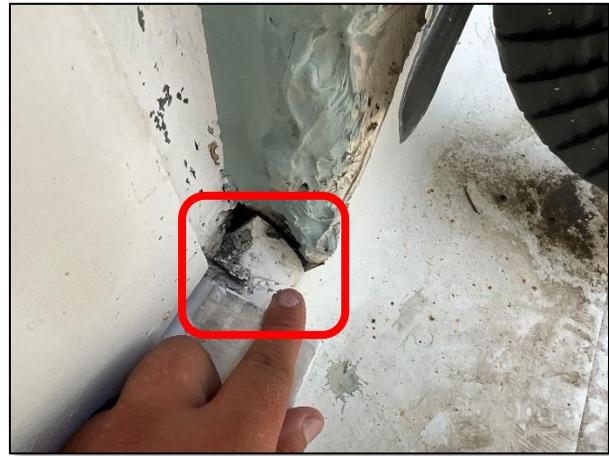
- 3.1.4 At the alcove opening adjacent to the roof access door, we noted a section of roofing membrane that was loose and unbonded beneath the metalflashing. We noted an additional void at the lower right corner of the Noreast elevator equipment room door. These conditions could allow water to travel underneath the membrane system and into the roof assembly (Reference Figures 10 and 11 and Photo Exhibit Nos. 27 through 30). *We recommend sealing the two (2) unbonded and loose membrane locations.*

3.1.4	Seal two (2) locations of loose and unbonded roof membrane.	New	
3.1.5	Remediate the corrosion at the roof access and MEP metal doors and frames.	New

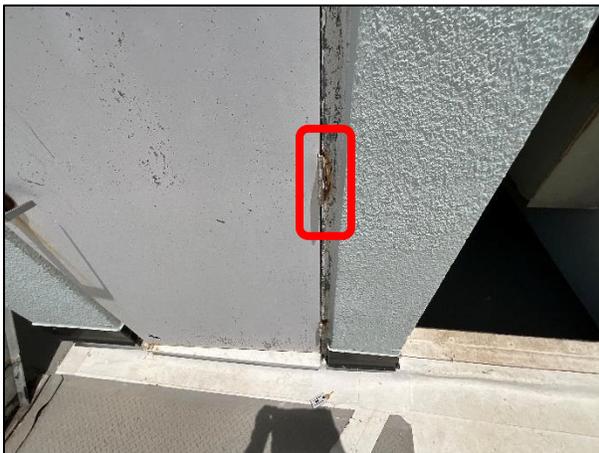
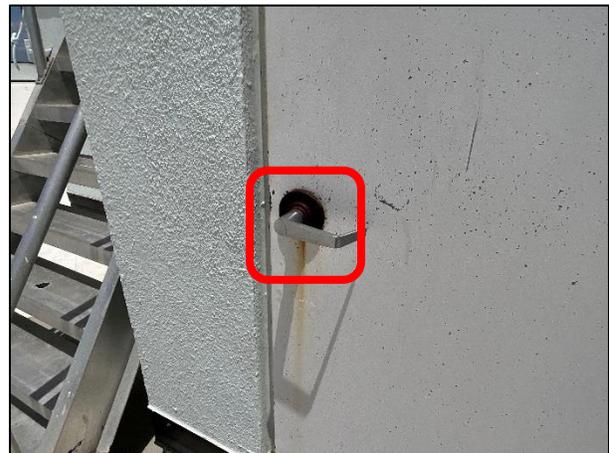
3.1.5 At the metal doors and frames of the roof access and MEP (Mechanical, Electrical, and Plumbing), we observed minor-to-moderate corrosion (Reference Figures 12 and 13 and Photo Exhibit Nos. 31 through 35). The corrosion appeared to be surface-level in most cases, consistent with prolonged exposure to moisture and insufficient coating maintenance. *We recommend cleaning all affected surfaces to remove corrosion and oxidation. A corrosion inhibitor should then be applied to the affected surfaces. Then, the doors are to be sealed with a protective coating to prevent further oxidation and corrosion of the metal door frames.*

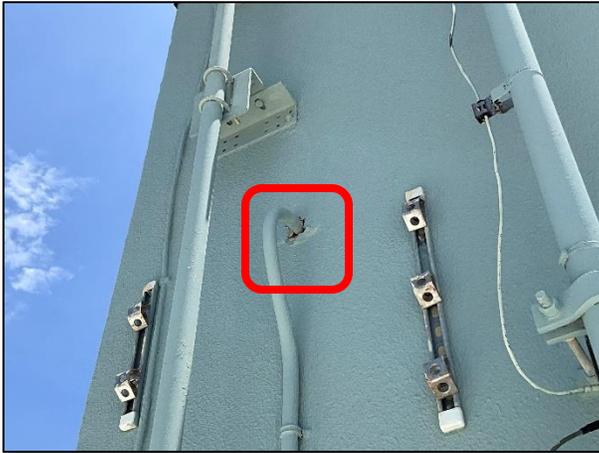
3.1.6 We noted one (1) unsealed wall penetration at the Northwest tower on the North elevation wall. (Reference Figure 14 and Photo Exhibit Nos. 36 and 37). *We recommend sealing the perimeter of the wall penetration to prevent water intrusion from occurring.*

3.1.6	Seal the one (1) isolated unsealed wall penetration at the Northwest tower on the North elevation wall.	New

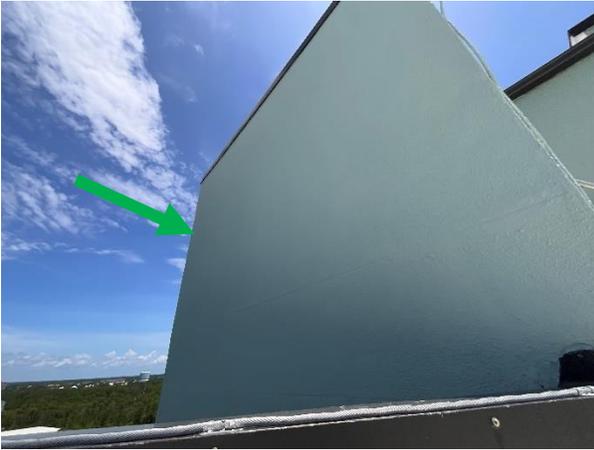
Photo 1
Low-Slope Roof – Stucco cladding in overall good condition.

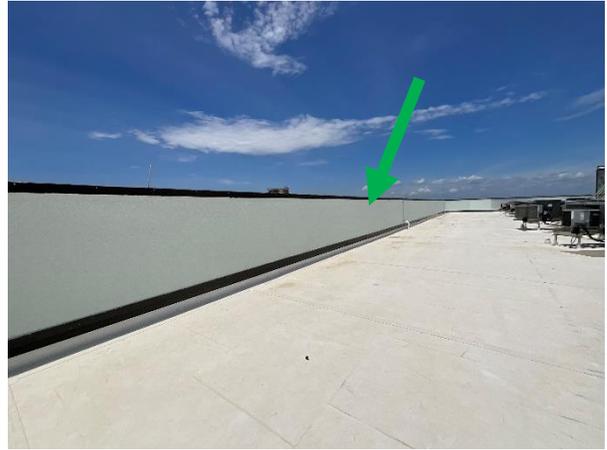
Photo 4
Low-Slope Roof – Parapet wall in overall good condition.

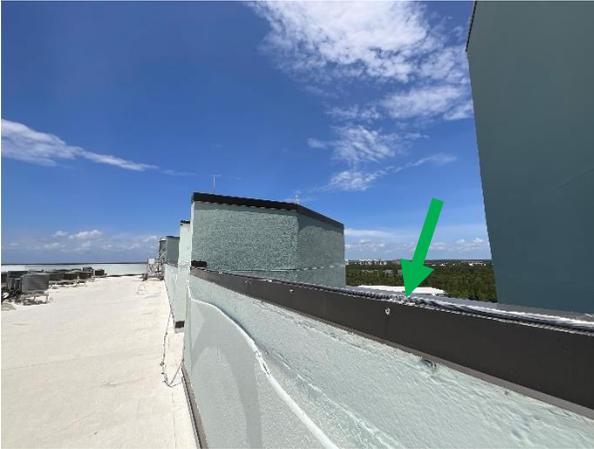
Photo 2
Low-Slope Roof – Coping in overall good condition.

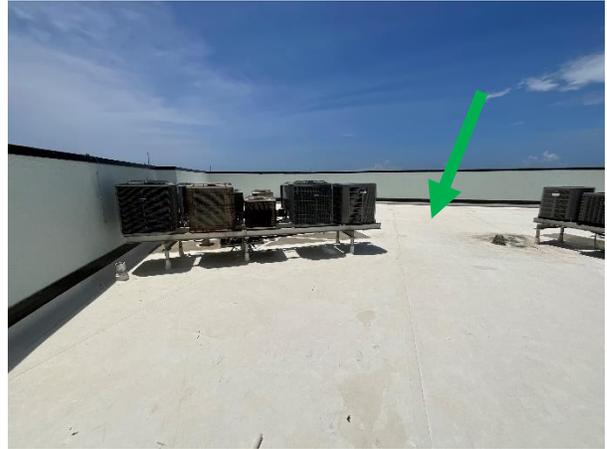
Photo 5
Low-Slope Roof – Single-ply membrane in overall good condition.

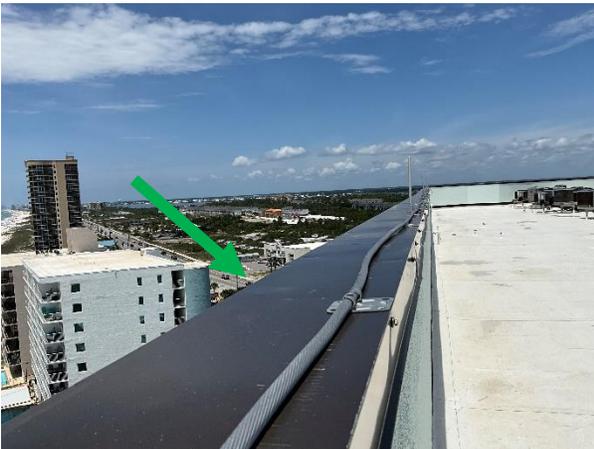
Photo 3
Low-Slope Roof – Coping in overall good condition.

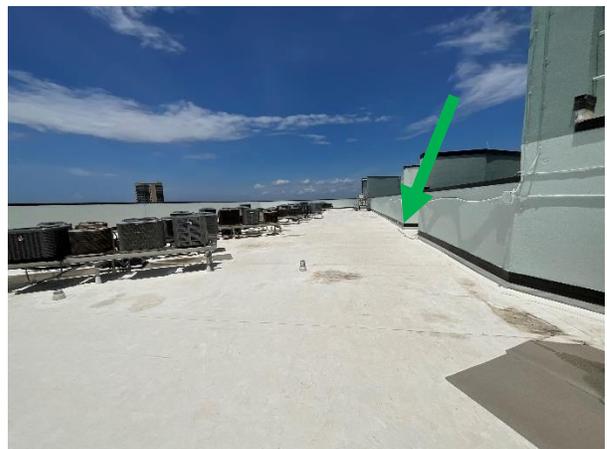
Photo 6
Low-Slope Roof – Single-ply membrane in overall good condition.

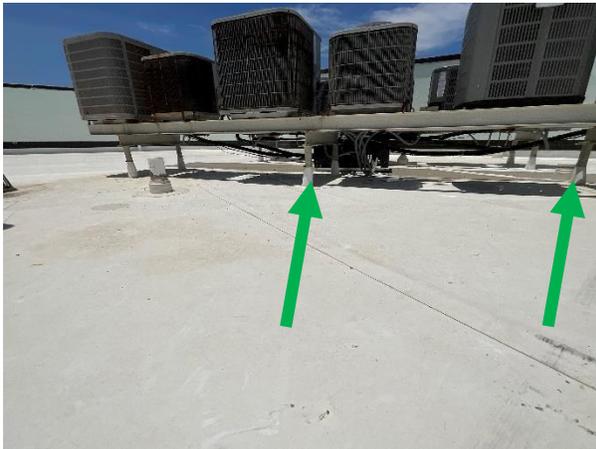
Photo 7
Low-Slope Roof – HVAC racks and pipe flashing boots in overall good condition.

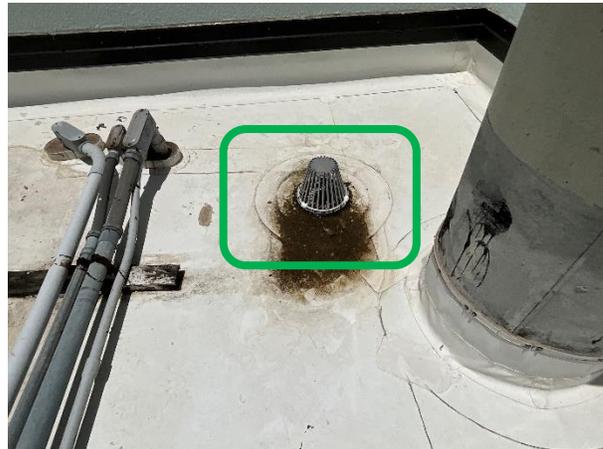
Photo 10
Low-Slope Roof – Drain cover installed at western most drain.

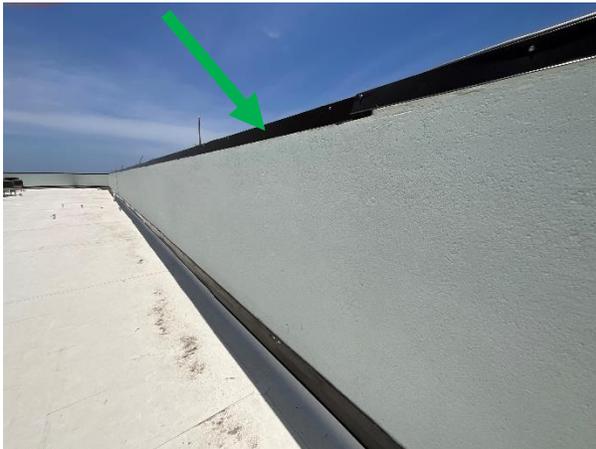
Photo 8
Low-Slope Roof – Parapet wall in good condition with no cracking or damage present.

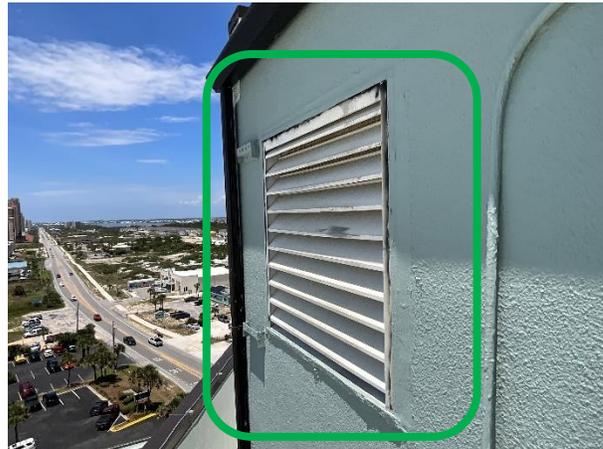
Photo 11
Low-Slope Roof – View of louver perimeter sealed to the cladding with protective coating applied.

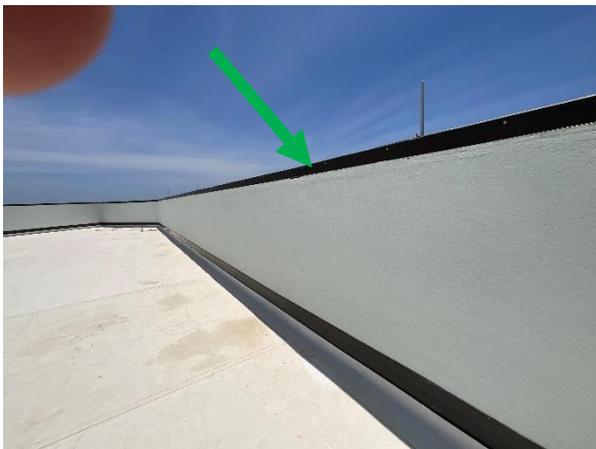
Photo 9
Low-Slope Roof – Parapet wall in good condition with no cracking or damage present.

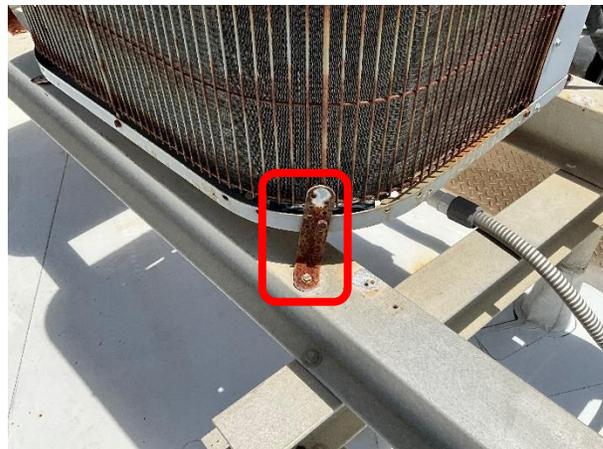
Photo 12
Low-Slope Roof – Corrosion present at HVAC unit hurricane strap.

SECTION	DESCRIPTION	STATUS & ACTION TAKEN	RESOLUTION
2023 Annual Roof Survey Report			
1.8.1	Remove and replace all corroded hurricane straps at HVAC units.	Outstanding

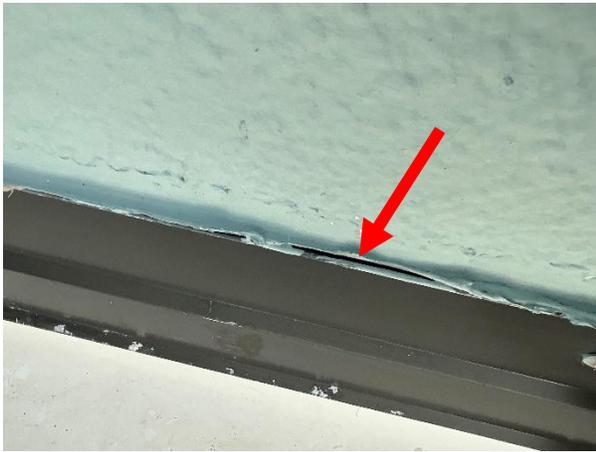
Photo 13
Low-Slope Roof – Superficial skim coat applied over previously deteriorated material.

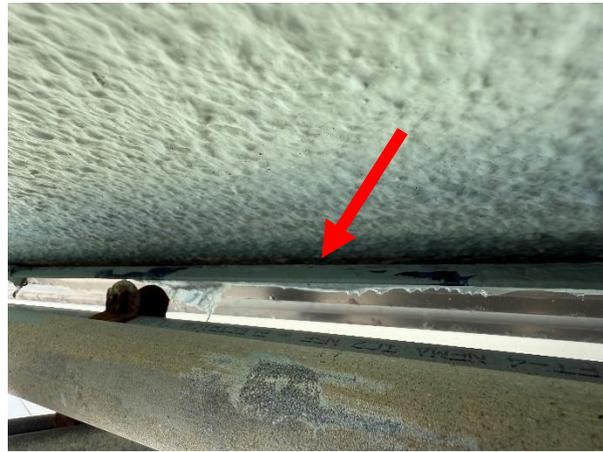
Photo 16
Low-Slope Roof – Missing sealant at metal flashing interface.

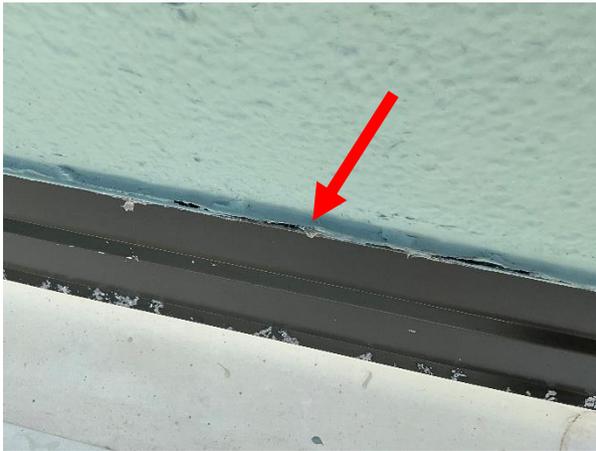
Photo 14
Low-Slope Roof – Superficial skim coat applied over previously deteriorated material.

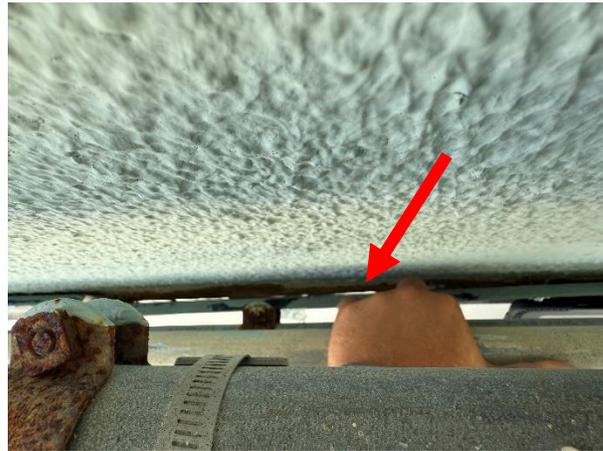
Photo 17
Low-Slope Roof – Missing sealant at metal flashing interface.

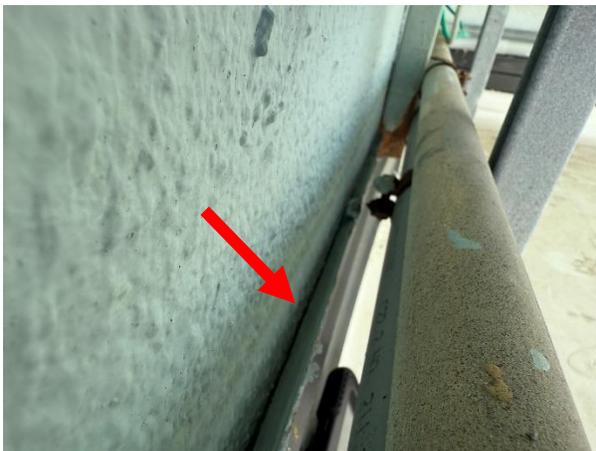
Photo 15
Low-Slope Roof – Missing sealant at metal flashing interface.

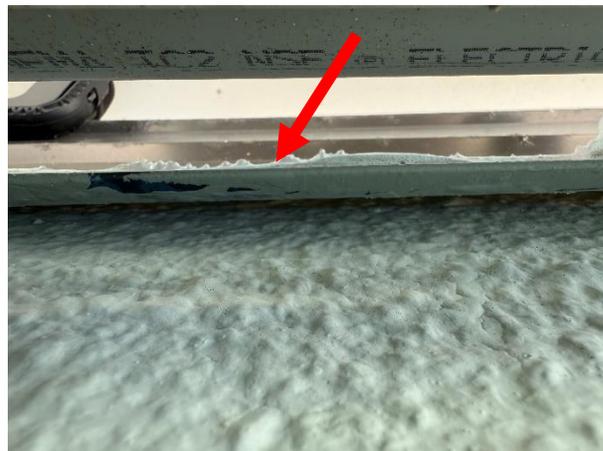
Photo 18
Low-Slope Roof – Missing sealant at metal flashing interface.

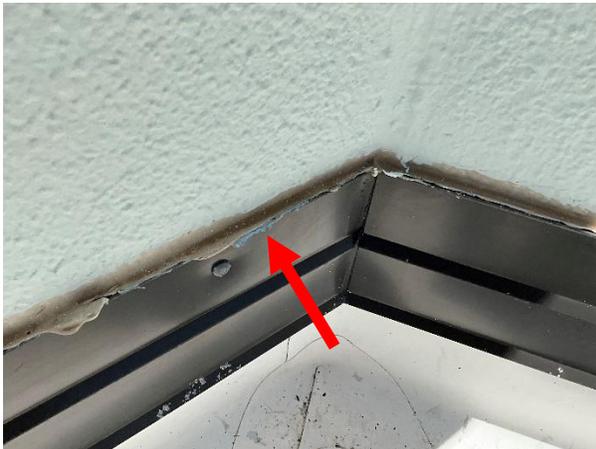
Photo 19
Low-Slope Roof – Sealant at metal flashing interface applied over exposed plastic film.

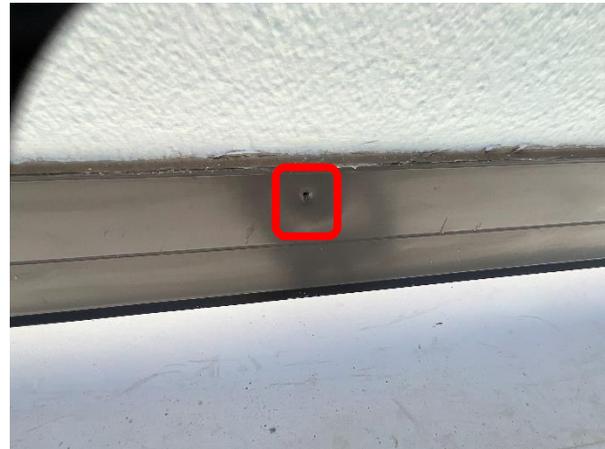
Photo 22
Low-Slope Roof – Hole present due to missing fastener.

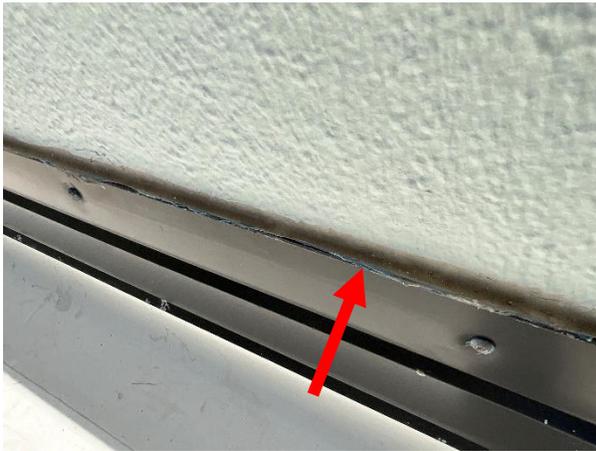
Photo 20
Low-Slope Roof – Sealant at metal flashing interface applied over exposed plastic film.

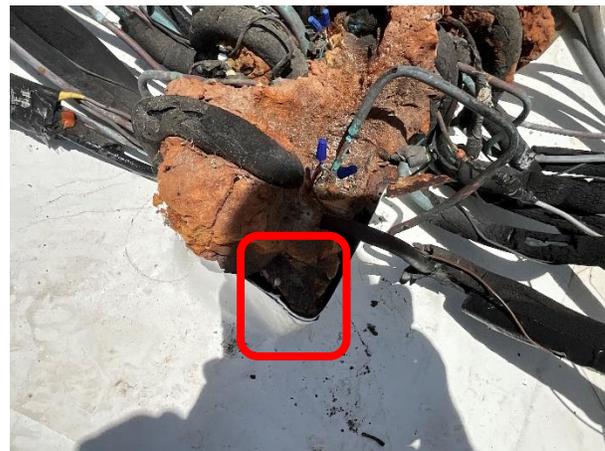
Photo 23
Low-Slope Roof – Typical void around AC conduit.

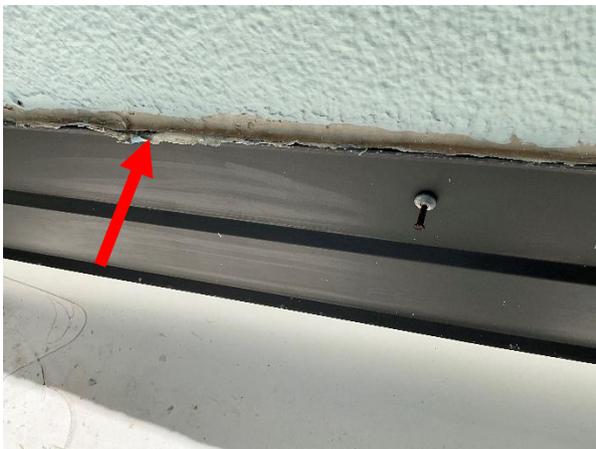
Photo 21
Low-Slope Roof – Sealant at metal flashing interface applied over exposed plastic film.

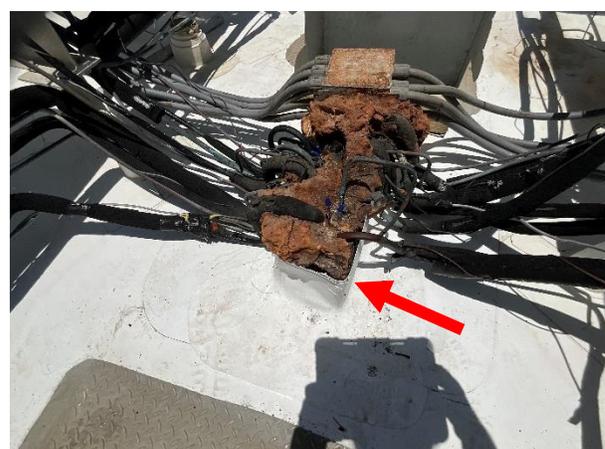
Photo 24
Low-Slope Roof – Typical void around AC conduit.

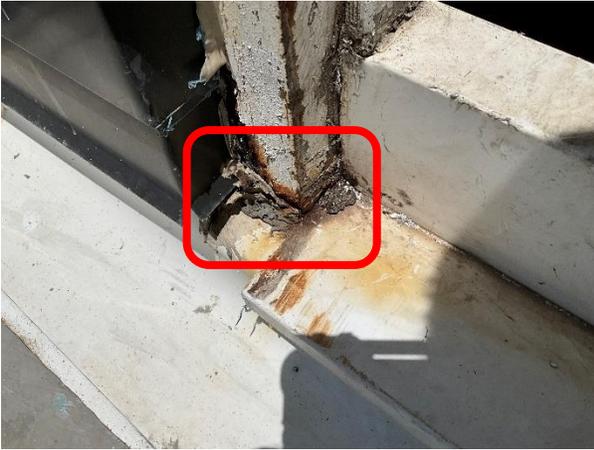
Photo 25
Low-Slope Roof – Roof access door threshold sealant in poor condition.

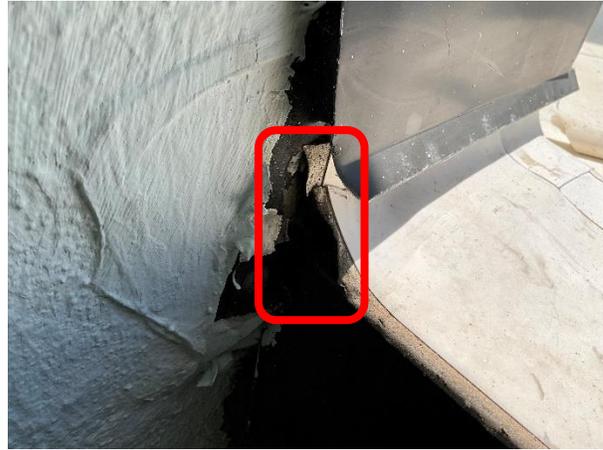
Photo 28
Low-Slope Roof – Loose and unbonded membrane at alcove.

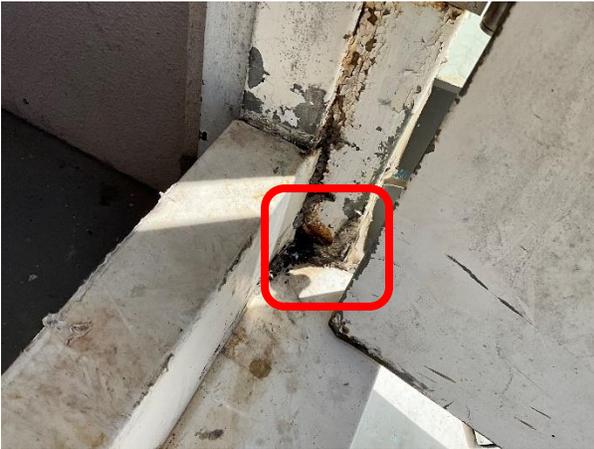
Photo 26
Low-Slope Roof – Roof access door threshold sealant in poor condition

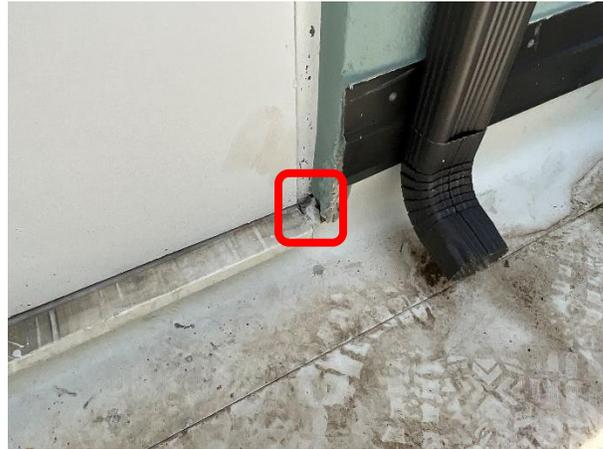
Photo 29
Low-Slope Roof – Loose and unbonded membrane at Northeast elevator equipment door.

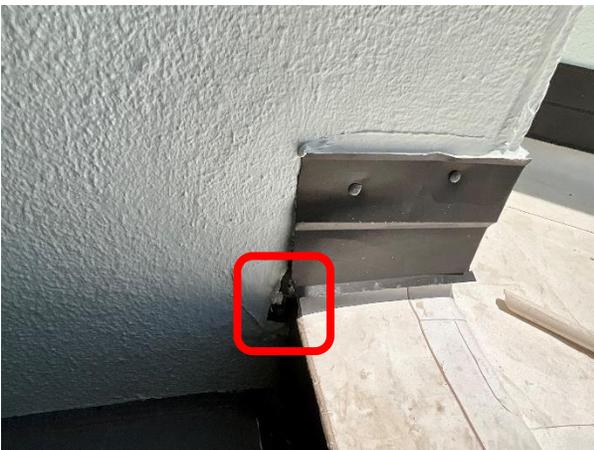
Photo 27
Low-Slope Roof – Loose and unbonded membrane at alcove.

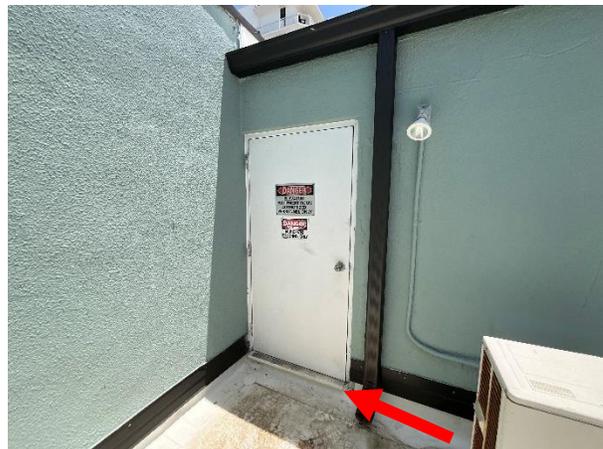
Photo 30
Low-Slope Roof – Loose and unbonded membrane at Northeast elevator equipment door.

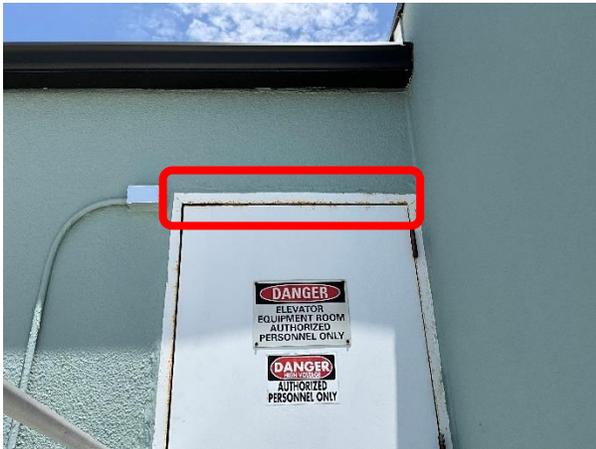
Photo 31
Low-Slope Roof – Minor corrosion on door and frame of MEP door.

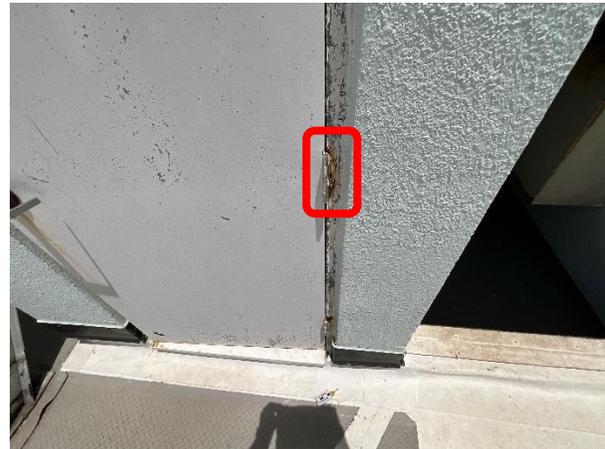
Photo 34
Low-Slope Roof – Minor corrosion on hardware of roof access door.

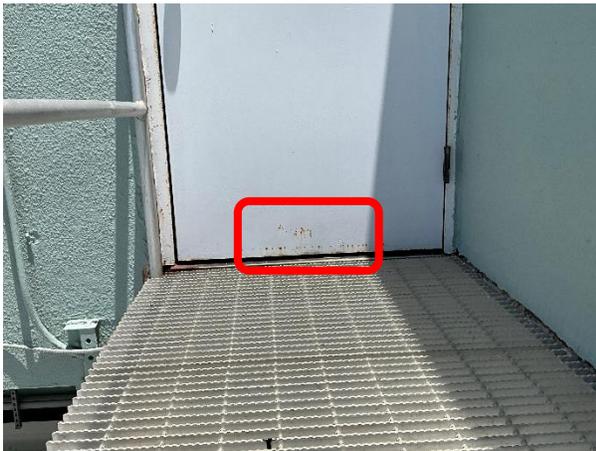
Photo 32
Low-Slope Roof – Minor corrosion on door and frame of MEP door.

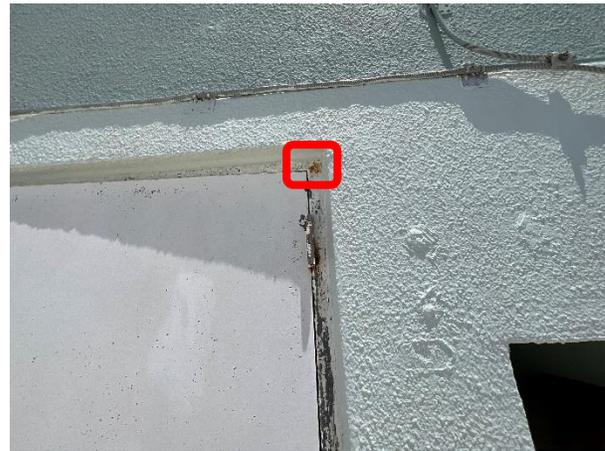
Photo 35
Low-Slope Roof – Minor corrosion on frame of roof access door.

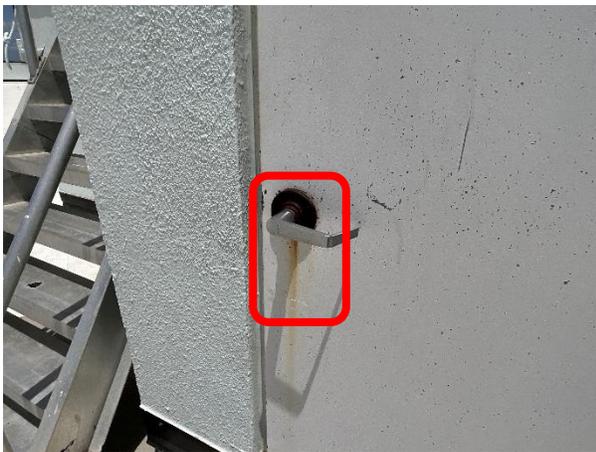
Photo 33
Low-Slope Roof – Moderate corrosion on hardware of roof access door.

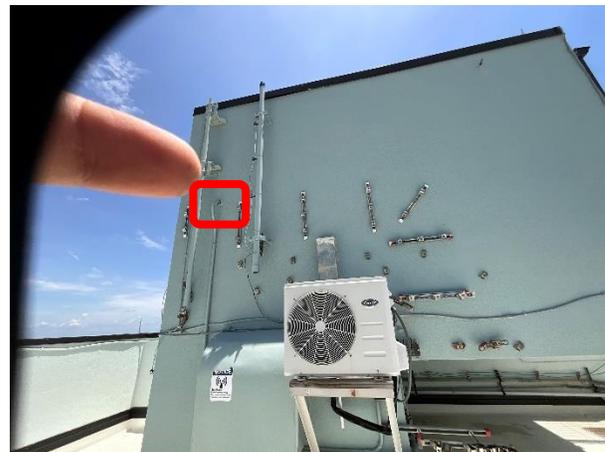
Photo 36
Low-Slope Roof – Isolated unsealed wall penetration.

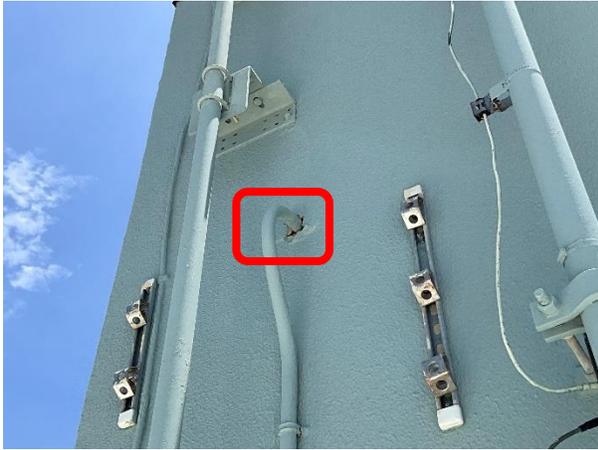
Photo 37
Low-Slope Roof – Isolated unsealed wall penetration.
