BE-CI Annual Exterior Wall Survey Report

Project:
Perdido Sun Condominiums
13753 Perdido Key Dr.
Pensacola, FL 32507

REPORT YEAR: **2025**

CONSULTANT'S PROJECT NO: P01157

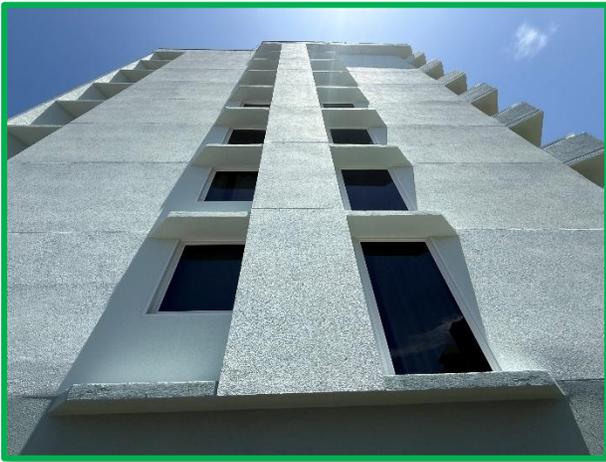
Figure 1 – West Elevation – New coatings and windows in overall good condition.

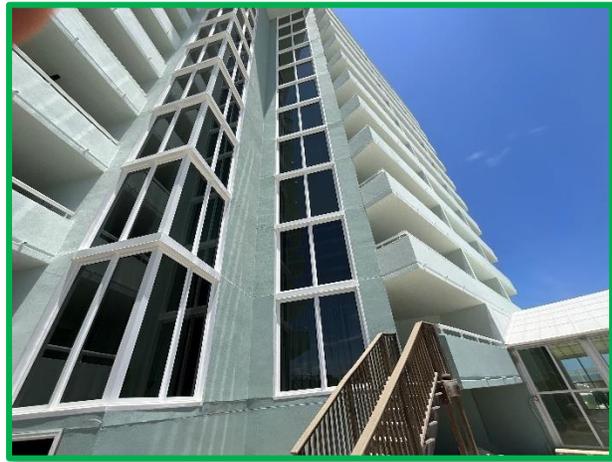
Figure 2 – South Elevation – New coatings and windows in overall good condition.

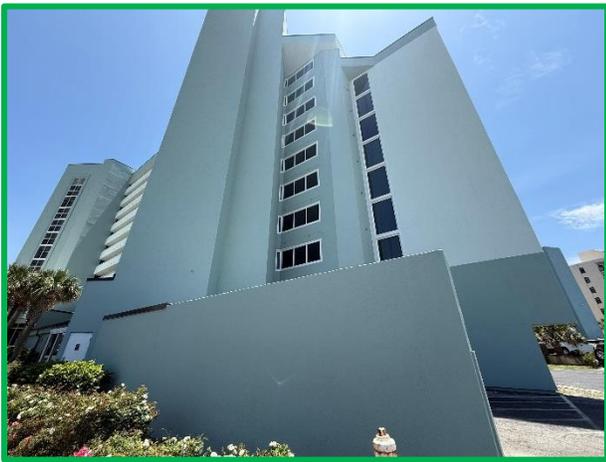
Figure 3 – North Elevation – New coatings and windows in overall good condition.

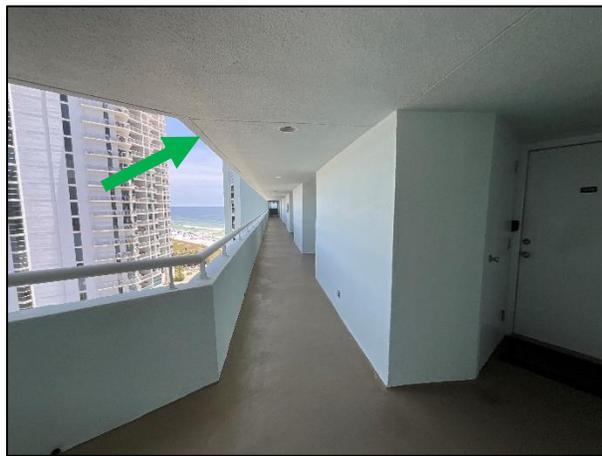
Figure 4 – North Elevation – Common Walkways – Floor 10 – New coatings in overall good condition.

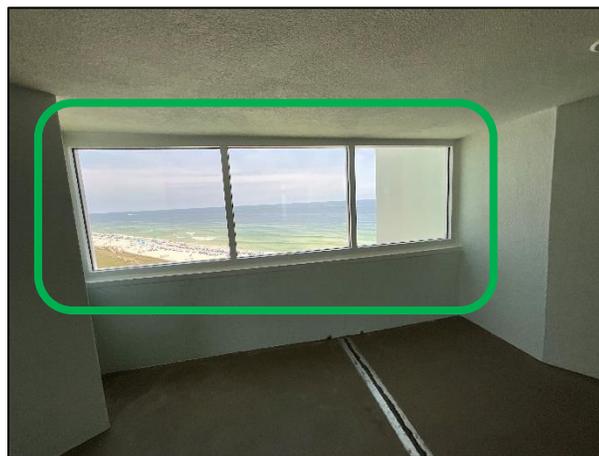
**Figure 5 – North Elevation – Common Walkways –
Floor 9 – New window in overall good condition.**

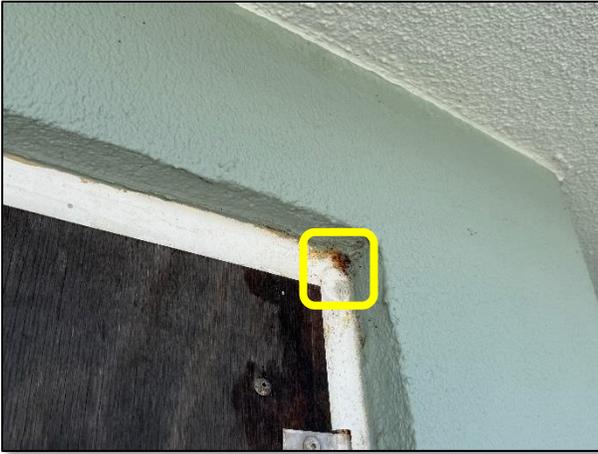
3.1.1. At the doors of the ground floor maintenance rooms located at the Northwest corner of the building, the corrosion noted during our previous 2024 Annual Exterior Wall Survey has progressed. We observed minor-to-moderate corrosion at the steel door frames and door hardware of the doors (Reference Figures 6 and 7 and Photo Exhibit Nos. 48 through 54). *We recommend removing all corrosion and applying a corrosion inhibitor. Then, the doors are to be sealed with a protective coating to prevent further oxidation and corrosion of the metal door frames.*

Figure 6 – North Elevation – Moderate corrosion present on door frame.

3.1.1	Northwest Corner – Repair further corrosion on steel door frames and hardware.	New	
3.1.2	South Elevation – Replace missing perimeter sealant between door frame and cladding at single maintenance closet door.	New

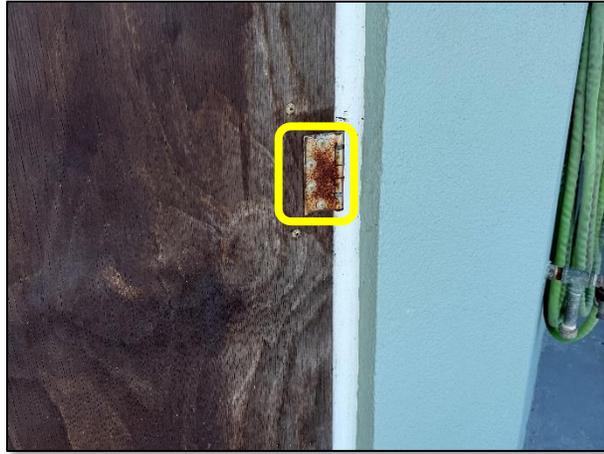
Figure 7 – North Elevation – Moderate corrosion present on door hardware.

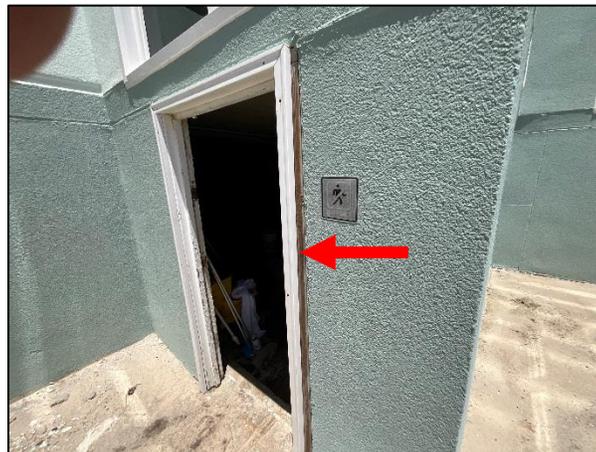
3.1.2 At the single door of the maintenance closet located on the South elevation of the building, we noted the door frame missing perimeter sealant between the frame and the cladding (Reference Figure 8 and Photo Exhibit Nos. 55 through 57). *We recommend replacing the missing perimeter sealant between door frame and cladding at single maintenance closet door.*

Figure 8 – South Elevation – Missing perimeter sealant between door frame and stucco cladding.

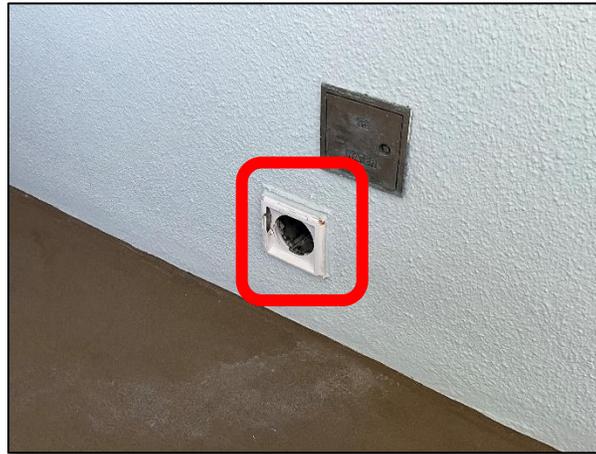
- 3.1.3 On Floor 11 of the common walkways, we observed a missing dryer vent louver at Unit 1100 (Reference Figure 9 and Photo Exhibit Nos. 58 and 59). Additionally, at Floor 7, we observed a damaged dryer vent louver at Unit 700 (Reference Photo Exhibit Nos. 60 and 61). *We recommend replacing the missing dryer vent louver at Unit 1100 and replacing the damaged dryer vent louver at Unit 700.*

Figure 9 – North Elevation – Common Walkways – Floor 11 – Unit 1102 – Missing dryer vent louver.

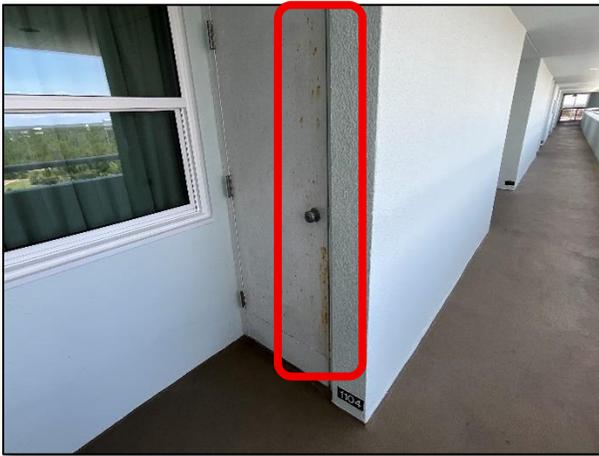
- 3.1.4 At the metal doors, frames, and hardware of the storage, mechanical, and stairway doors of the common walkways, we observed minor-to-moderate corrosion (Reference Figures 10 and 11 and Photo Exhibit Nos. 62 through 68). The corrosion appeared to be surface-level in most cases, consistent with prolonged exposure to moisture and insufficient coating maintenance. *We recommend cleaning all affected surfaces to remove corrosion and oxidation. A corrosion inhibitor should then be applied to the affected surfaces. Then, the doors are to be sealed with a protective coating to prevent further oxidation and corrosion of the metal door frames.*

Figure 10 – North Elevation – Common Walkways – Floor 11 – Corrosion present at door and frames.

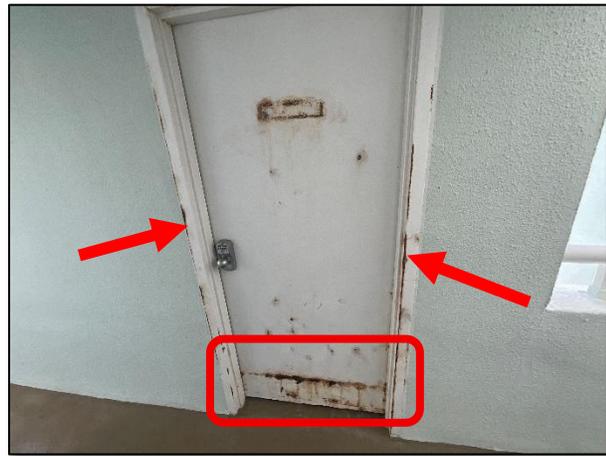
Figure 11 – North Elevation – Common Walkways – Floor 4 – Corrosion present at door and frames.

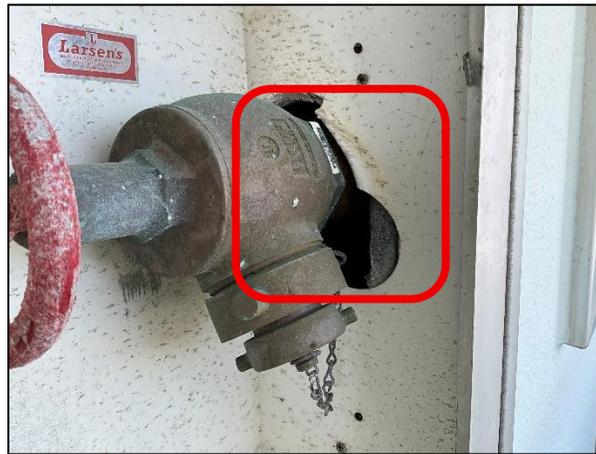
- 3.1.5 At Floors 11 through 9 of the common walkways, we observed the fire system wall penetrations to be missing approved plastic/glass cover assemblies over the systems. We noted voids in the wall system at these locations where the wall framing was visible (Reference Figure 12 and Photo Exhibit Nos. 69 through 74). *We recommend the covers at the fire system wall penetrations at Floors 11 through 9 be replaced.*

Figure 12 – North Elevation – Common Walkways – Floor 11 – Opening in wall at fire wall penetration.

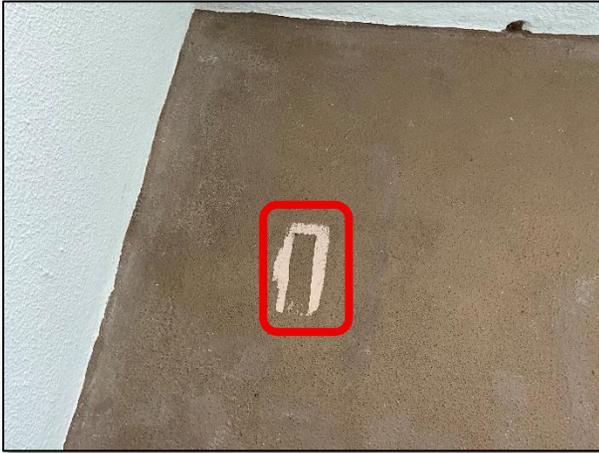
- 3.1.6 We observed the deck coating on the common walkways to be in overall fair condition, with several isolated damage noted throughout. (Reference Figures 13 and 14 and Photo Exhibit Nos. 75 through 79). This damage can compromise the overall performance of the deck coating system. It should be noted that the deck coating system appears to have less than (7) years of remaining useful service life based on all problematic areas being repaired. *We recommend repairing the isolated damaged deck coating as soon as practicable. We would also recommend considering the replacement of the deck coating system within the next two (2) years.*

Figure 13 – North Elevation – Common Walkways – Floor 11 – Corrosion present at door and frames.

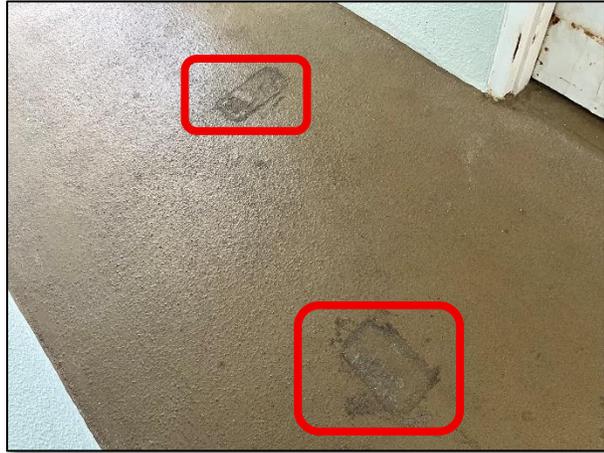
Figure 14 – North Elevation – Common Walkways – Floor 4 – Corrosion present at door and frames.

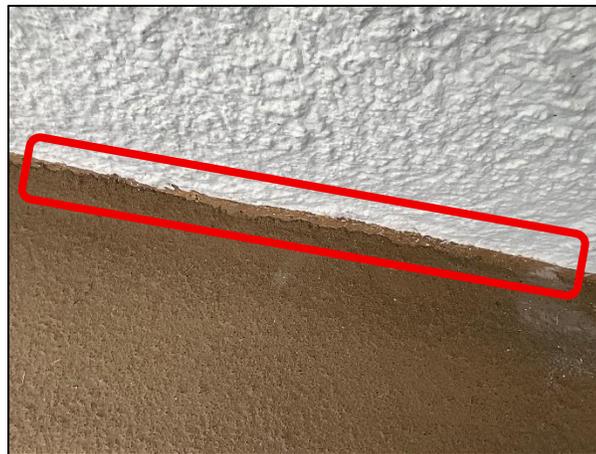
3.1.7 On Floor 2 of the common walkways, we noted isolated uncoated sealant at the base-of-wall interface. (Reference Figure 15 and Photo Exhibit Nos. 80 and 81). It appeared that the deck coating had not been properly brought up to cover the sealant during the initial installation of the system. The deck coating provides an additional layer of protection and waterproofing to the sealant. *We recommend applying deck coating at the uncoated deck-to-wall sealant. Alternatively, this can be done during the application of a new deck coating system if done within the next two (2) years.*

Figure 15 – North Elevation – Common Walkways – Floor 11 – Corrosion present at door and frames.

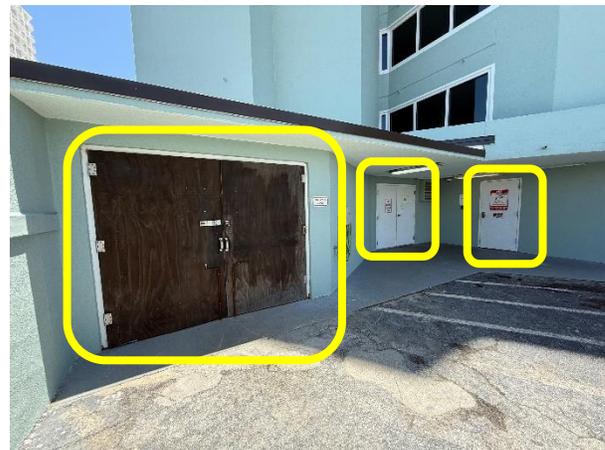
Photo 48
North Elevation – Steel door frames with minor-to-moderate corrosion present on door hardware and frames.

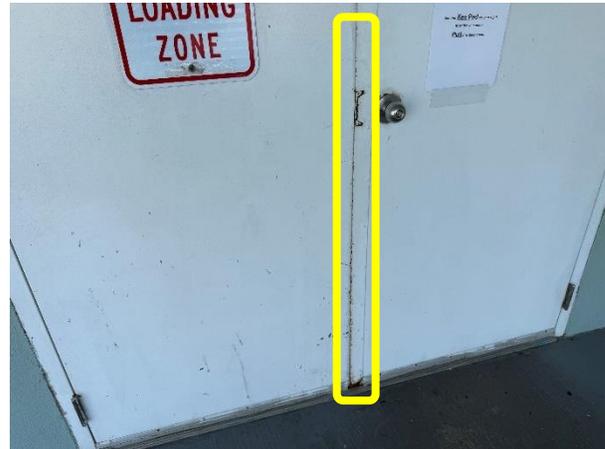
Photo 52
North Elevation – Minor corrosion present on door hardware.

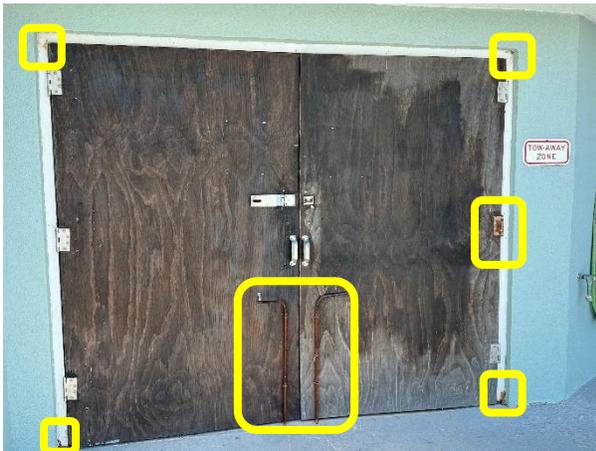
Photo 50
North Elevation – Moderate corrosion present on door frame and hardware.

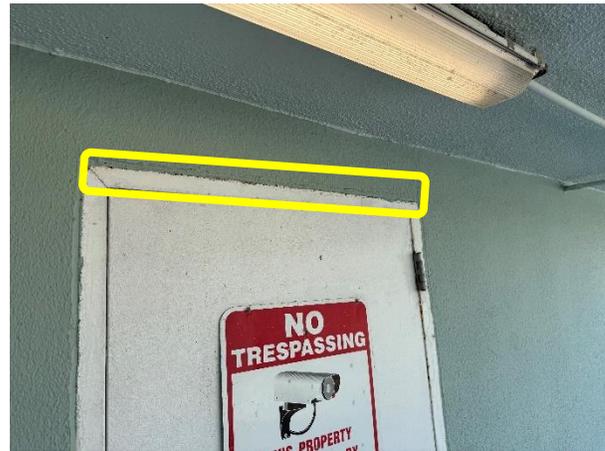
Photo 53
North Elevation – Minor corrosion present on door frame.

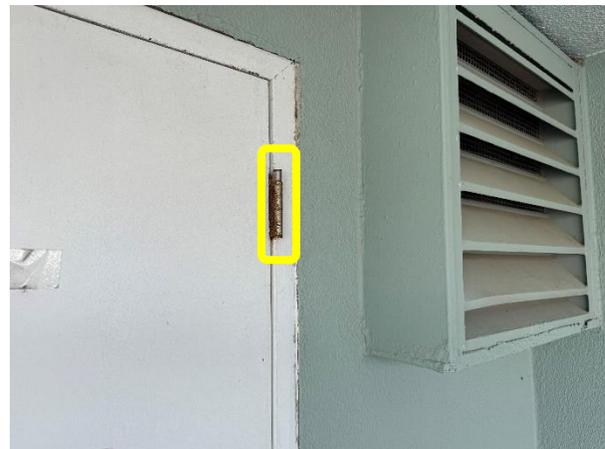
Photo 54
North Elevation – Minor corrosion present on door hardware.

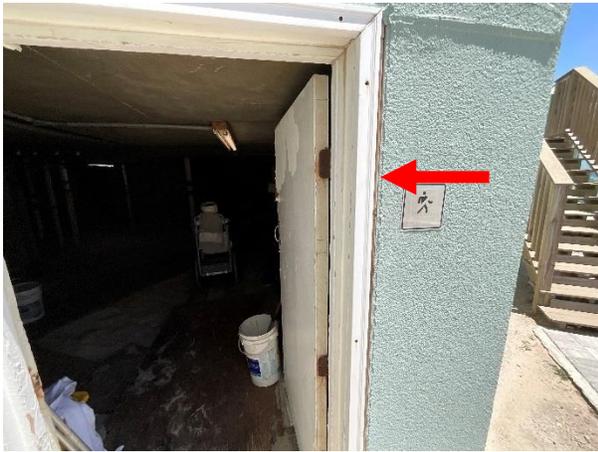
Photo 55
South Elevation – Missing perimeter sealant between door frame and stucco cladding.

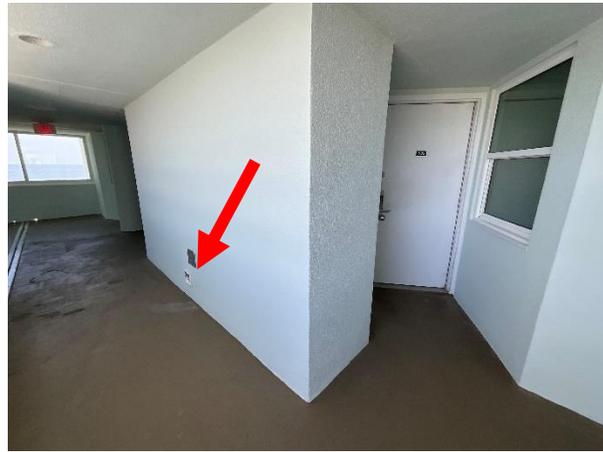
Photo 58
North Elevation – Common Walkways – Floor 11 – Unit 1102 – Missing dryer vent louver.

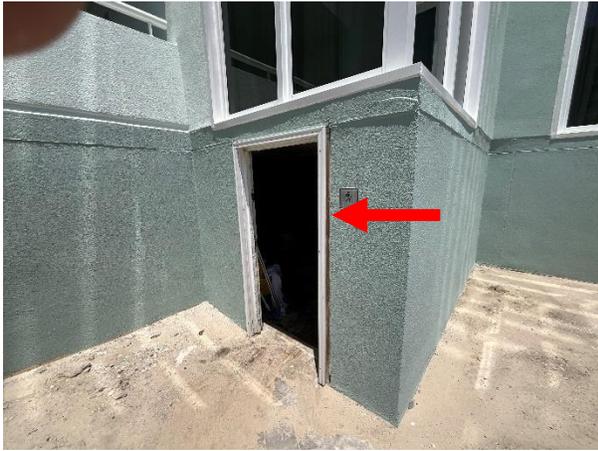
Photo 56
South Elevation – Missing perimeter sealant between door frame and stucco cladding.

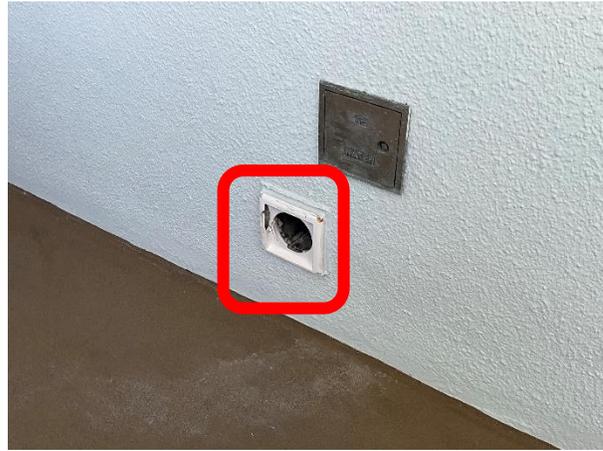
Photo 59
North Elevation – Common Walkways – Floor 11 – Unit 1102 – Missing dryer vent louver.

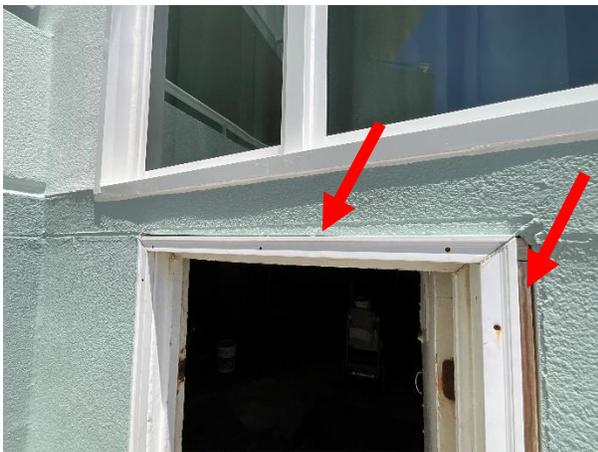
Photo 57
South Elevation – Missing perimeter sealant between door frame and stucco cladding.

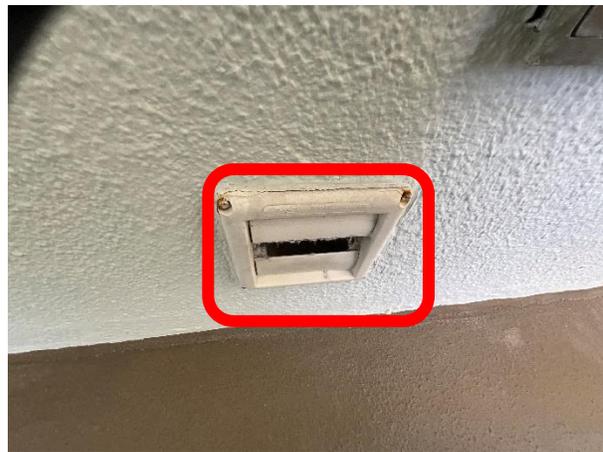
Photo 60
North Elevation – Common Walkways – Floor 7 – Unit 702 – Damaged dryer vent louver.

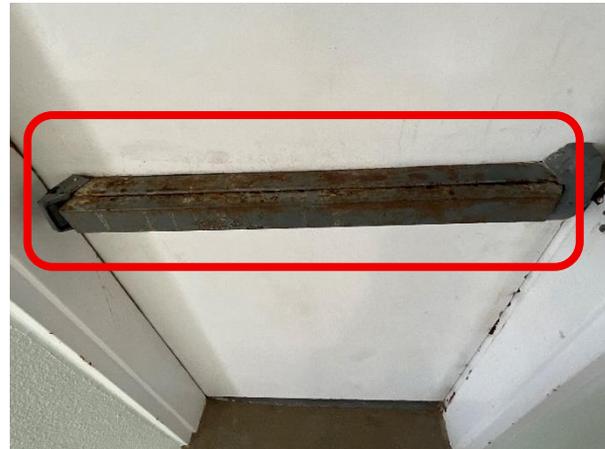
Photo 64
North Elevation – Common Walkways – Floor 11 – Corrosion present at door hardware.

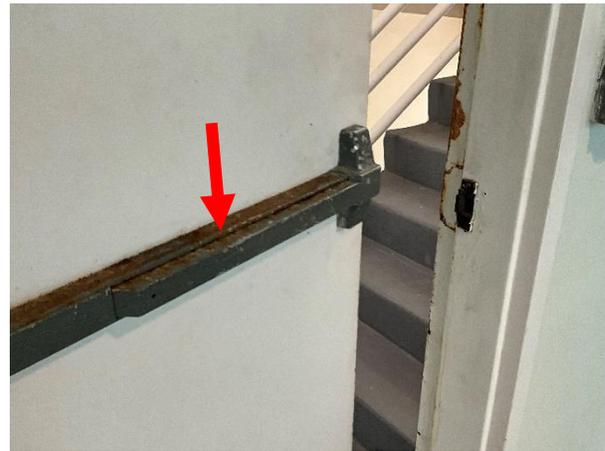
Photo 65
North Elevation – Common Walkways – Floor 7 – Corrosion present at door hardware.

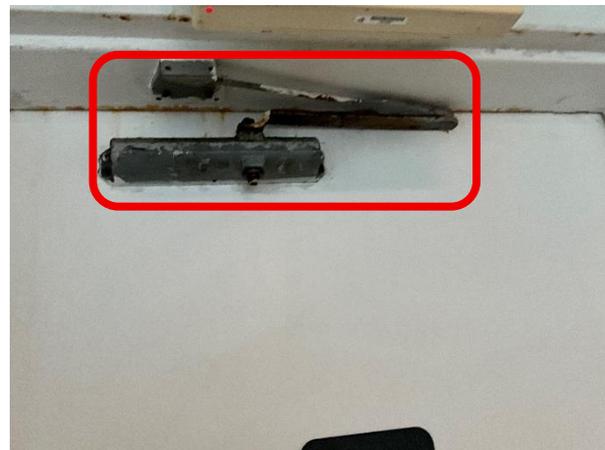
Photo 66
North Elevation – Common Walkways – Floor 7 – Corrosion present at door hardware.

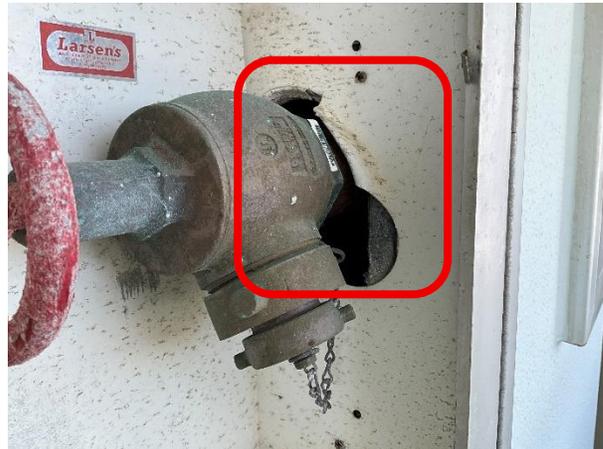
Photo 70
North Elevation – Common Walkways – Floor 11 – Opening in wall at fire wall penetration.

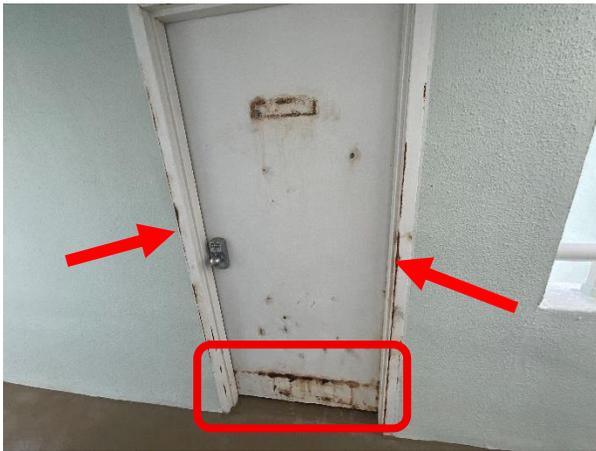
Photo 68
North Elevation – Common Walkways – Floor 4 – Corrosion present at door and frames.

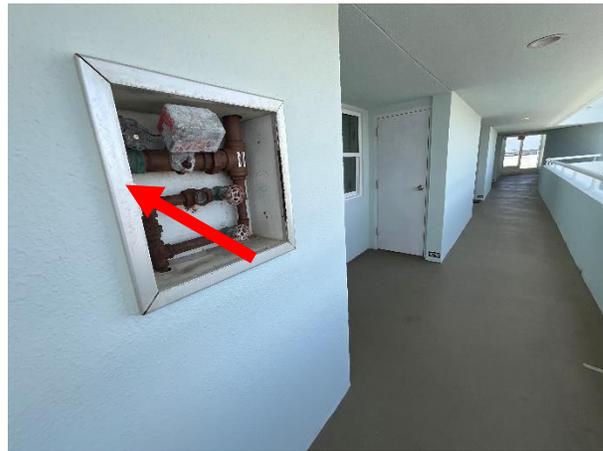
Photo 71
North Elevation – Common Walkways – Floor 10 – Opening in wall at fire wall penetration.

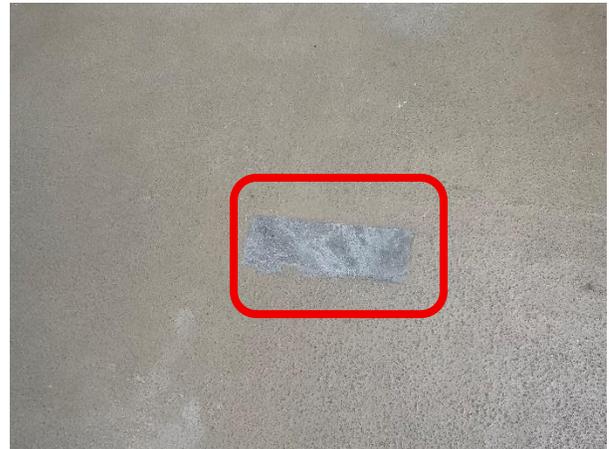
Photo 76
North Elevation – Common Walkways – Floor 4 – Isolated damaged deck coating.

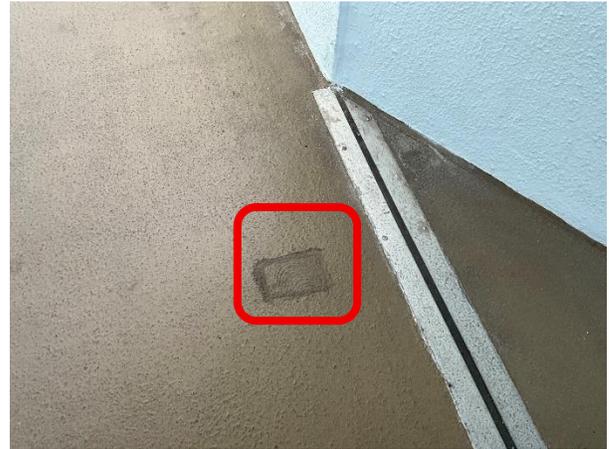
Photo 77
North Elevation – Common Walkways – Floor 4 – Isolated damaged deck coating.

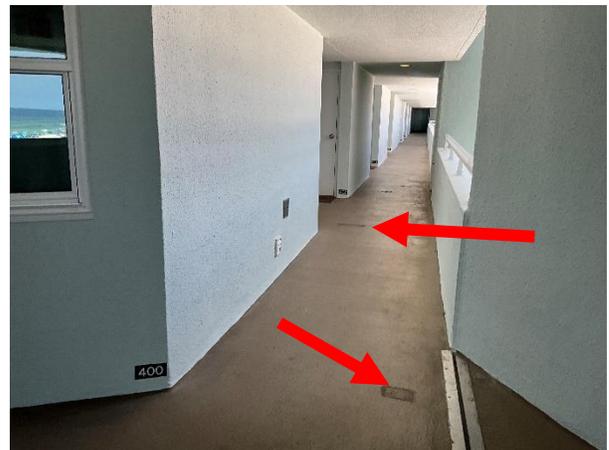
Photo 78
North Elevation – Common Walkways – Floor 4 – Isolated damaged deck coating.
