BECI Field Report

Perdido Sun
13753 Perdido Key Dr.
Pensacola, FL 32507

FIELD REPORT NO: **PRDDSN010**

CONSULTANTS PROJECT NO: **P140741899**

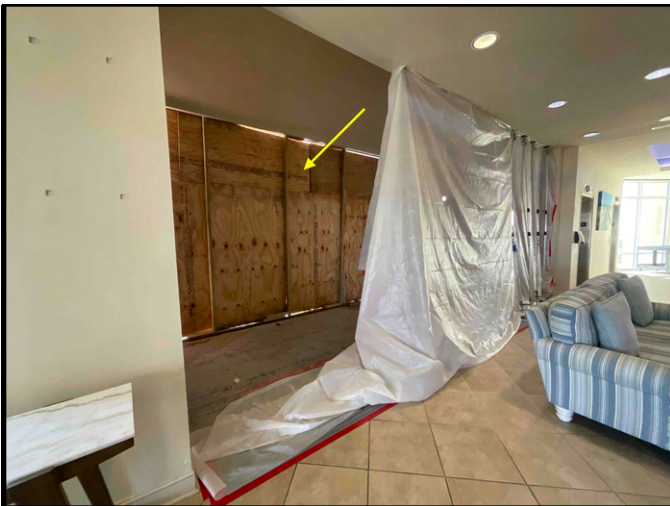
At the East Elevation Lobby Window Opening, we observed that the crew had installed plywood to protect the storefront window opening during the preparation of the rough opening and after the removal of the existing storefront window (see Figure 1). Additionally, we identified areas of hollow concrete at the jambs of the rough window opening, which appeared to form a distinct layer separate from the underlying substrate (see Figures 2 through 4).

FIGURE 1 - Lobby East Elevation Storefront Window - View of plywood installed to protect opening during rough opening preparation - Work in Progress.

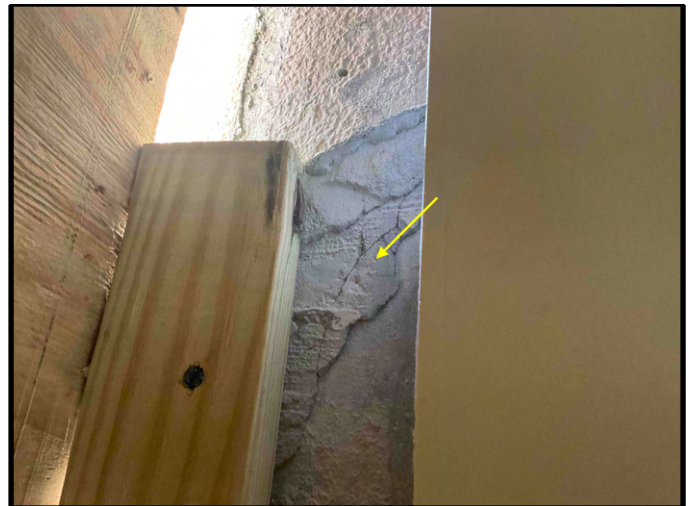
FIGURE 2 - Lobby East Elevation Storefront Window - View of hollow concrete at jambs of window rough opening - Work in Progress.

The underlying concrete substrate appeared to be sound. Once the delaminated concrete is removed from the jambs, the exposed concrete should be thoroughly sounded to confirm its integrity and suitability as a substrate for anchoring. The new EFCO S526 Storefront Windows will be fastened at the head, sill, and jambs. It is critical to ensure that the substrate used for attaching the window anchors is structurally sound to guarantee proper fastening and long-term performance of the window system.

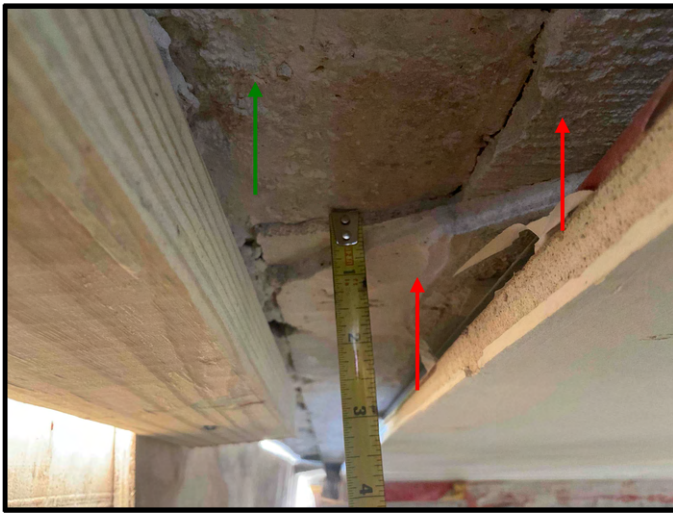
FIGURE 3 - Lobby East Elevation Storefront Window - View of hollow concrete at jambs of window rough opening - Work in Progress.

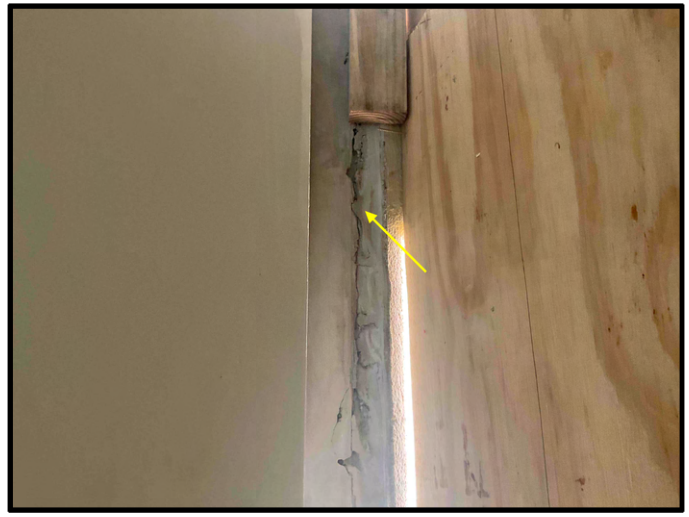
FIGURE 4 - Lobby East Elevation Storefront Window - View of hollow concrete at jambs of window rough opening - Work in Progress.

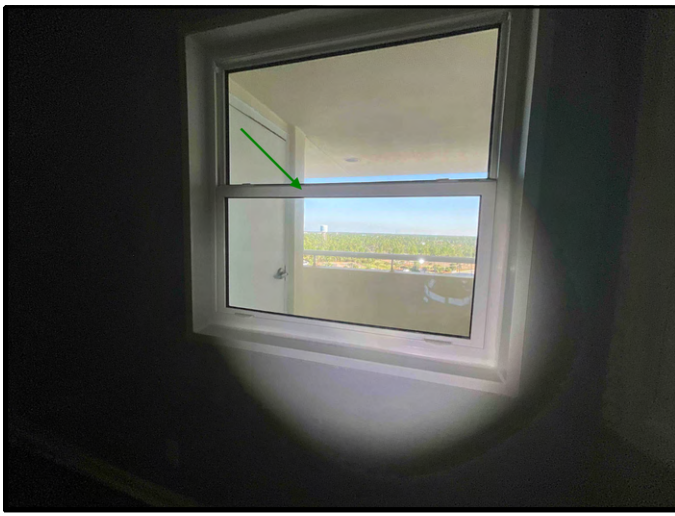
FIGURE 5 - Unit No. 904 - View of new PGT SH5500 Window in overall good condition.

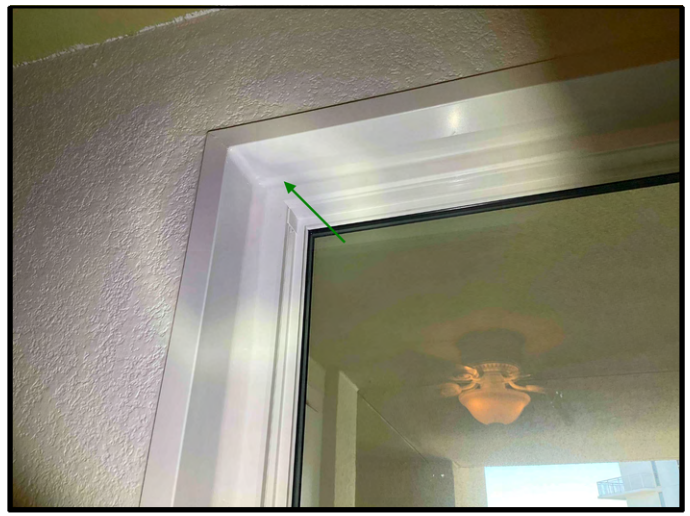
FIGURE 6 - Unit No. 802 - View of new PGT SH5500 Window in overall good condition.

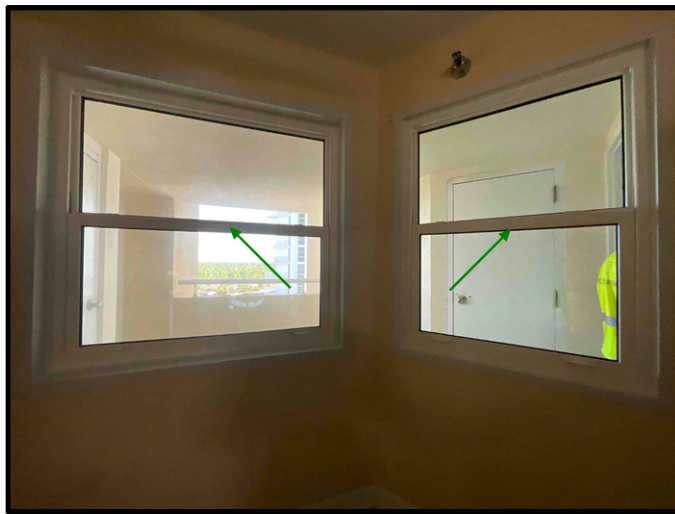
FIGURE 7 - Unit No. 702 - View of new PGT SH5500 Window in overall good condition.

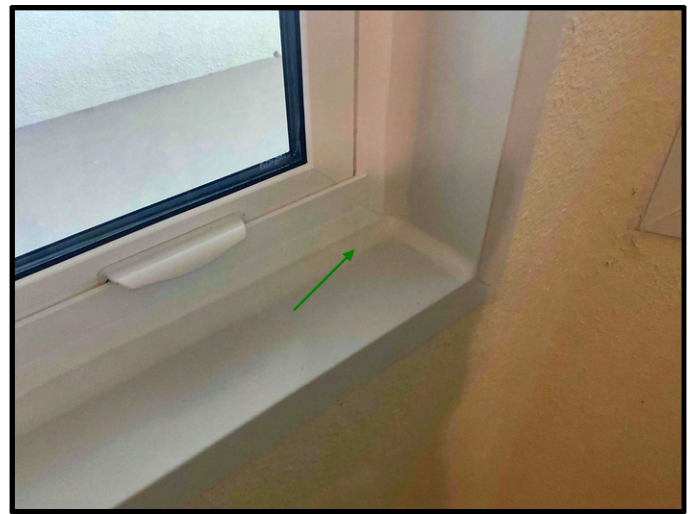
FIGURE 8 - Unit No. 602 - View of new PGT SH5500 Window in overall good condition.

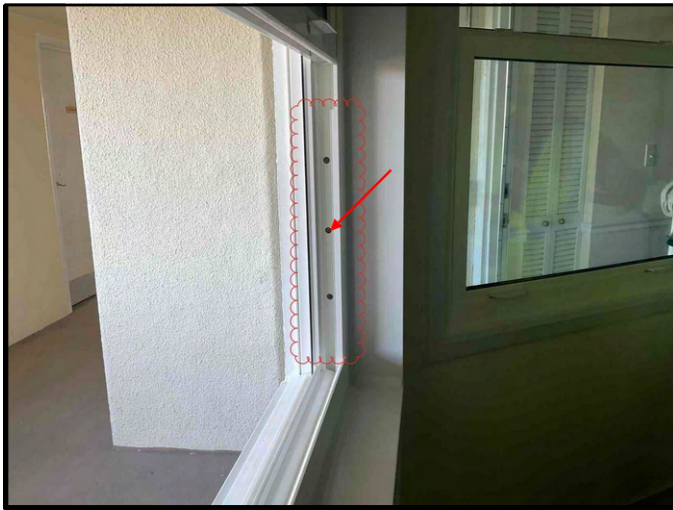
- At Unit Nos. 402 and 204, button caps were not installed over the fasteners (see Figure 9).
- At Unit No. 304, the window handles require replacement due to chipped paint (see Figure 10).
- At Unit Nos. 110 and 112, general cleaning was needed on the walls and window frames (see Figure 11).
- At Unit No. 112, crew members were actively completing the installation of the smaller window (see Figure 12).

FIGURE 9 - Unit No. 204 - View of missing button caps - Punch Item.

Aside from these isolated issues, general cleaning was a recurring anomaly, which was addressed during the punch inspection. C/Sharpe is tasked with completing these punch items and providing photo documentation of the resolved issues as confirmation (Action

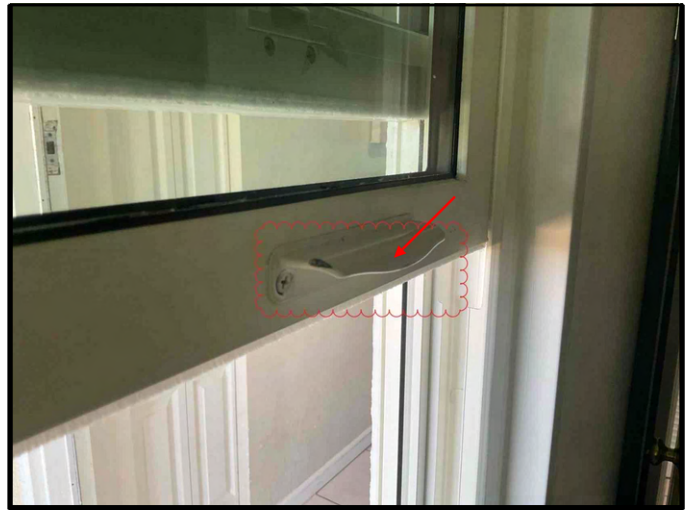
FIGURE 10 - Unit No. 304 - View of handle to be replaced - Punch Item.

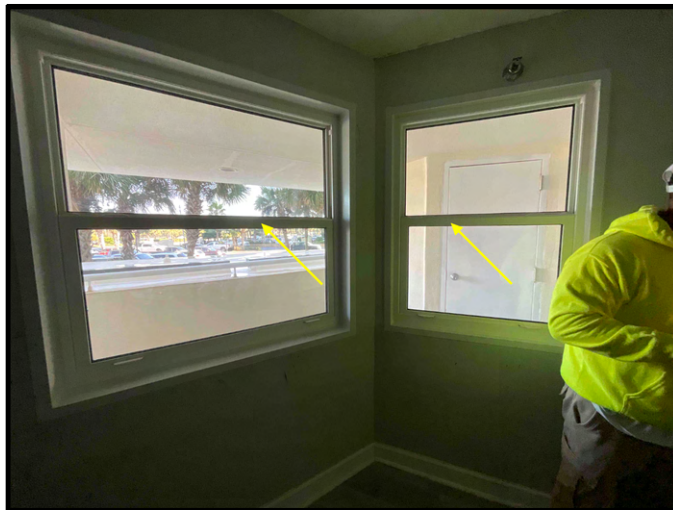
FIGURE 11 - Unit No. 110 - View of general cleaning to be performed - Work in Progress.

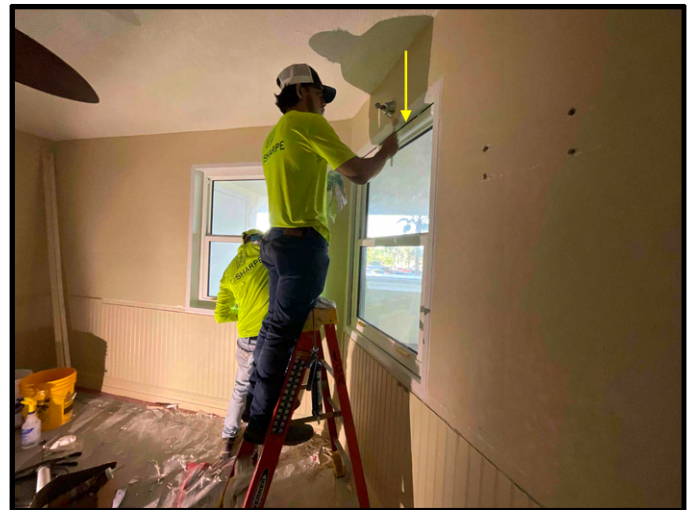
FIGURE 12 - Unit No. 112 - View of crew member installing sealant - Punch Item.

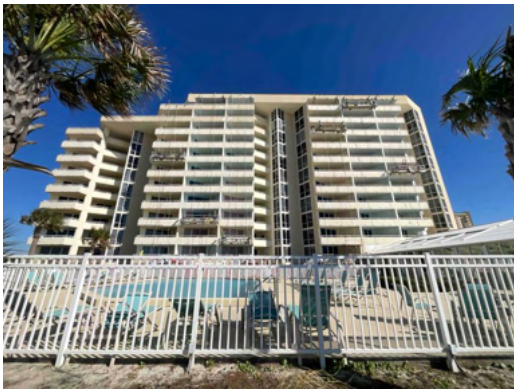
Photo 1
South Elevation - Overall view.

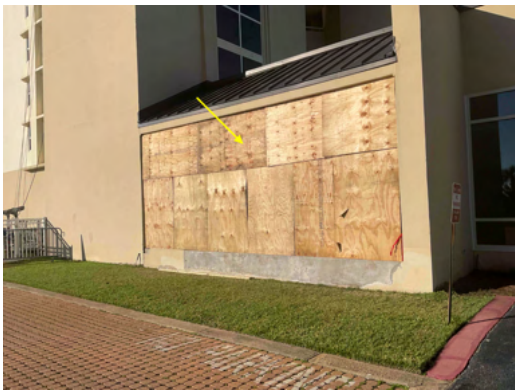
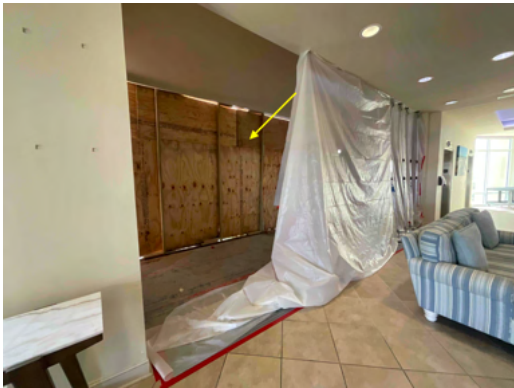
Photo 2
East Elevation - Lobby Storefront Window - View of plywood installed to protect opening during rough opening preparation - Work in Progress.

Photo 3
East Elevation - Lobby Storefront Window - View of plywood installed to protect opening during rough opening preparation - Work in Progress.

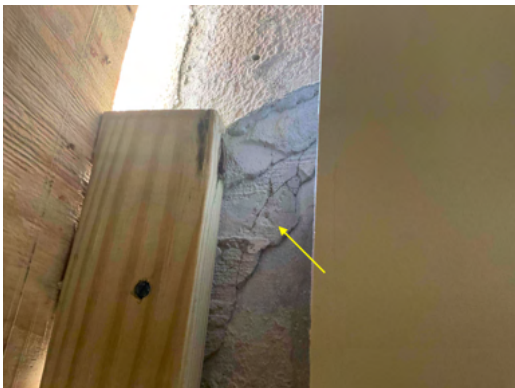
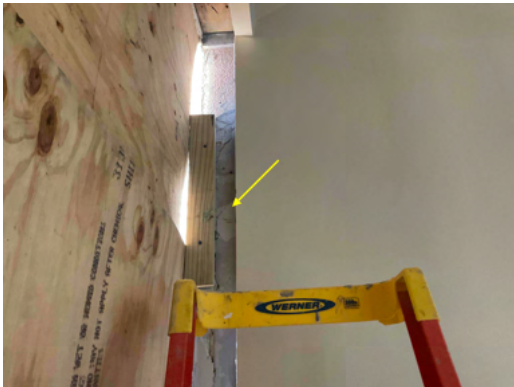
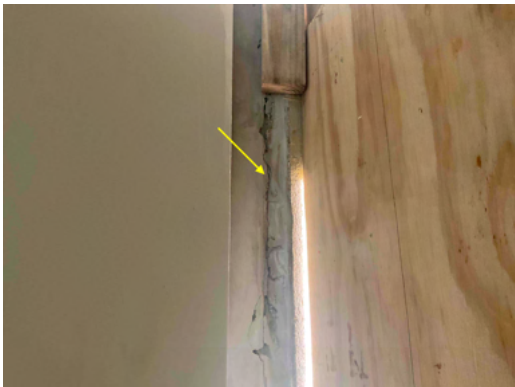
Photo 4
East Elevation - Lobby Storefront Window - View of hollow concrete at jambs of window rough opening - Work in Progress.

Photo 5
East Elevation - Lobby Storefront Window - View of hollow concrete at jambs of window rough opening - Work in Progress.

Photo 6
East Elevation - Lobby Storefront Window - View of hollow concrete at jambs of window rough opening - Work in Progress.

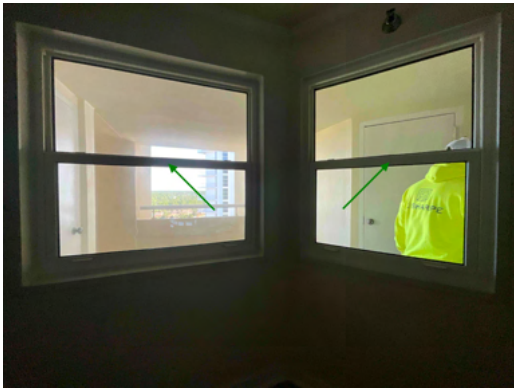
Photo 7

Unit No. 902 - View of new PGT SH5500 Window in overall good condition.

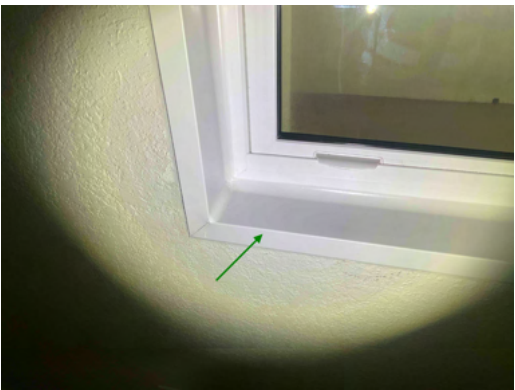
Photo 8

Unit No. 902 - View of new PGT SH5500 Window in overall good condition.

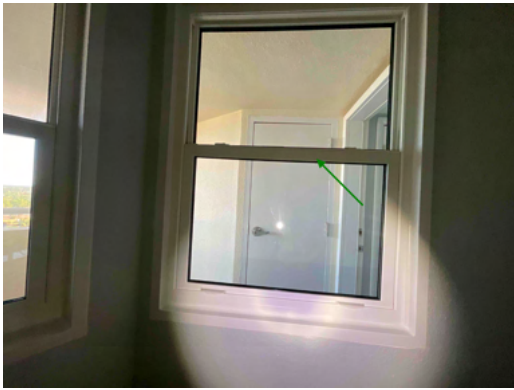
Photo 9

Unit No. 904 - View of new PGT SH5500 Window in overall good condition.

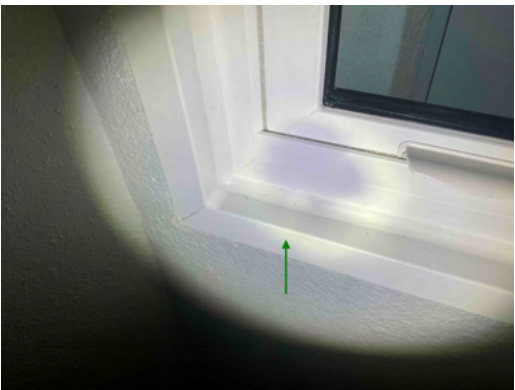
Photo 10

Unit No. 904 - View of new PGT SH5500 Window in overall good condition.

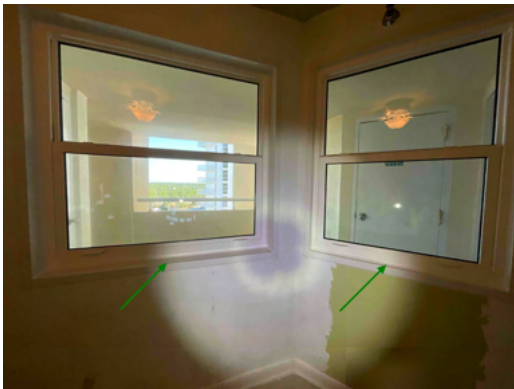
Photo 11

Unit No. 802 - View of new PGT SH5500 Window in overall good condition.

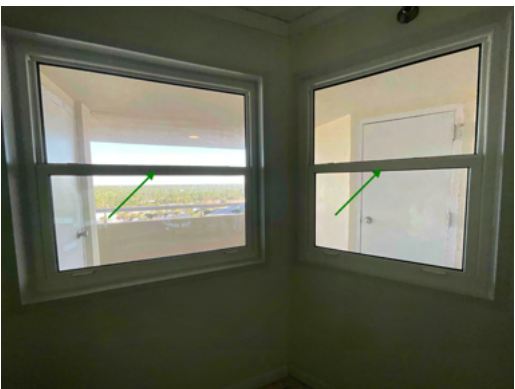
Photo 12

Unit No. 812 - View of new PGT SH5500 Window in overall good condition.

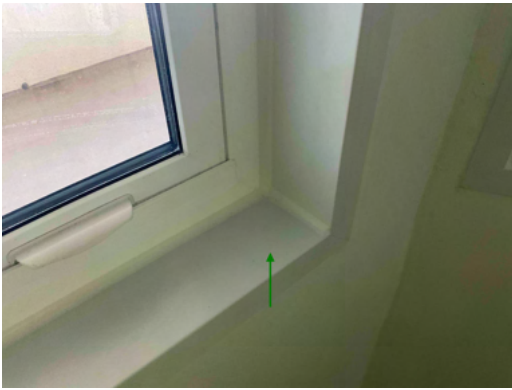
Photo 13

Unit No. 812 - View of new PGT SH5500 Window in overall good condition.

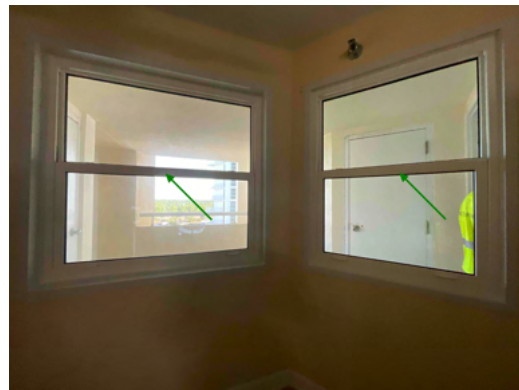
Photo 14

Unit No. 702 - View of new PGT SH5500 Window in overall good condition.

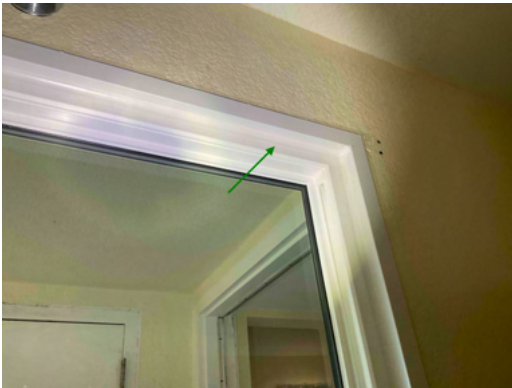
Photo 15

Unit No. 702 - View of new PGT SH5500 Window in overall good condition.

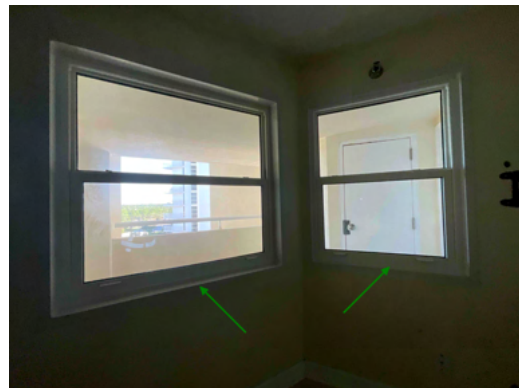
Photo 16

Unit No. 602 - View of new PGT SH5500 Window in overall good condition.

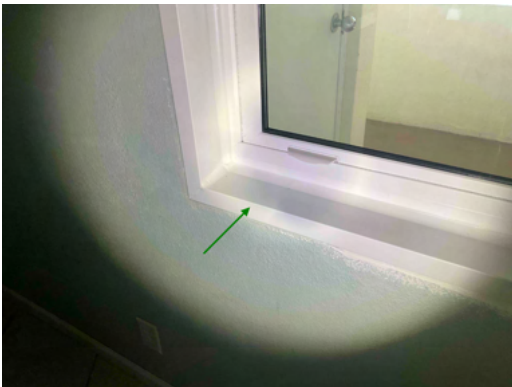
Photo 17

Unit No. 604 - View of new PGT SH5500 Window in overall good condition.

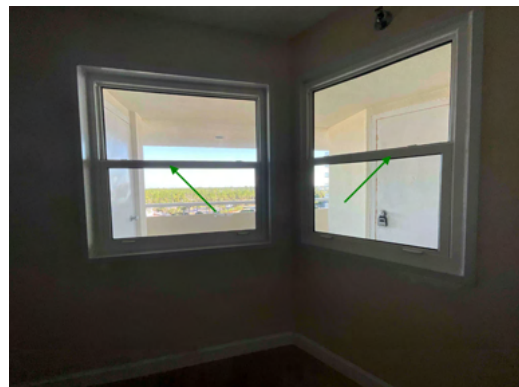
Photo 18

Unit No. 610 - View of new PGT SH5500 Window in overall good condition.

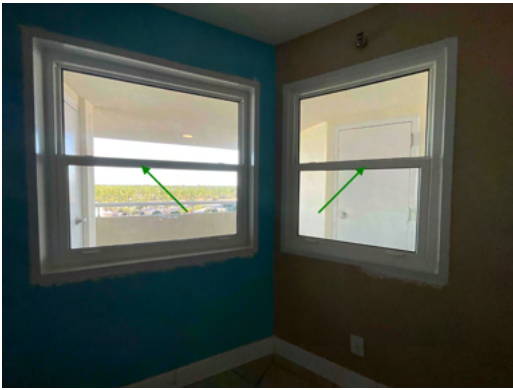
Photo 19

Unit No. 612 - View of new PGT SH5500 Window in overall good condition.

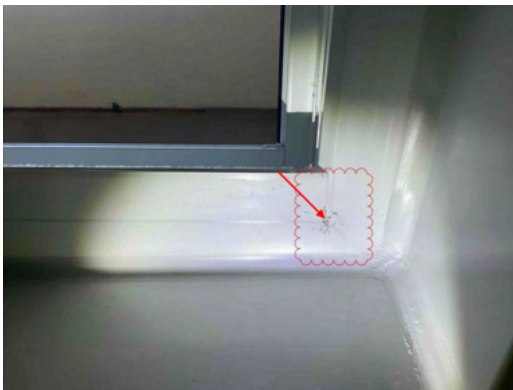
Photo 20

Unit No. 512 - View of sealant touch up needed at interior sealant between trim and window frame and frame cleaning needed - Punch Item.

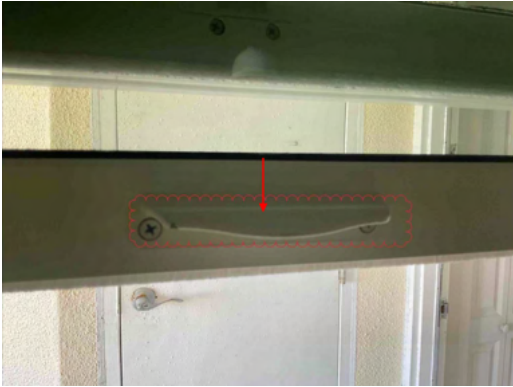
Photo 21

Unit No. 304 - View of handle to be replaced - Punch Item.

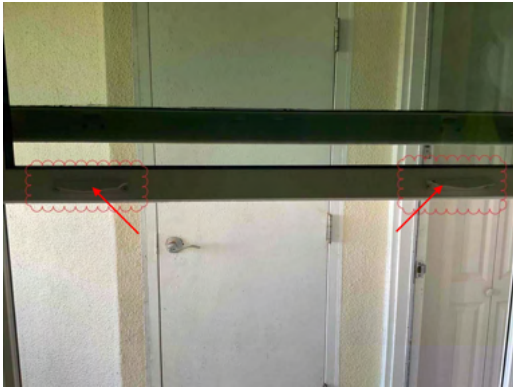
Photo 22

Unit No. 304 - View of handles to be replaced - Punch Item.

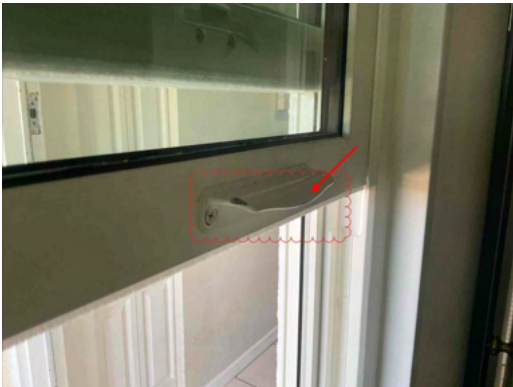
Photo 23

Unit No. 304 - View of handle to be replaced - Punch Item.

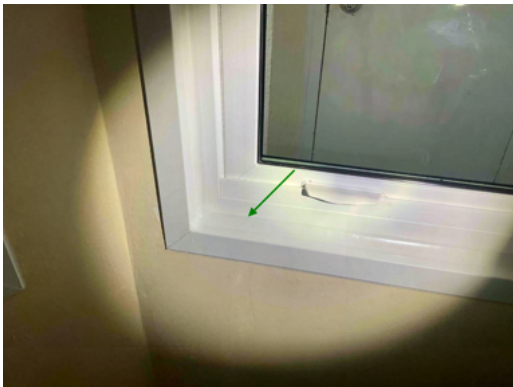
Photo 24

Unit No. 402 - View of new PGT SH5500 Window in overall good condition.

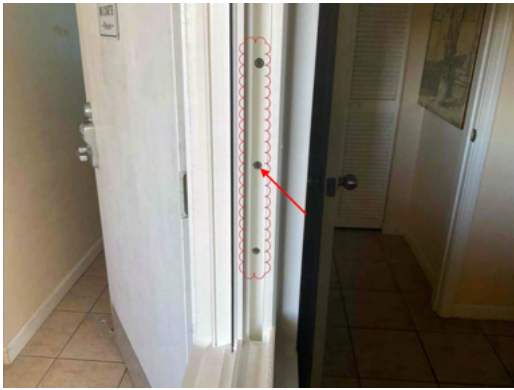
Photo 25

Unit No. 402 - View of missing button caps - Punch Item.

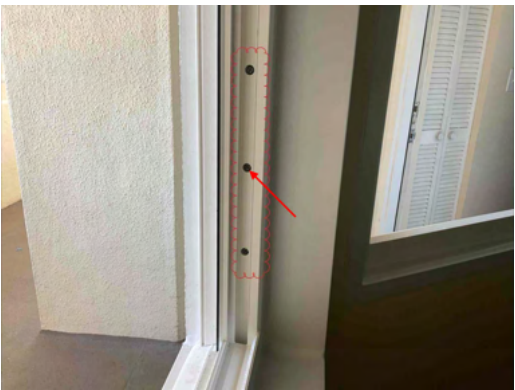
Photo 26

Unit No. 402 - View of missing button caps - Punch Item.

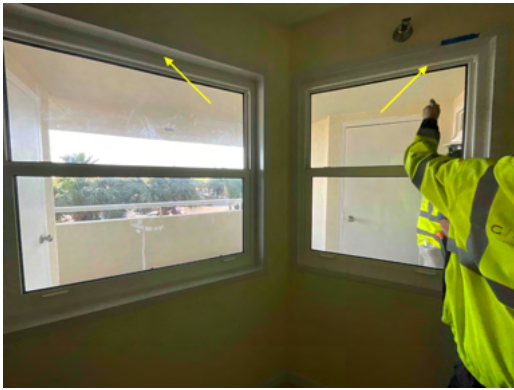
Photo 27

Unit No. 210 - View of cleaning to be performed - Work in Progress.

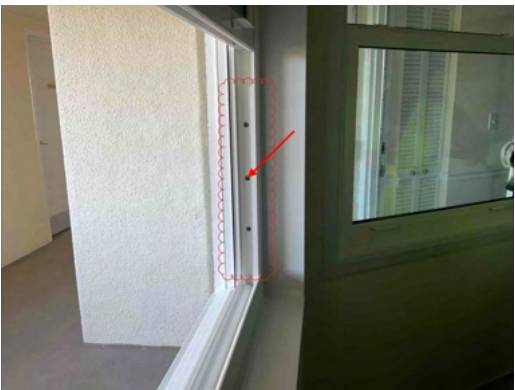
Photo 28

Unit No. 204 - View of missing button caps - Punch Item.

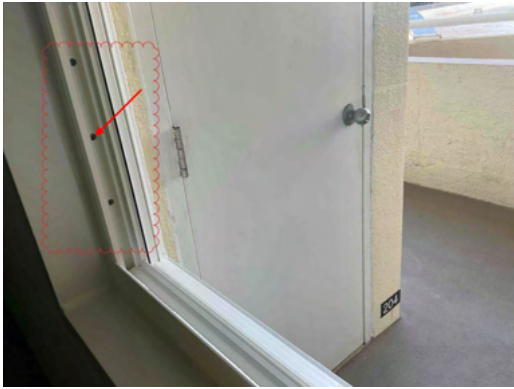
Photo 29

Unit No. 204 - View of missing button caps - Punch Item.

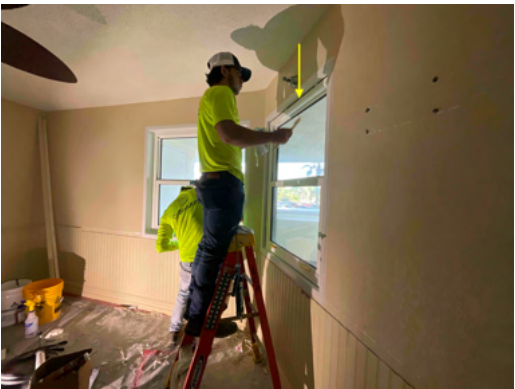
Photo 30

Unit No. 112 - View of crew member installing sealant - Punch Item.
