# BECI Field Report

**Perdido Sun**  
13753 Perdido Key Dr.  
Pensacola, FL 32507

FIELD REPORT NO: **PRDDSN017**

SITE VISIT DATE: **12/19/2024**

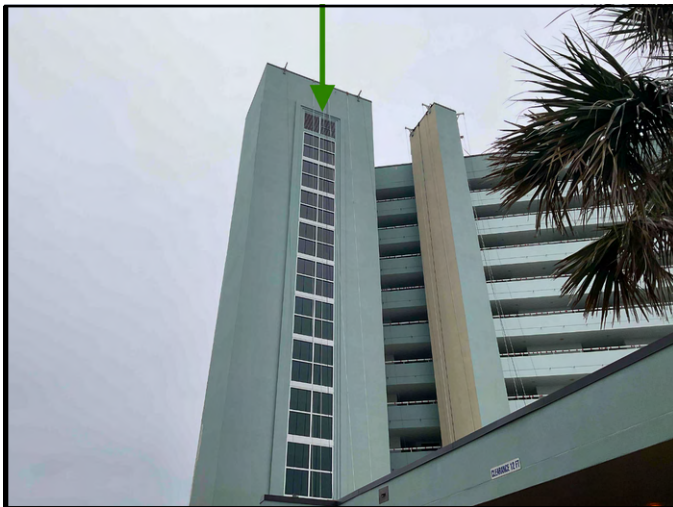
- 17.2 BECI, C/Sharpe, and Perdido Sun Representatives met on-site to review the completed slab edge flashing mock-up installed between the new storefront windows at the north elevation above the Porte cochere (Reference Figure 1). The new two-piece metal flashing was installed between the concrete slabs and the EFCO storefront windows, following BECI's Detail 1/A-501 and field directives from Report No. 14 (Reference Figure 2). The goal was for the flashing to sit flush with the window systems; however, due to varying conditions of the concrete slabs, there were some areas where the flashing jutted out slightly. Despite these minor variations, the flashing still performs as intended from both a technical and waterproofing standpoint, ensuring no issues with the building's protection against the elements. BECI reviewed the mock-up both during and after installation, confirming the flashing was installed as planned, met all technical requirements, and was adjusted when directed by BECI. The purpose of meeting with Perdido Sun representative Curtis was to review the mock-up and ensure it met the project's aesthetic goals. After inspecting the installation, Curtis approved the look, agreeing that the design met the visual standards. With this approval, Action Item No. 14.2.1 will be marked as completed.

**FIGURE 1 - View of new EFCO storefront windows installed at north elevation above Porte cochere.**

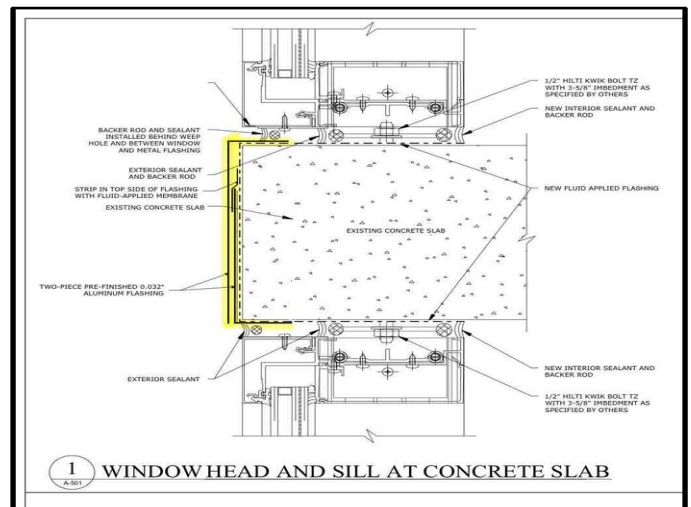
**FIGURE 2 - View of BECI Detail 1/A-501.**

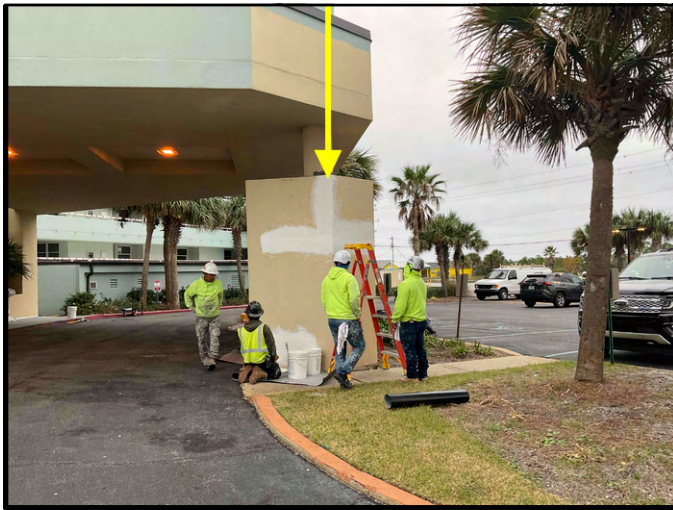
- 17.3 We observed crew members performing finish repairs at the stucco column while others were applying a new coating to the ceiling of the Porte Cochere (Reference Figures 3 through 6). The finish repairs involved addressing imperfections and cracks in the stucco, where crew members filled and repaired areas to restore the surface. At the same time, other workers were applying SIKA Thorocoat 200 Acrylic Coating to the ceiling. This first coat of the high-performance coating, known for its durability and resistance to the elements, was being carefully applied to ensure a smooth, even finish. To protect the surrounding pavement from any excess paint splatter, protective fabric was laid on the ground. The coating was being cut in around edges of penetrations and seams to prevent issues with peeling or water infiltration, which helps ensure the long-term performance and

**FIGURE 3 - Porte Cochere - View of crew members performing finish repairs at stucco column - Work in Progress.**

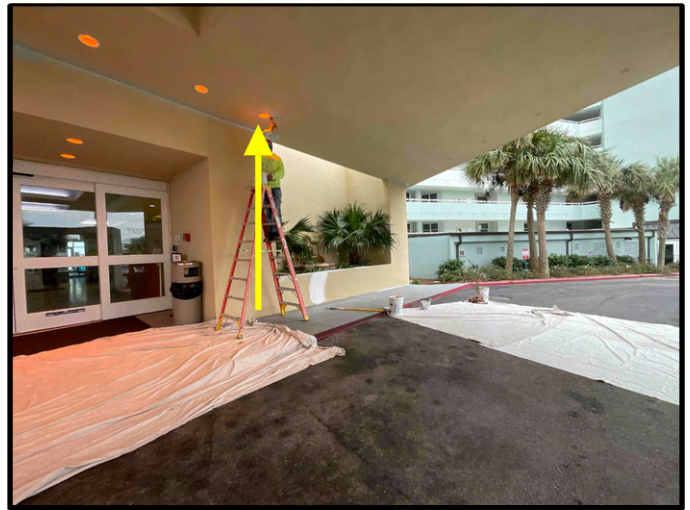
**FIGURE 4 - Porte Cochere - View of crew members performing coating application at ceiling - Work in Progress.**

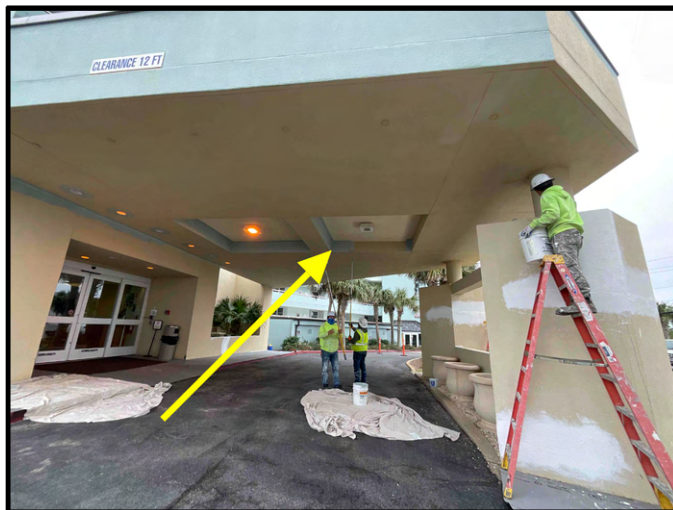
**FIGURE 5 - Porte Cochere - View of crew members performing coating application at ceiling - Work in Progress.**

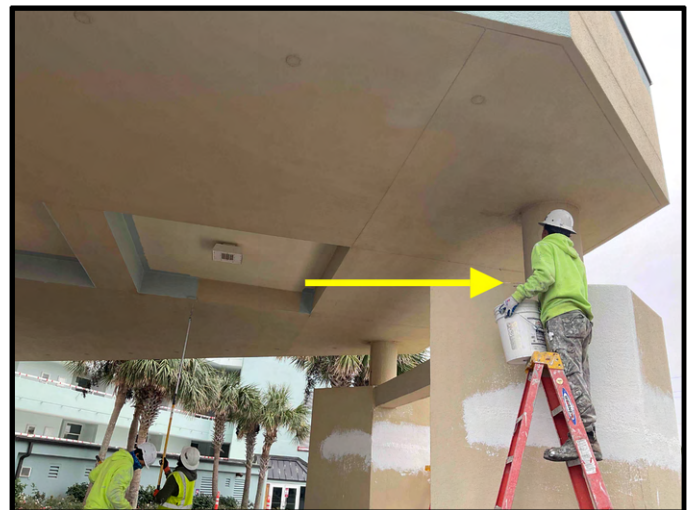
**FIGURE 6 - Porte Cochere - View of crew members performing finish repairs at stucco column and applying new coating at ceiling - Work in Progress.**

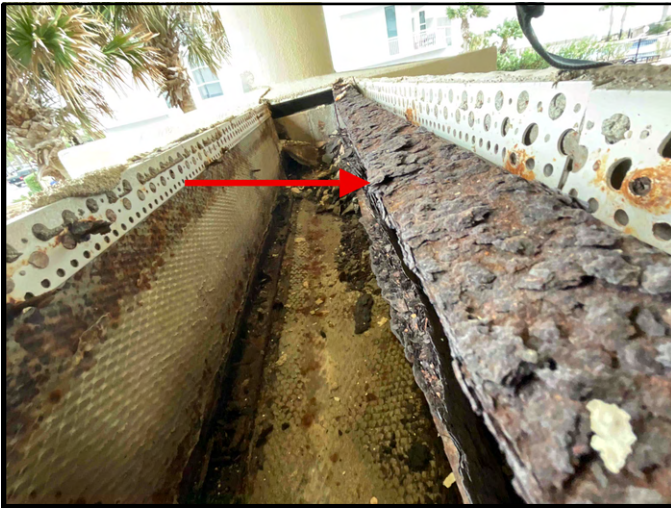
17.3.1 We also examined the existing architectural beam at the Porte Cochere. It was noted that the top side of the beam had been removed to allow for stucco repairs, revealing severely corroded framing within (Reference Figures 7 and 8). On one side of the stucco, the framing was completely absent, causing the stucco to detach. On the opposite side, the framing was heavily corroded, compromising its structural integrity. This condition was discussed with representatives from Perdido Sun, who were made aware of the situation. It was agreed that the beam could either be repaired or removed entirely. Additionally, a conduit box was found inside the beam, which appeared to no longer be in use. The beam likely served to conceal the conduit and wiring in the past, but since it is no longer active, it could be removed along with the beam. However, before proceeding with any removal, an electrician would need to confirm that the conduit is indeed inactive. If the decision is made to remove the beam, the openings where it connects to the columns will need to be repaired to maintain the integrity of the columns. The Association is to provide final direction on whether to repair or remove the beam. (ACTION ITEM)

**FIGURE 7 - Porte Cochere - View of existing architectural beam with severely corroded framing.**

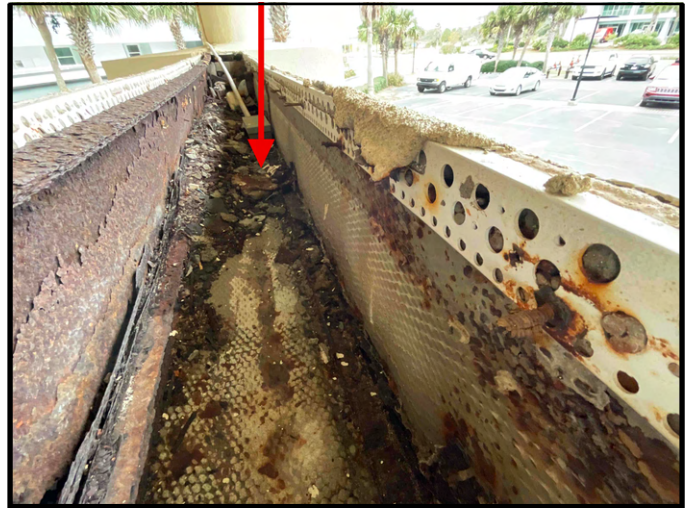
**FIGURE 8 - Porte Cochere - View of existing architectural beam with severely corroded framing.**

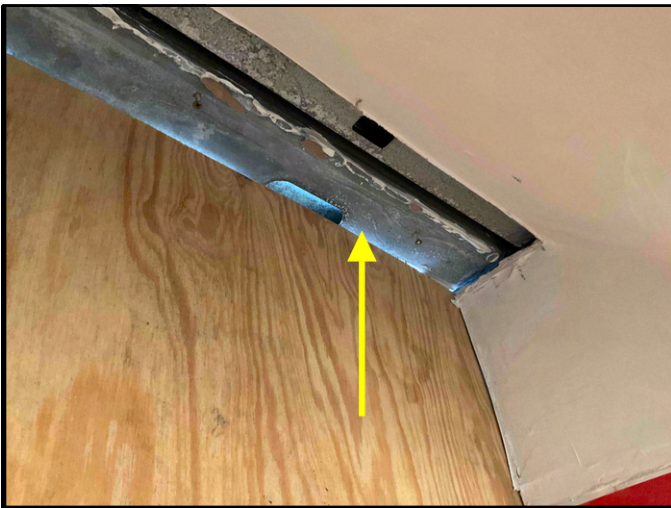
17.4 In Unit No. 200, we observed the existing metal framing at the head of the window after the existing window was removed (Reference Figure 9). The existing framing was measured to be 0.07 inches, equating to a 14 Gauge metal stud (Reference Figure 10). We noted that the existing 14 Gauge framing was attached to concrete (Reference Figure 11). However, it was unclear how approximately 10-11 inches of the track was installed, as we found insulation instead of concrete (Reference Figure 12). Further investigation is needed to determine how the track is attached and if any additional measures are required for window installation.

**FIGURE 9 - Unit No. 200 - View of existing metal framing at head of window after existing window was removed - Work in Progress.**

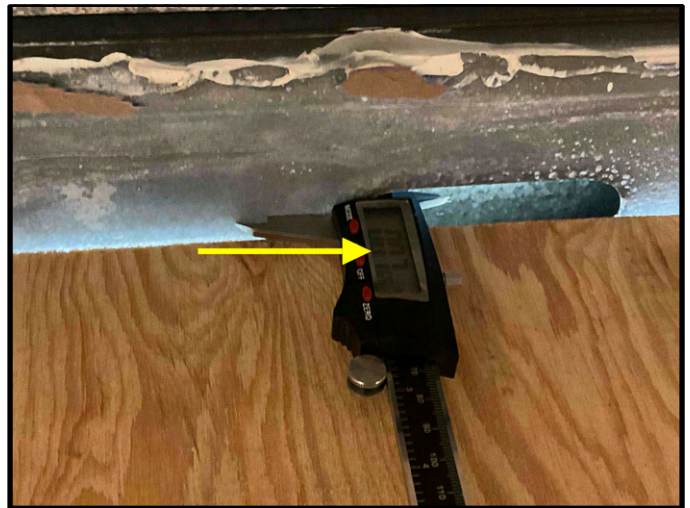
**FIGURE 10 - Unit No. 200 - View of existing framing measuring 0.07" which equates to a 14 Gauge metal stud.**

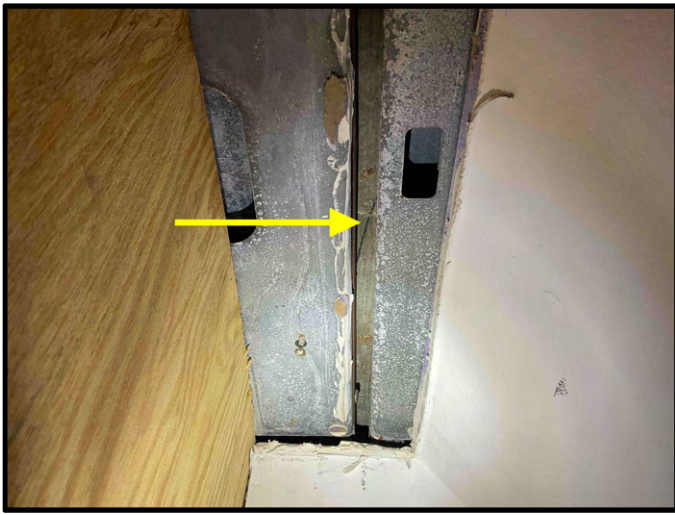
**FIGURE 11 - Unit No. 200 - View of existing 14G framing attached to concrete - Further Investigation Needed.**

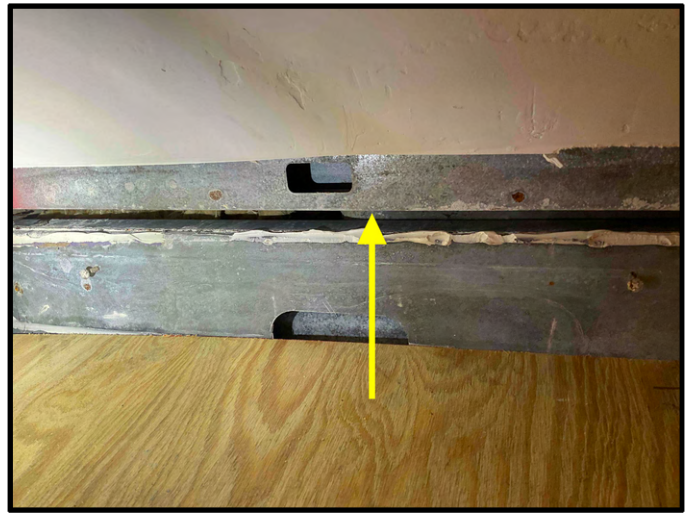
**FIGURE 12 - Unit No. 200 - View of existing 14G framing attached at ceiling - Further Investigation Needed.**

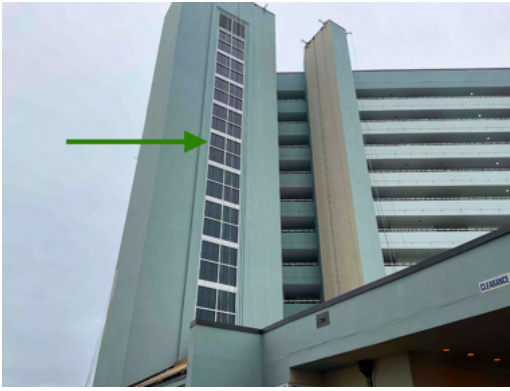
**Photo 1**

North Elevation - View of EFCO storefront windows installed above Porte cochere.

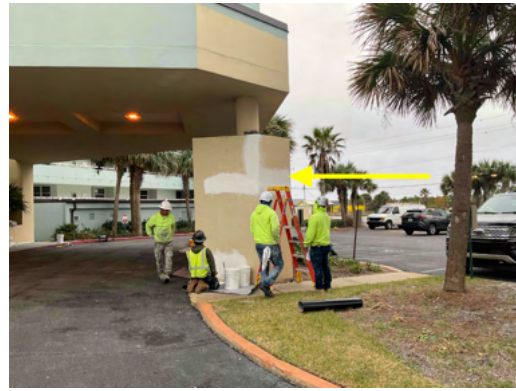
**Photo 2**

North Elevation - View of crew members performing finish repairs at stucco column - Work in progress.

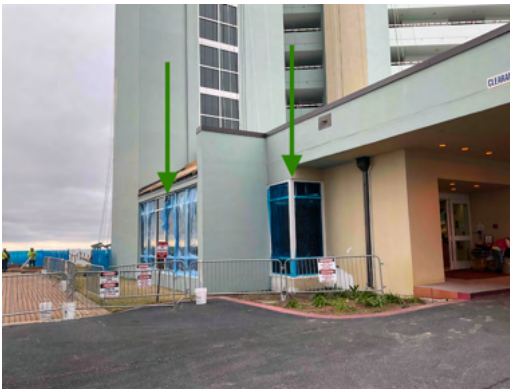
**Photo 3**

North Elevation - View of View of EFCO storefront windows installed.

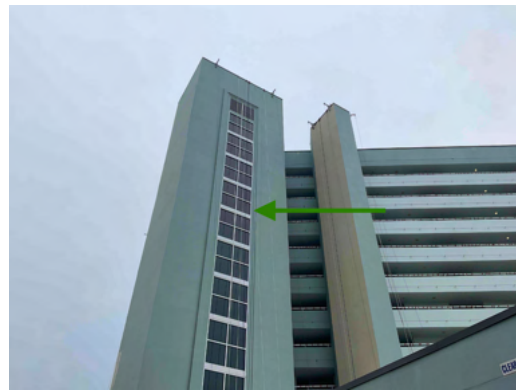
**Photo 4**

North Elevation - View of EFCO storefront windows installed above Porte cochere.

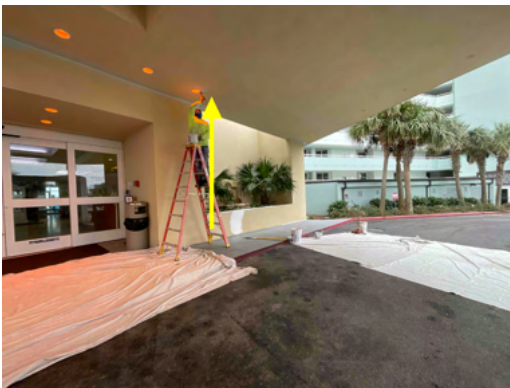
**Photo 5**

North Elevation - View of crew members performing coating application at ceiling - Work in progress.

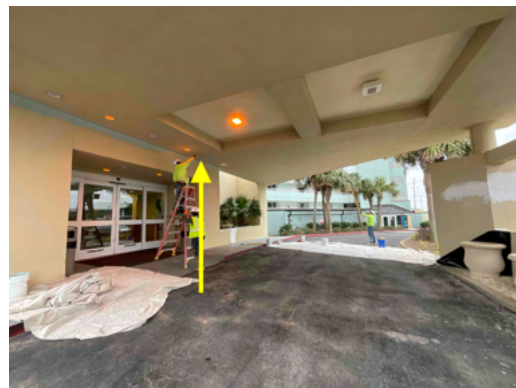
**Photo 6**

North Elevation - View of crew members performing coating application at ceiling - Work in progress.

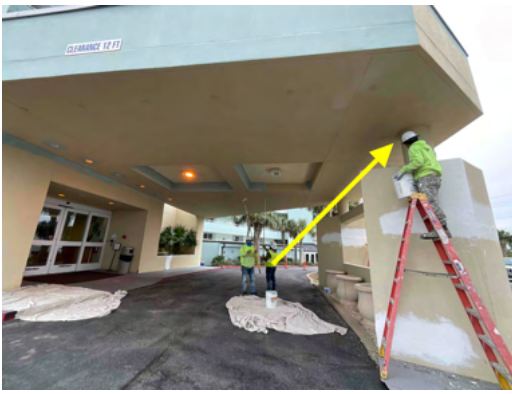
**Photo 7**  
North Elevation - View of crew members performing coating application at ceiling - Work in progress.

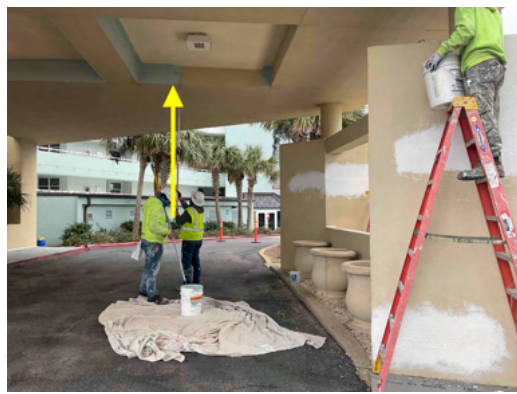
**Photo 8**  
North Elevation - View of crew members performing coating application at ceiling - Work in progress.

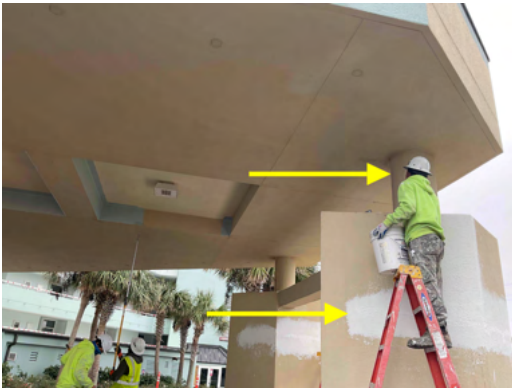
**Photo 9**  
North Elevation - View of crew members performing finish repairs at stucco column and applying new coating at ceiling - Work in progress.

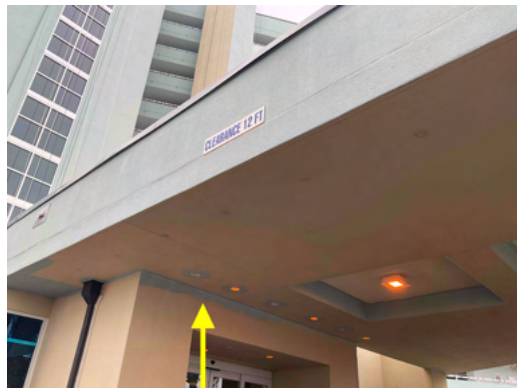
**Photo 10**  
North Elevation - View of finish repairs at stucco - Work in progress.

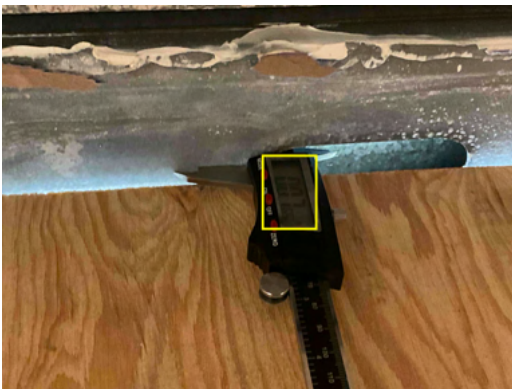
**Photo 11**  
Unit No. 200 - View of existing framing measuring 0.07" which equates to a 14 Gauge metal stud.

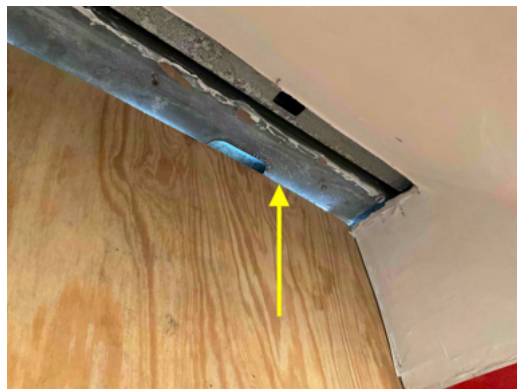
**Photo 12**  
Unit No. 200 - View of existing metal framing at head of window after existing window was removed - Work in progress.

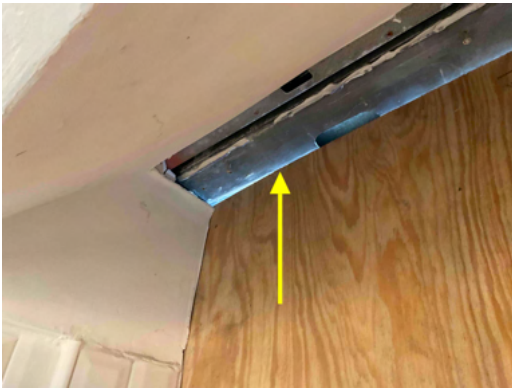
**Photo 13**  
Unit No. 200 - View of existing metal framing at head of window after existing window was removed - Work in progress.

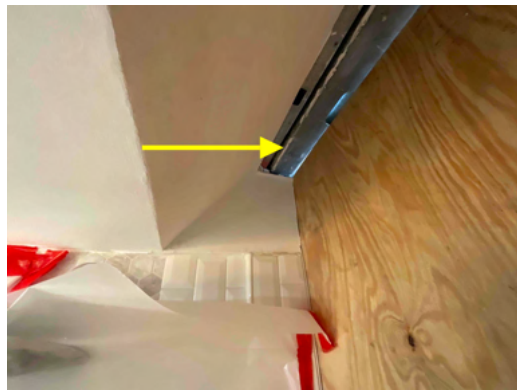
**Photo 14**  
Unit No. 200 - View of existing metal framing at head of window after existing window was removed - Work in progress.

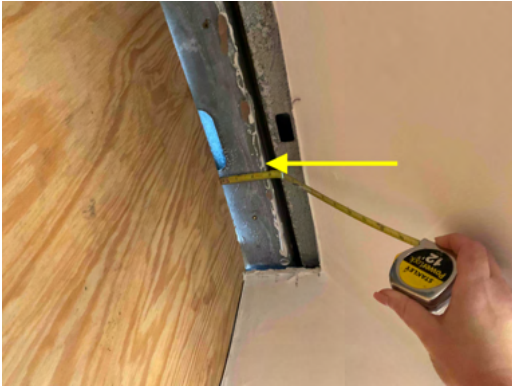
**Photo 15**  
Unit No. 200 - View of existing framing 14G framing attached at concrete - Further investigation needed.

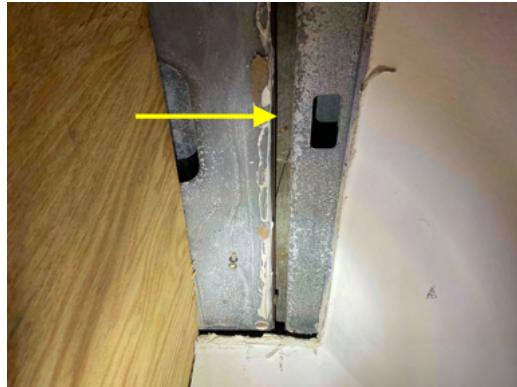
**Photo 16**  
Unit No. 200 - View of existing framing 14G framing attached at ceiling - Further investigation needed.

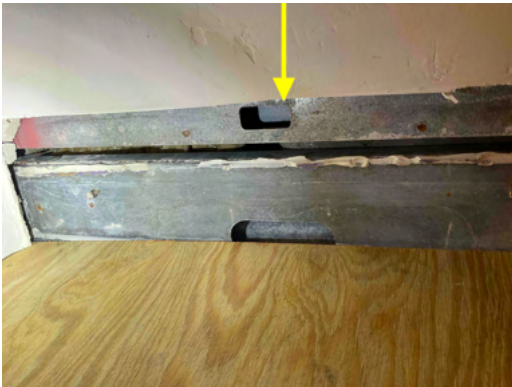
**Photo 17**  
Unit No. 200 - View of existing framing 14G framing attached at ceiling - Further investigation needed.

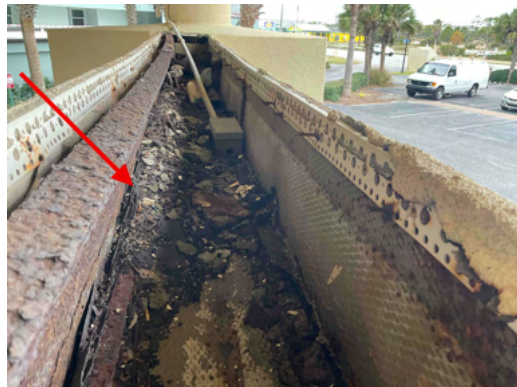
**Photo 18**  
Porte Cochere - View of existing architectural beam with severely corroded framing.

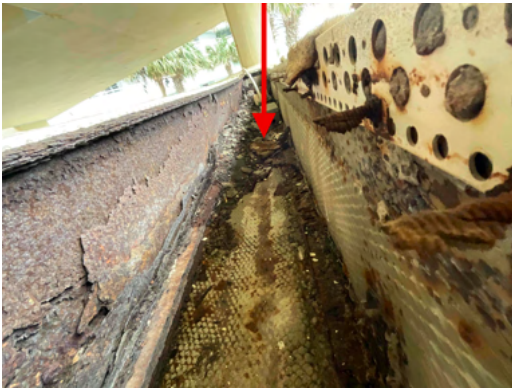
**Photo 19**  
Porte Cochere - View of existing architectural beam with severely corroded framing.

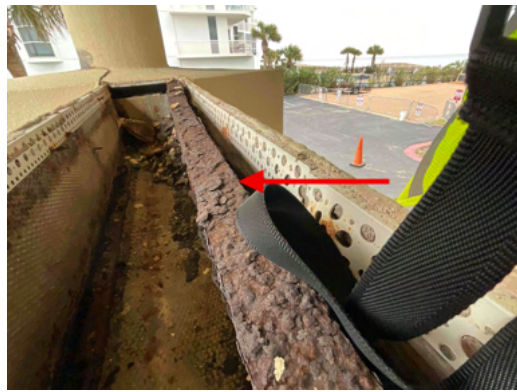
**Photo 20**  
Porte Cochere - View of existing architectural beam with severely corroded framing.

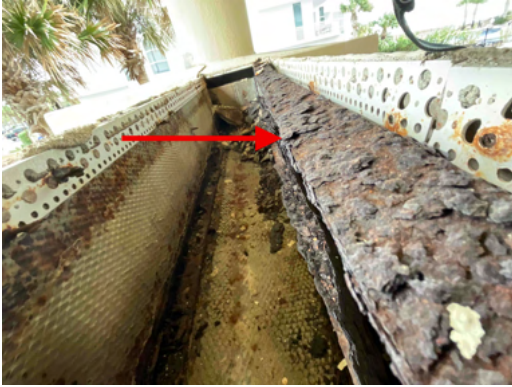
**Photo 21**  
Porte Cochere - View of existing architectural beam with severely corroded framing.
