BECI Field Report

Perdido Sun
13753 Perdido Key Dr.
Pensacola, FL 32507

FIELD REPORT NO: **PRDDSN021**

Window Mock-up review at Unit No. 200

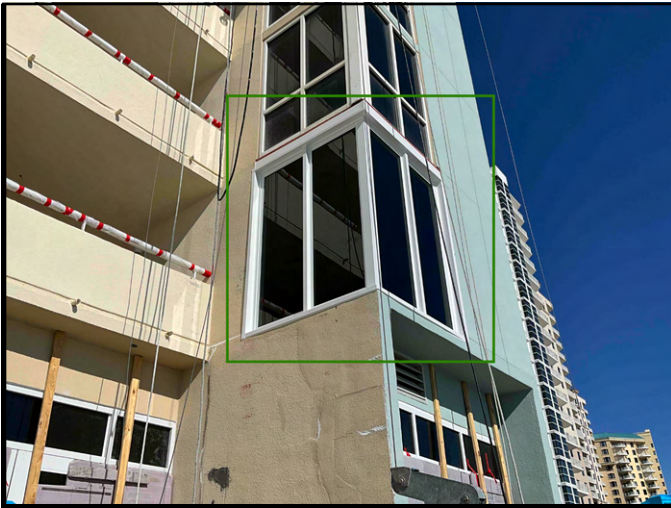
- 21.1 Michael Rhea, with BECI, arrived onsite at 12:00 PM. The primary purpose of this site visit was to observe work in progress conditions related to the building enclosure and to report on compliance with plans, specifications, and industry standards. We discussed the ongoing work with the site team and focused our attention on the mock-up at Unit 200. A summary of our observations is as follows:
- 21.2 At Unit No. 200, South Bedroom, we observed the exterior of the mock-up EFCO Series 2701 Fixed Window at the corner condition. We noted that the metal-to-metal and metal-to-stucco perimeter sealants were applied continuously and free of any voids or discontinuities. We observed weep holes evenly spaced throughout the sealant bead at the sill of the window. Overall, the window was installed in good condition and in accordance with the Engineered Shop Drawings for the EFCO Windows.

FIGURE 1 - Unit No. 200 - South Bedroom - Overall view of mock-up EFCO Series 2701 Fixed Window at corner condition.

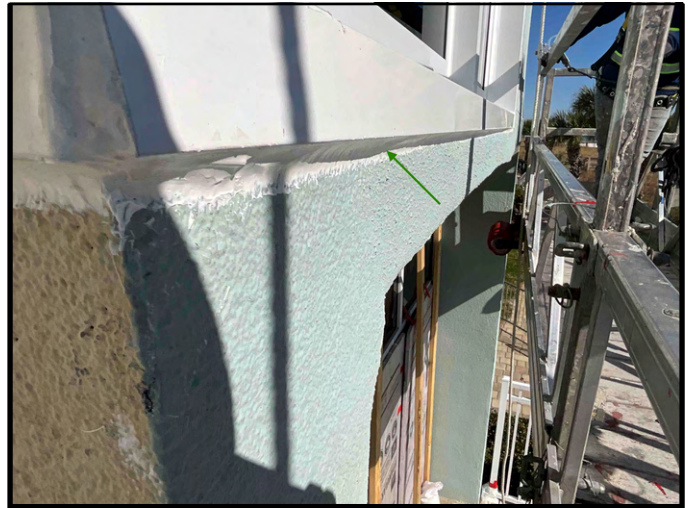
FIGURE 2 - Unit No. 200 - South Bedroom - View of sealant in good condition.

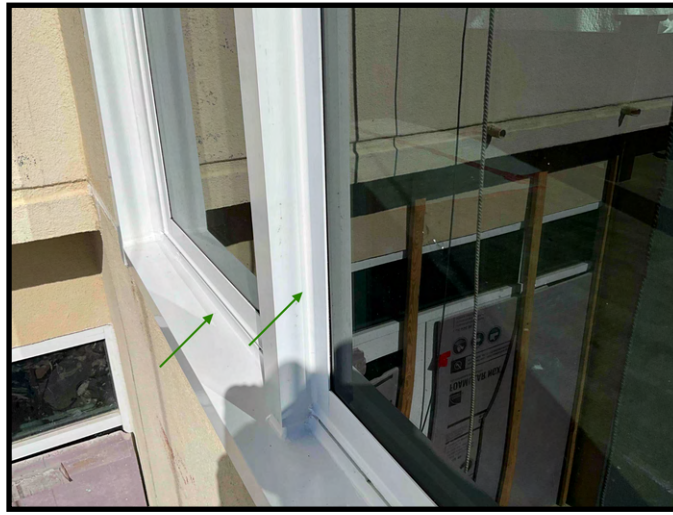
FIGURE 3 - Unit No. 200 - South Bedroom - View of sealant in good condition.

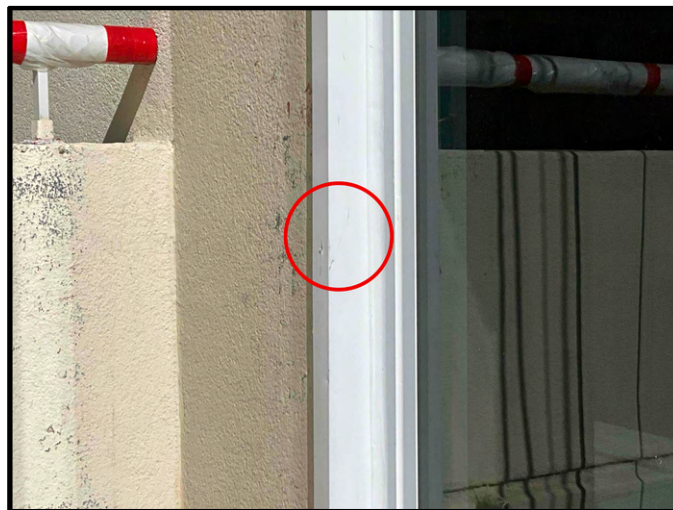
- 21.2.1 However, we observed isolated damage to the window frame, which was discussed with the contractor on-site and is to be touched up with additional paint (Action Item).

FIGURE 4 - Unit No. 200 - South Bedroom - View of isolated damage to window frame. This was discussed with the contractor on site and is to be touched up with additional paint.

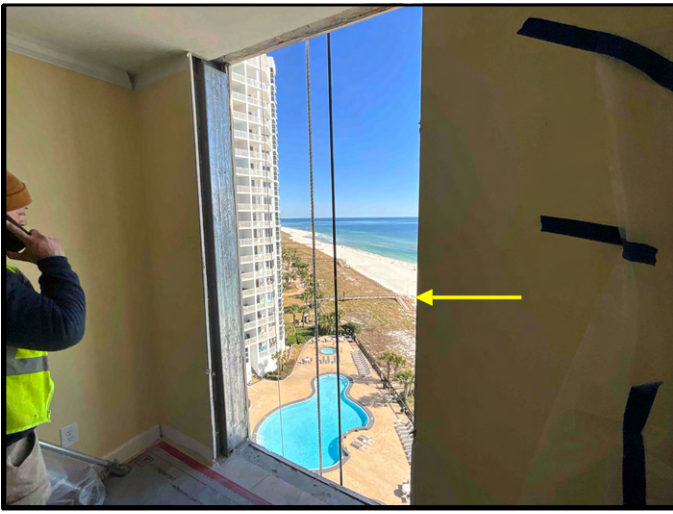
- 21.3 In Unit No. 1100, we observed the rough opening being prepared for EFCO window installation. We noted that the EFCO window clips were measured at the required 5 inches. Additionally, we observed the installation of new FastFlash waterproofing in progress at the rough openings. We noted the currently newly installed windows to be in good condition with continuous perimeter sealants.

FIGURE 5 - Unit No. 1100 - North Bedroom - View of rough opening to be prepared for EFCO window installation.

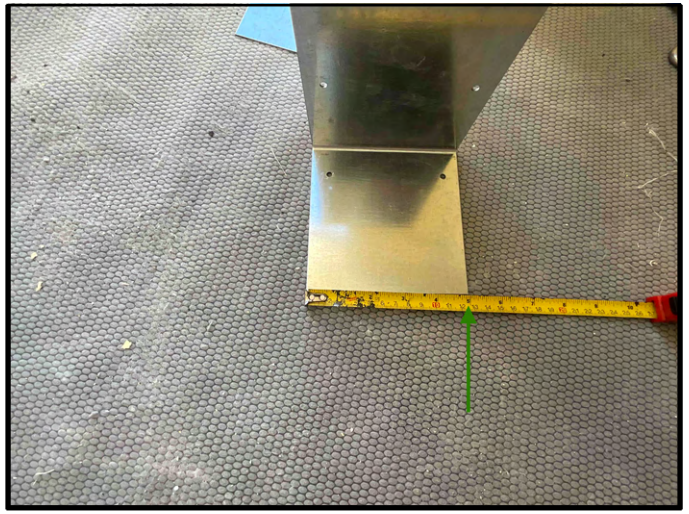
FIGURE 6 - Unit No. 1100 - North Bedroom - View of EFCO window clip measured at the required 5".

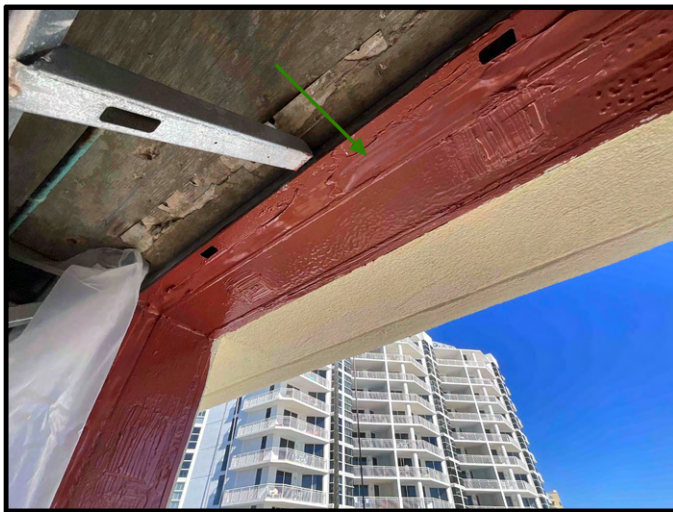
FIGURE 7 - Unit No. 1100 - Bathroom - View of new FastFlash waterproofing installed at rough opening.

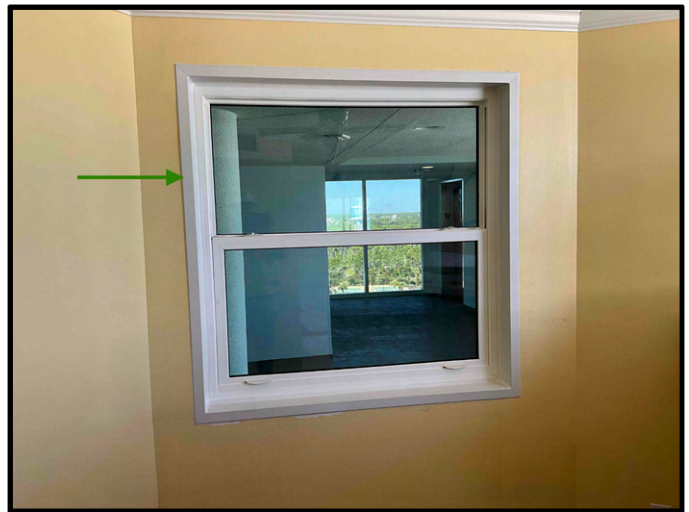
FIGURE 8 - Unit No. 1100 - North Bedroom - View of EFCO window in good condition.

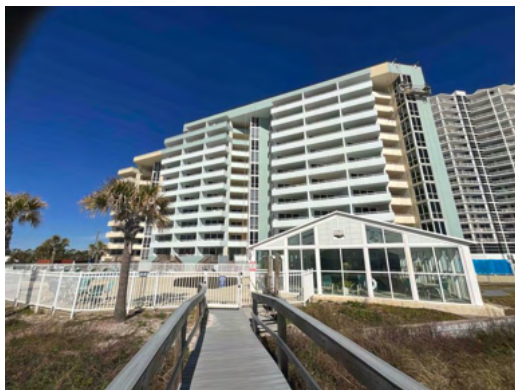
Photo 1

South Elevation - Overall view.

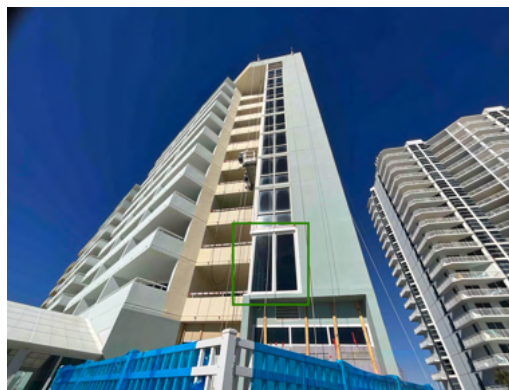
Photo 2

Unit No. 200 - South Bedroom - Overall view of mock-up EFCO Series 2701 Fixed Window at corner condition.

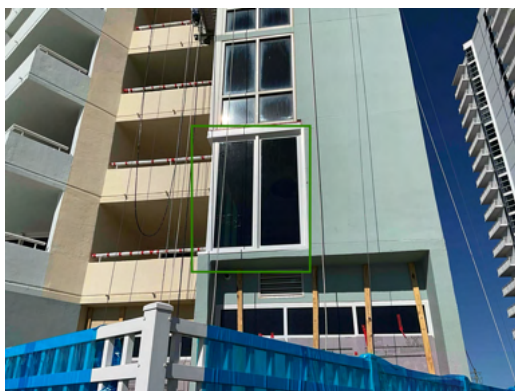
Photo 3

Unit No. 200 - South Bedroom - Overall view of mock-up EFCO Series 2701 Fixed Window at corner condition.

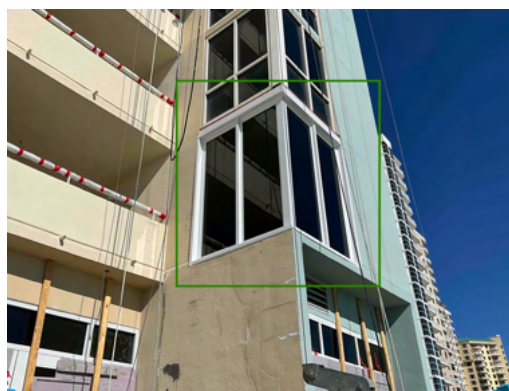
Photo 4

Unit No. 200 - South Bedroom - Overall view of mock-up EFCO Series 2701 Fixed Window at corner condition.

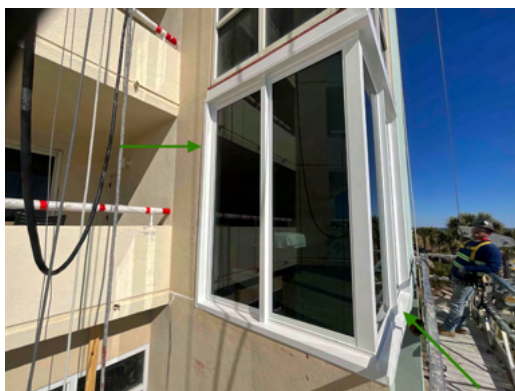
Photo 5

Unit No. 200 - South Bedroom - Overall view of mock-up EFCO Series 2701 Fixed Window at corner condition.

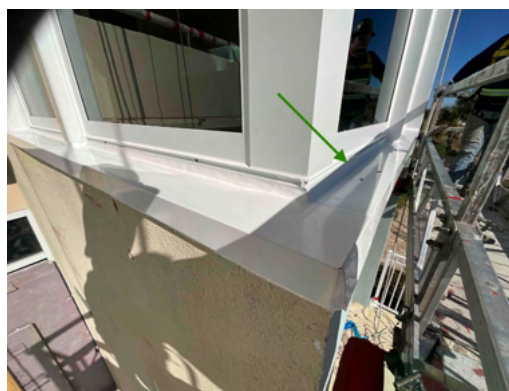
Photo 6

Unit No. 200 - South Bedroom - View of sealant in good condition with weep holes at sill.

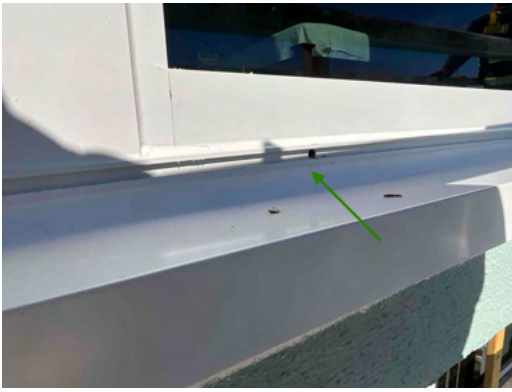
Photo 7

Unit No. 200 - South Bedroom - View of sealant in good condition.

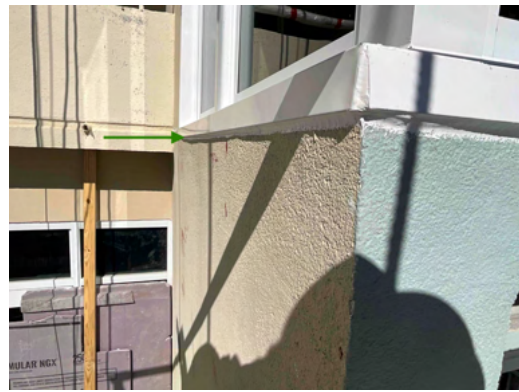
Photo 8

Unit No. 200 - South Bedroom - View of sealant in good condition.

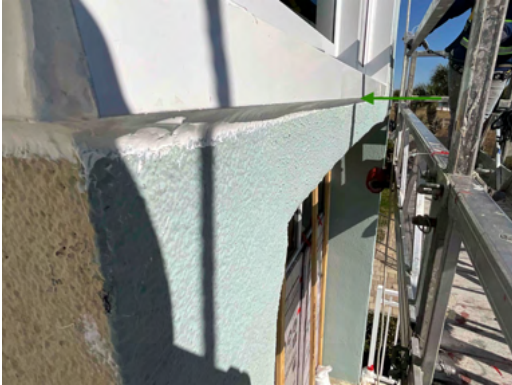
Photo 9

Unit No. 200 - South Bedroom - View of sealant in good condition.

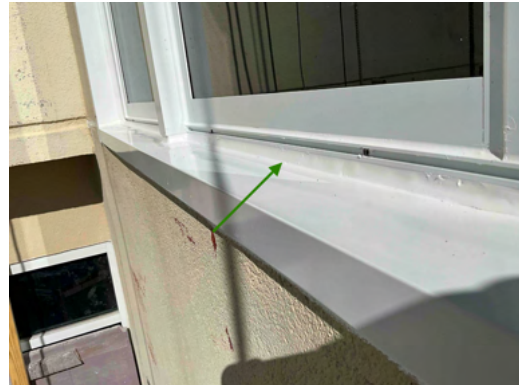
Photo 10

Unit No. 200 - South Bedroom - View of sealant in good condition.

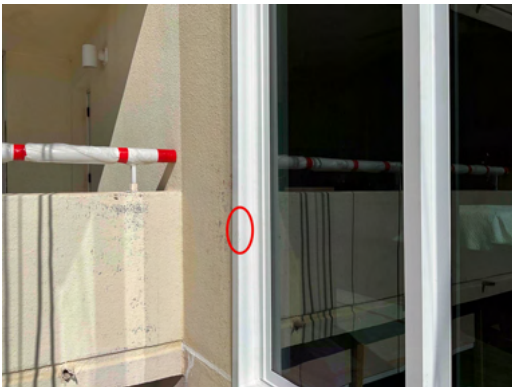
Photo 11

Unit No. 200 - South Bedroom - View of isolated damage to window frame. This was discussed with the contractor on site and is to be touched up with additional paint.

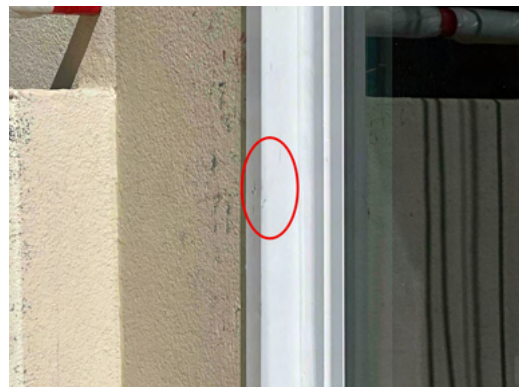
Photo 12

Unit No. 200 - South Bedroom - View of isolated damage to window frame. This was discussed with the contractor on site and is to be touched up with additional paint.

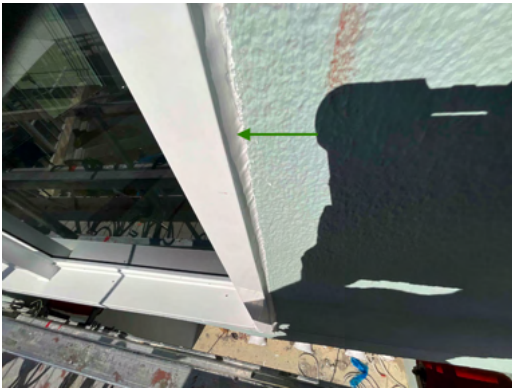
Photo 13

Unit No. 200 - South Bedroom - View of sealant in good condition.

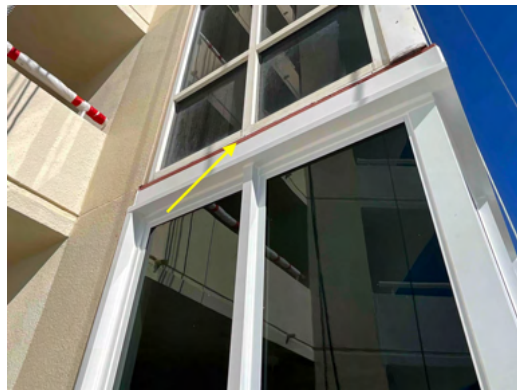
Photo 14

Unit No. 300 - South Bedroom - View of fluid-applied flashing installation.

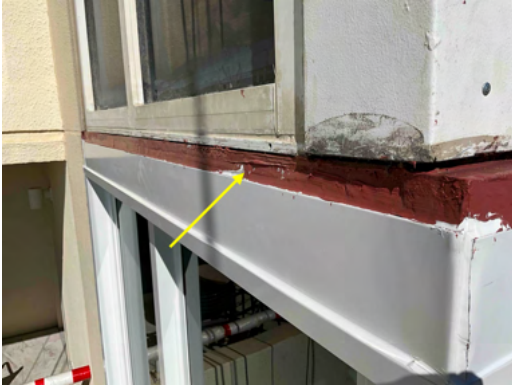
Photo 15

Unit No. 300 - South Bedroom - View of fluid-applied flashing installation.

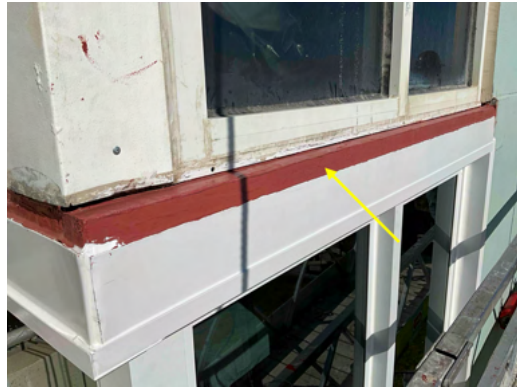
Photo 16

Unit No. 300 - South Bedroom - View of fluid-applied flashing installation.

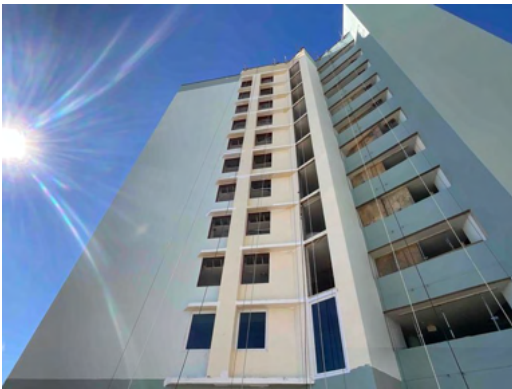
Photo 17

East Elevation - Overall view.

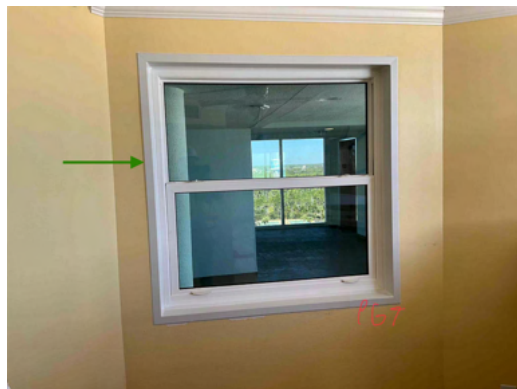
Photo 18

Unit No. 1100 - North Bedroom - View of EFCO window in good condition.

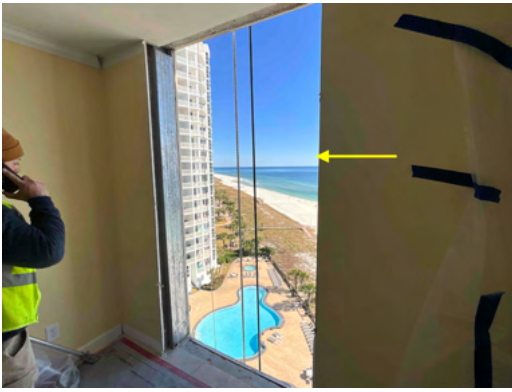
Photo 19

Unit No. 1100 - North Bedroom - View of rough opening to be prepared for EFCO window installation.

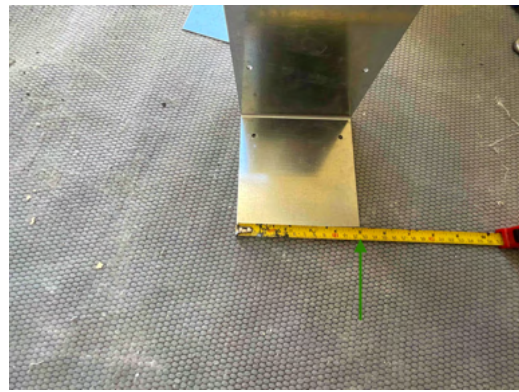
Photo 20

Unit No. 1100 - North Bedroom - View of EFCO window clip measured at the required 5".

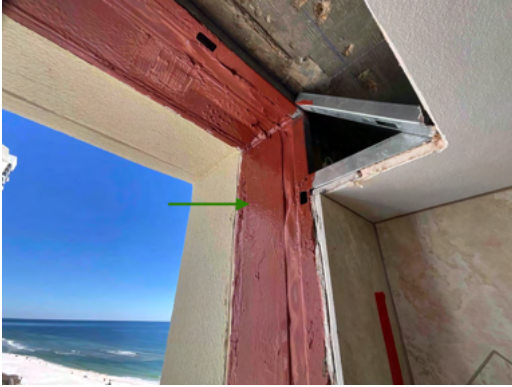
Photo 21

Unit No. 1100 - Bathroom - View of new FastFlash waterproofing installed at rough opening.

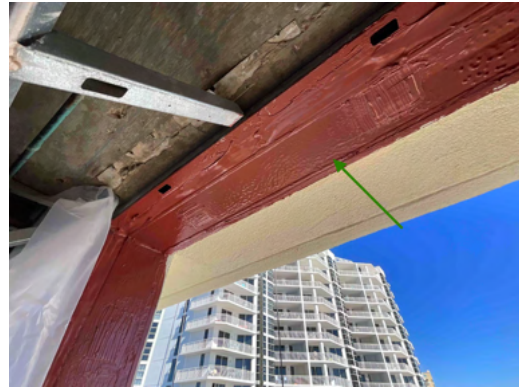
Photo 22

Unit No. 1100 - Bathroom - View of new FastFlash waterproofing installed at rough opening.

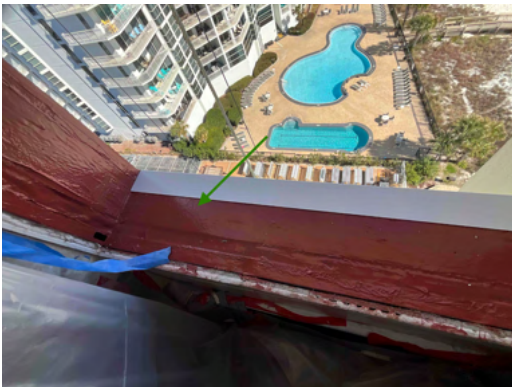
Photo 23

Unit No. 1100 - Bathroom - View of new FastFlash waterproofing installed at rough opening.
