BECI Field Report

Perdido Sun
13753 Perdido Key Dr.
Pensacola, FL 32507

FIELD REPORT NO: **PRDDSN022**

Window Replacement and Rough Opening
Preparation at 00 Stack and East Elevation CWW.

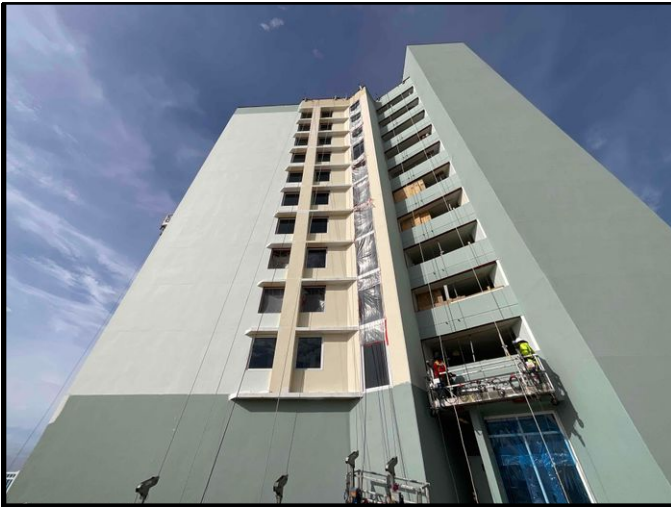
- 22.2 Upon arriving on-site, BECI & C/Sharpe visited all 00 Stack Units to observed the on-going work in progress surrounding the window replacement at the East and South Elevations (Reference Figure 1). At the East Elevation, crew members had completed window installation at the northeast bedroom at Unit Nos. 200, 900, 1000, and 1100. Window installation was in-progress at Unit Nos. 800 and 700 (Reference Figures 2 and 3), and the rough openings had been prepared and were ready to receive new windows at Unit Nos. 600, 500, 400, and 300. At the bathroom windows replacement, windows were installed at all 00 Stack Units, except for Unit Nos. 300 and 400 which was in progress. Crew members were working on completing waterproofing and rough opening preparation at the South corner windows (Reference Figure 4).

FIGURE 1 - East Elevation - Overall view of window replacement - Work in Progress.

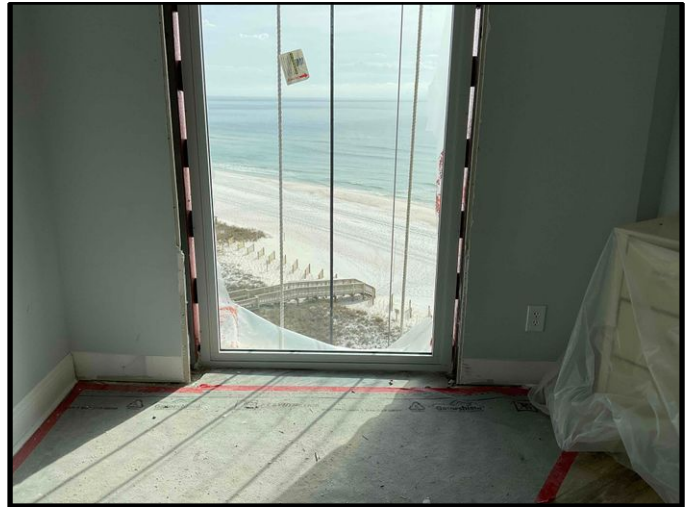
FIGURE 2 - East Elevation - Bedroom Window - Unit No. 800 - View of window replacement - Work in Progress.

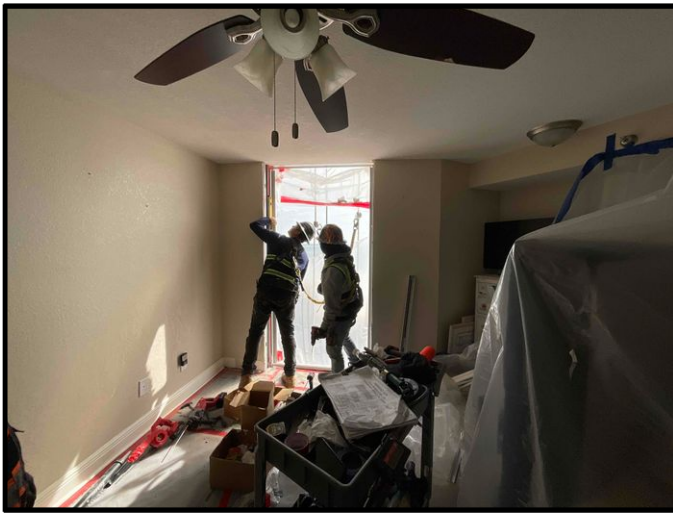
FIGURE 3 - East Elevation - Bedroom Window - Unit No. 700 - View of window replacement - Work in Progress.

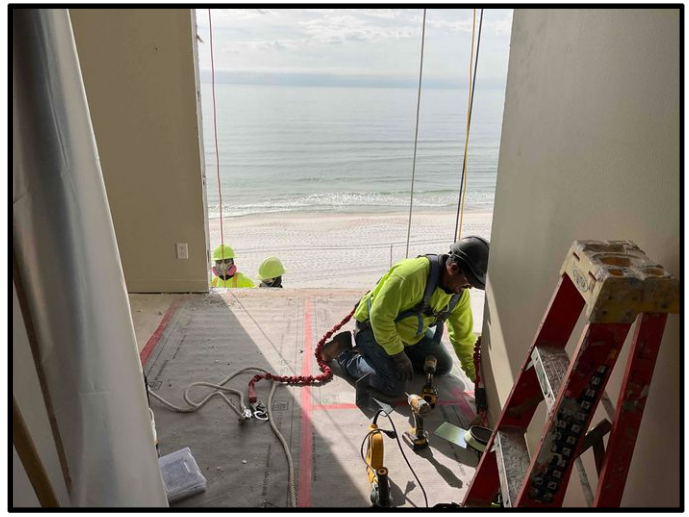
FIGURE 4 - South Elevation - Bedroom Window - Unit No. 700 - View of rough opening preparation - Work in Progress.

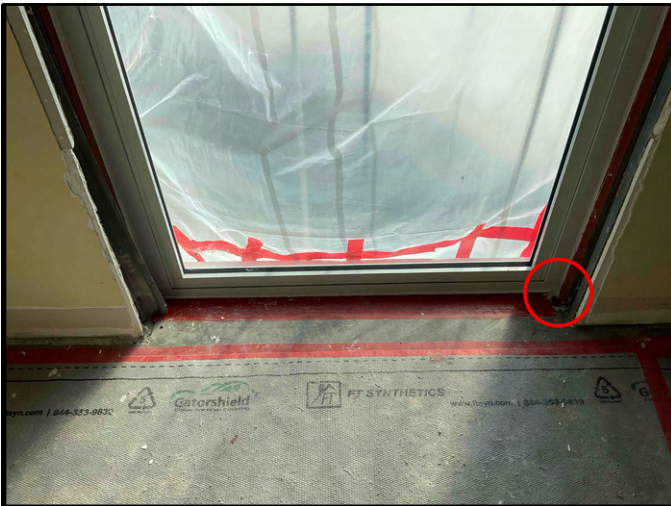
- 22.2.1 While observing the on-going window replacement, we observed in Unit Nos. 1000 that the sealant joints at the East Elevation Northmost Bedroom contained sections where it appeared to not be cleanly tooled (Reference Figures 5 through 8). We discussed with the site team that the sections would be removed and replaced to address the anomalies.

FIGURE 5 - Unit 1000 - View of sealant joints to be removed and replaced at not cleanly tooled locations.

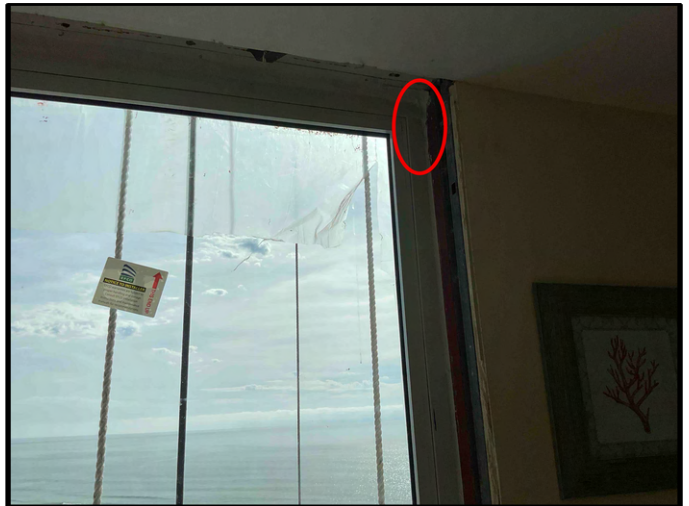
FIGURE 6 - Unit 1000 - View of sealant joints to be removed and replaced at not cleanly tooled locations.

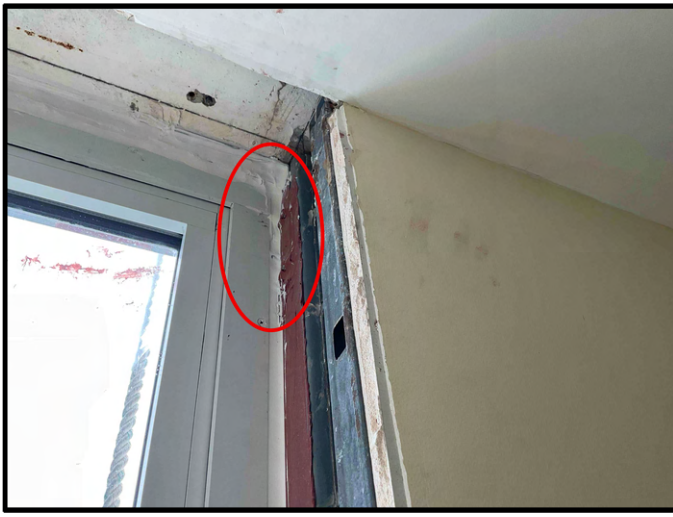
FIGURE 7 - Unit 1000 - View of sealant joints to be removed and replaced at not cleanly tooled locations.

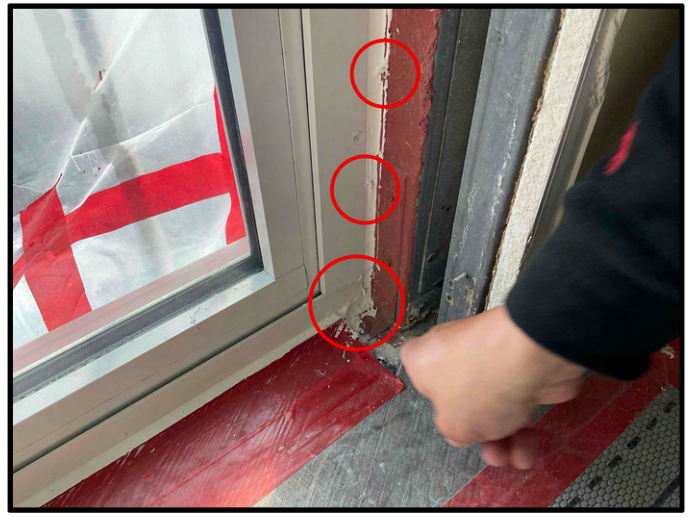
FIGURE 8 - Unit 1000 - View of sealant joints to be removed and replaced at not cleanly tooled locations.

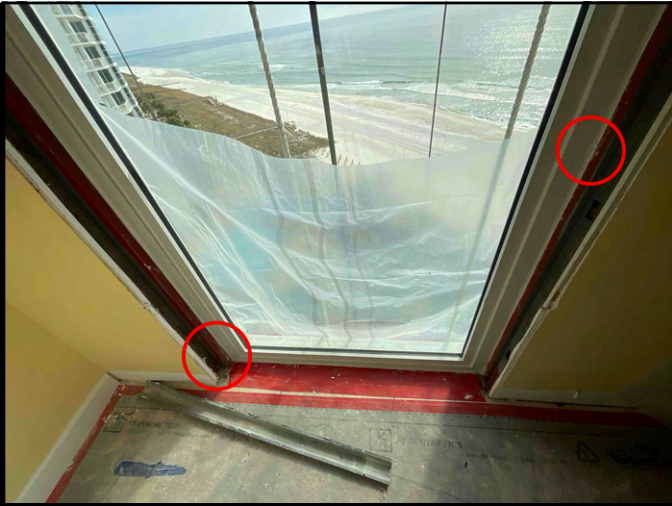
22.2.2 While observing the on-going window replacement, we observed in Unit Nos. 1100 that the sealant joints at the East Elevation Northmost Bedroom contained sections where it appeared to not be cleanly tooled (Reference Figures 9 through 11). We discussed with the site team that the sections would be removed and replaced to address the anomalies.

FIGURE 9 - Unit 1100 - View of sealant joints to be removed and replaced at not cleanly tooled locations.

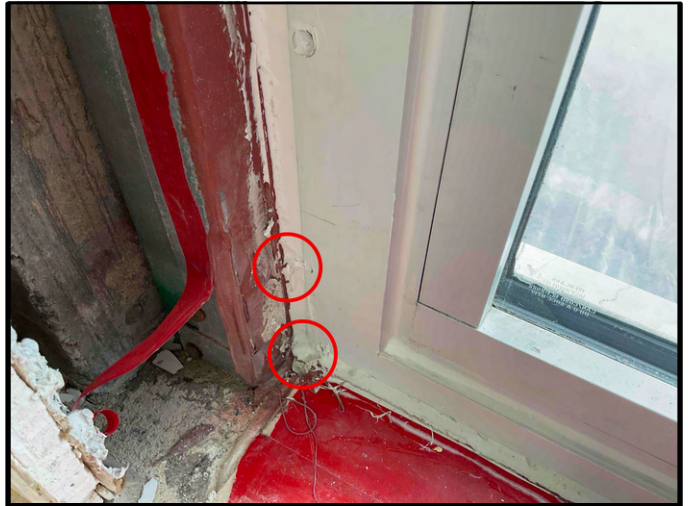
FIGURE 10 - Unit 1100 - View of sealant joints to be removed and replaced at not cleanly tooled locations.

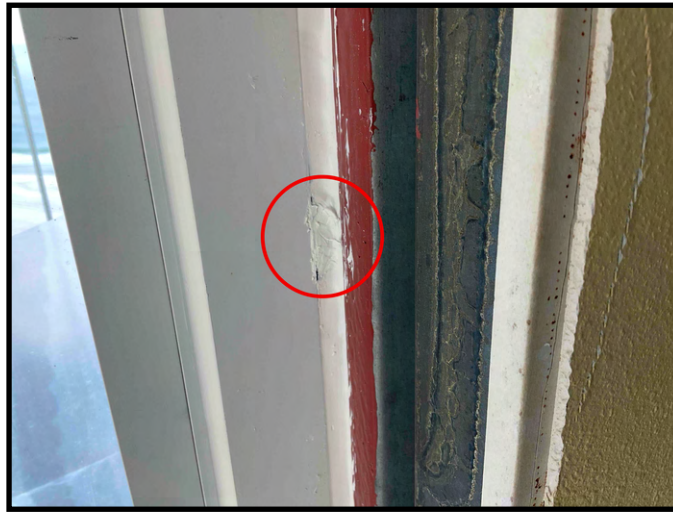
FIGURE 11 - Unit 1100 - View of sealant joints to be removed and replaced at not cleanly tooled locations.

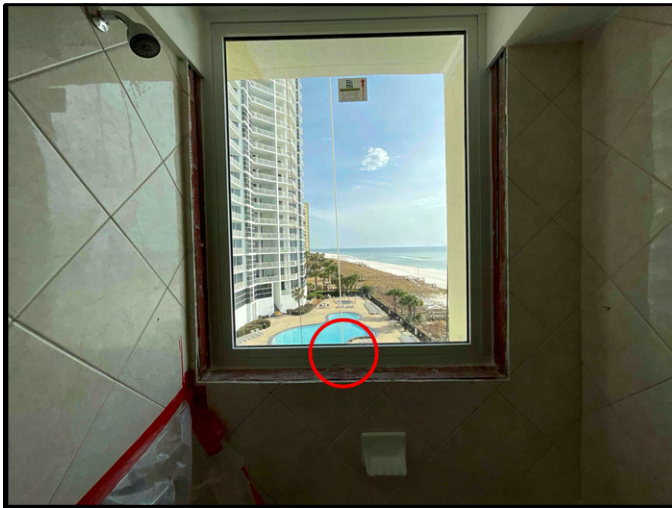
22.2.3 While observing the on-going window replacement, we observed in Unit No. 500 that the sealant joints at the Northmost Bathroom contained a large void, making the sealant joint not continuous or complete (Reference Figures 12 and 13). We discussed with the site team that the sections would be removed and replaced to address the anomaly.

FIGURE 12 - Unit 500 - Northmost Bathroom - View of sealant joints to be touched up where void exists.

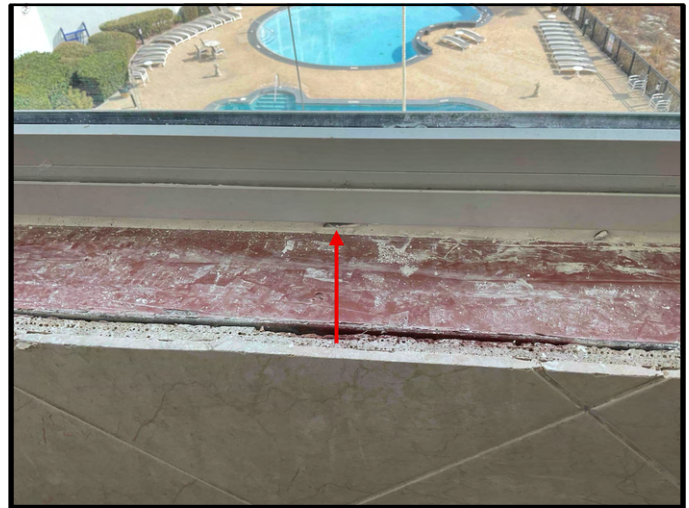
FIGURE 13 - Unit 500 - Northmost Bathroom - View of sealant joints to be touched up where void exists.
