LOCATION: PERDIDO SUN

QUARTERLY PMP INSPECTION

Date & Quarter Performed Q2: 5/28/2025

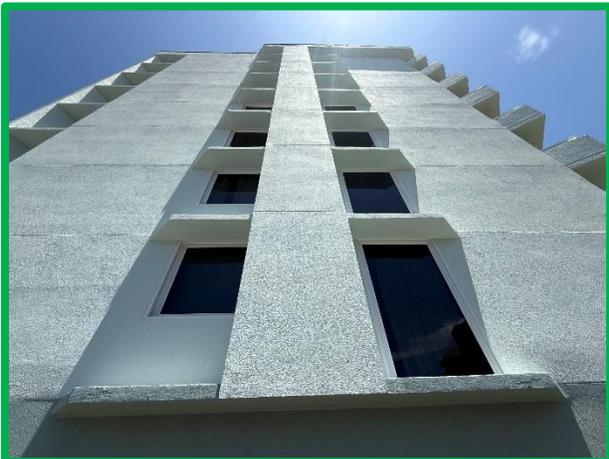
Photo 21
West Elevation – New coatings and windows in overall good condition.

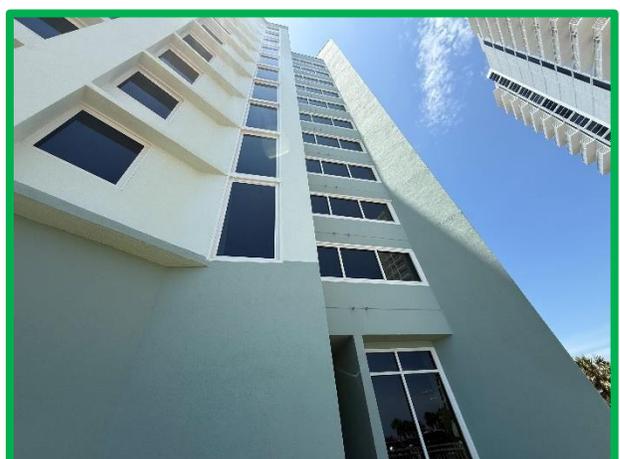
Photo 24
East Elevation – New coatings and windows in overall good condition.

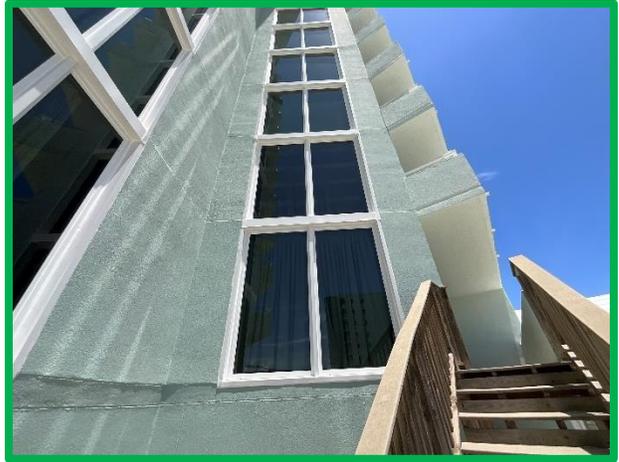
Photo 28
South Elevation – New coatings and windows in overall good condition.

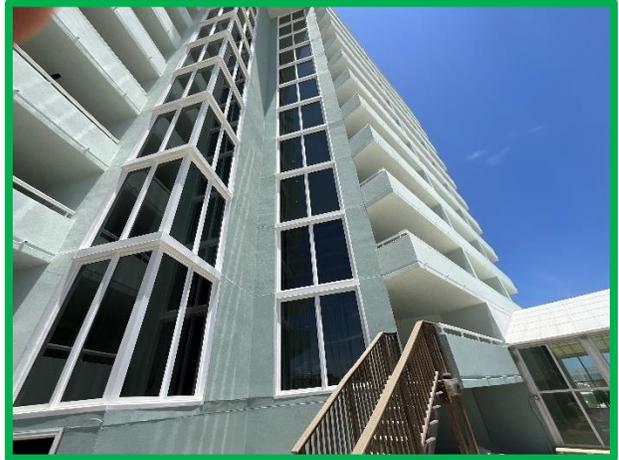
Photo 29
South Elevation – New coatings and windows in overall good condition.

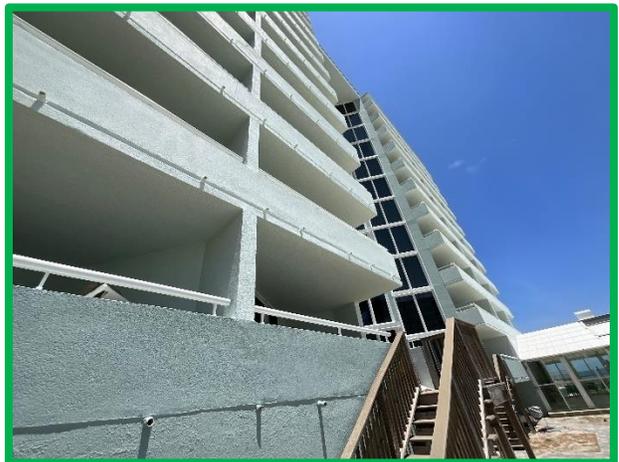
Photo 30
South Elevation – New coatings and windows in overall good condition.

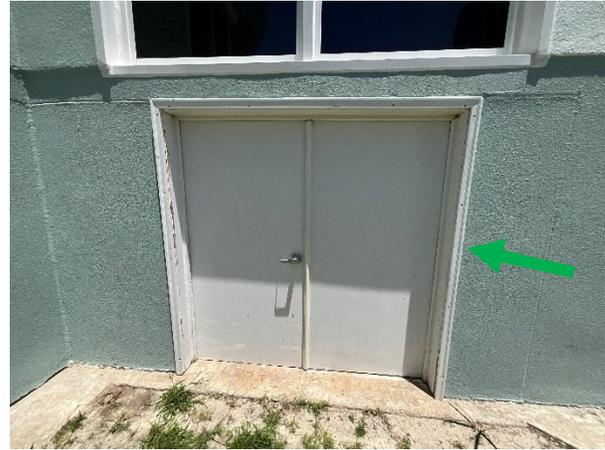
Photo 34
South Elevation – Perimeter sealant in good condition at door frame.

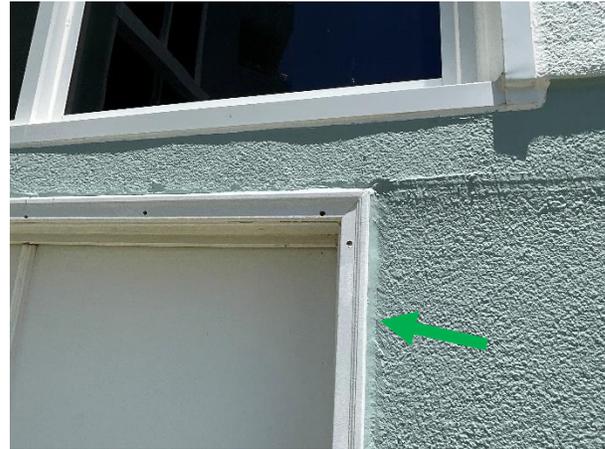
Photo 35
South Elevation – Perimeter sealant in good condition at door frame.

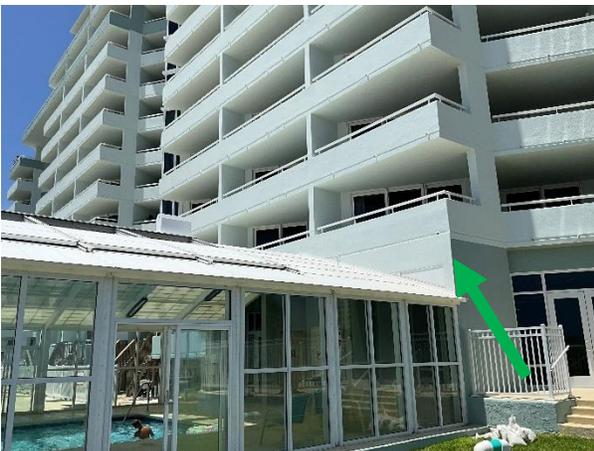
Photo 33
South Elevation – New coatings and windows in overall good condition.

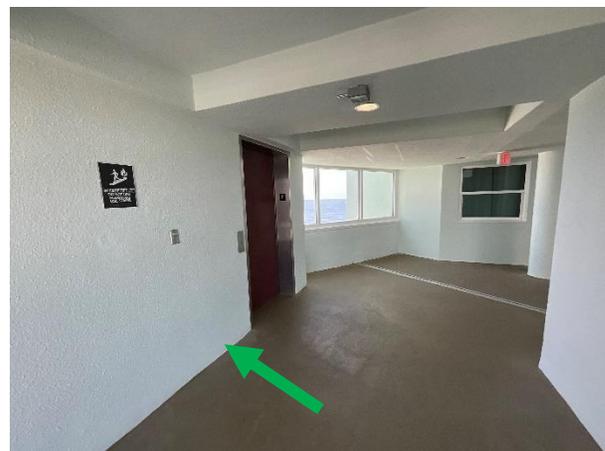
Photo 36
North Elevation – Common Walkways – Floor 11 – New coatings and windows in overall good condition.

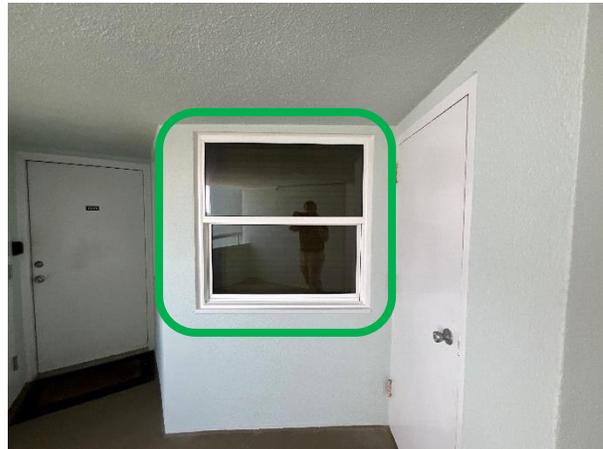
Photo 40
North Elevation – Common Walkways – Floor 10 – New window in overall good condition.

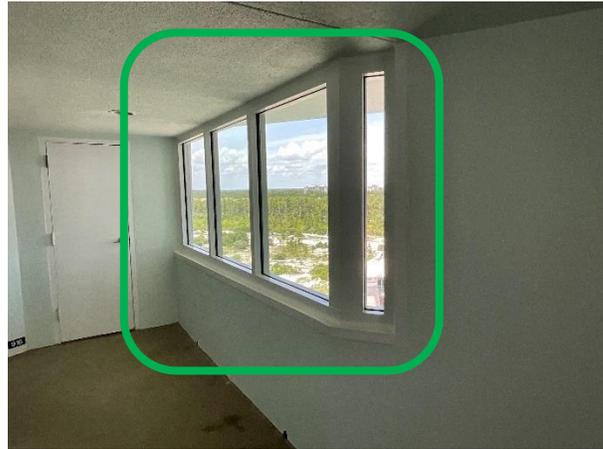
Photo 41
North Elevation – Common Walkways – Floor 9 – New window in overall good condition.

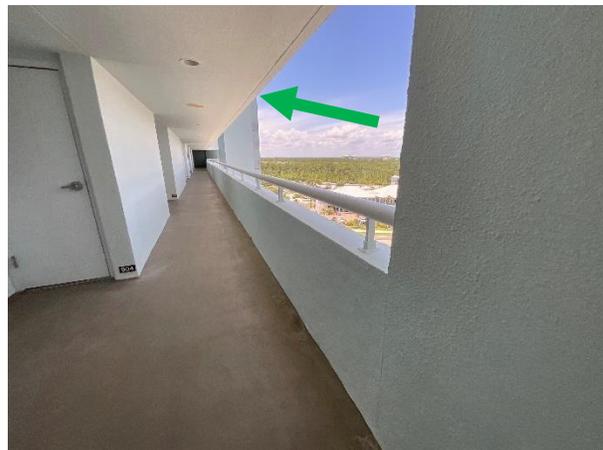
Photo 42
North Elevation – Common Walkways – Floor 9 – New coatings in overall good condition.

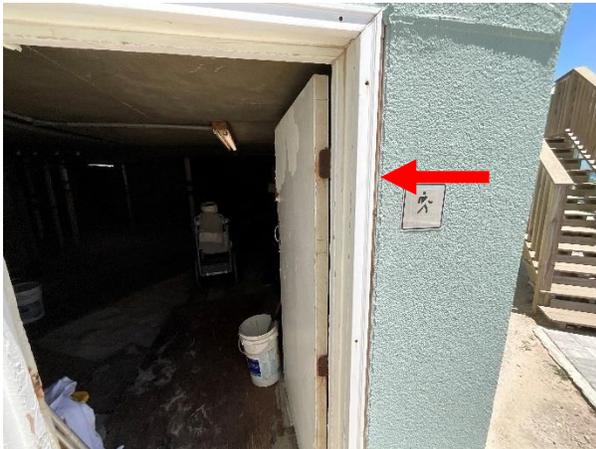
Photo 54
North Elevation – Minor corrosion present on door hardware.

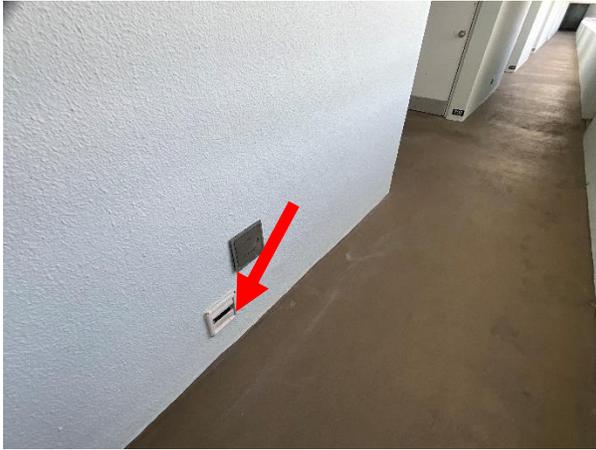
Isolated: Dryer Vent Damaged / missing at Units 1100, 500, and 700. Typical: Corroded Fasteners at Dryer Vents on All Floors.

Photo 60
North Elevation – Common Walkways – Floor 7 – Unit 702 – Damaged dryer vent louver.

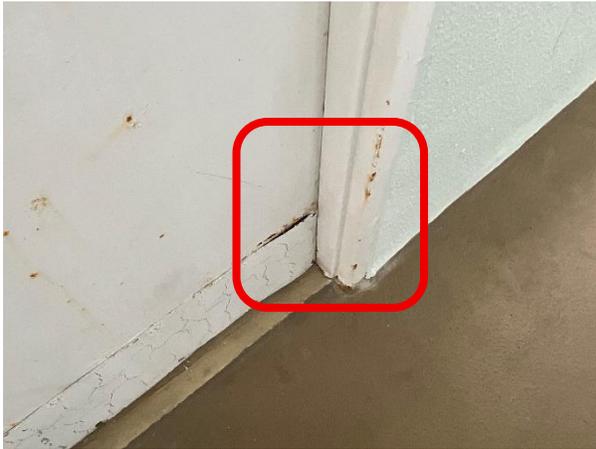
Isolated: Loose Door Frame at 8th Floor West Stairwell Door. Typical: Corroded Door Frames and Door Panels.

Photo 64
North Elevation – Common Walkways – Floor 11 – Corrosion present at door hardware.

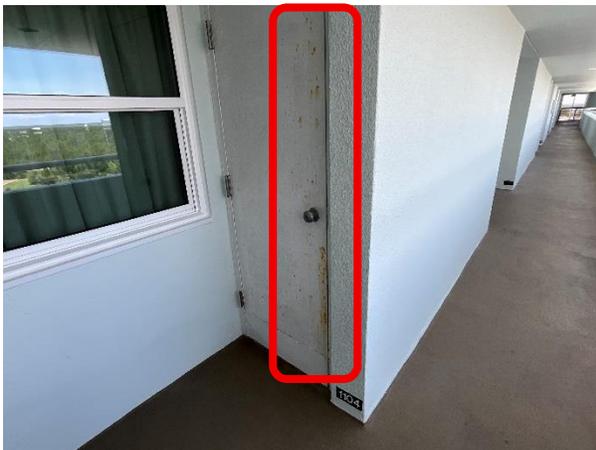
Photo 65
North Elevation – Common Walkways – Floor 7 – Corrosion present at door hardware.

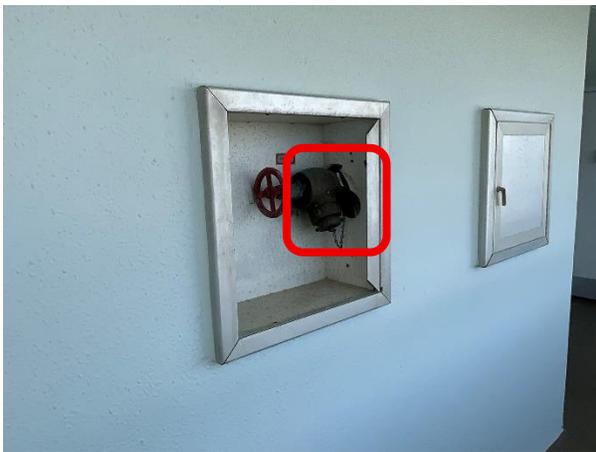
Photo 71
North Elevation – Common Walkways – Floor 10 – Opening in wall at fire wall penetration.

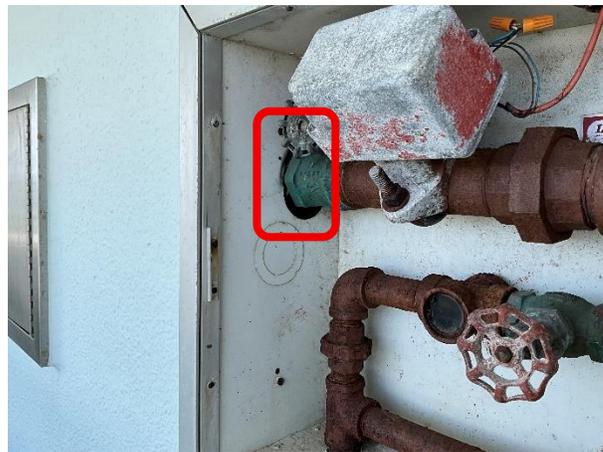
Photo 69
North Elevation – Common Walkways – Floor 11 – Opening in wall at fire wall penetration.

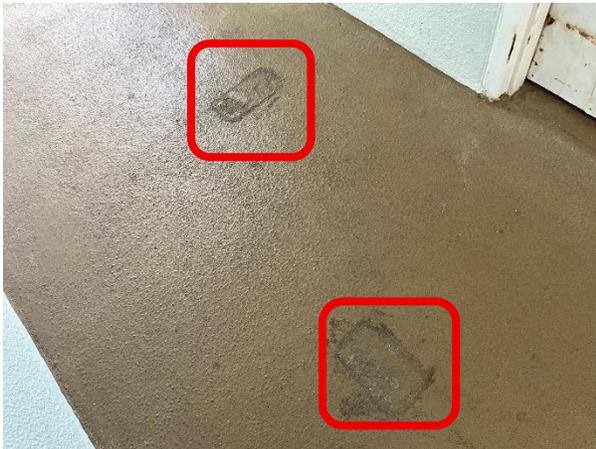
Photo 78
North Elevation – Common Walkways – Floor 4 – Isolated damaged deck coating.

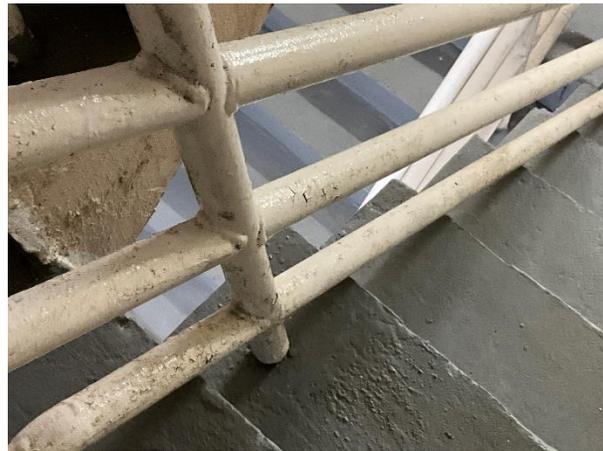
Photo 80
North Elevation – Common Walkways – Floor 2 – Isolated uncoated sealant.

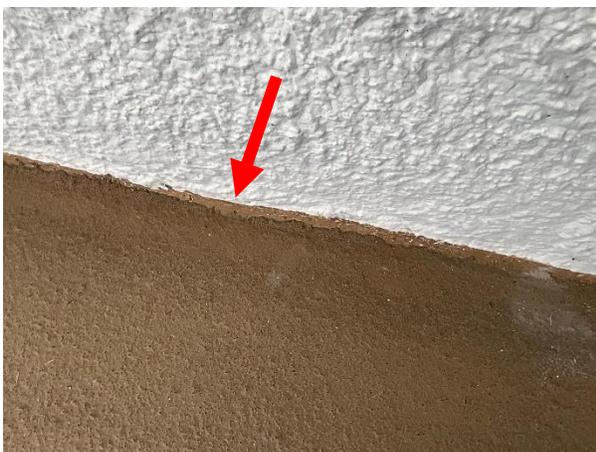
Photo 83
East Stairwell – Floor 11 – Chipped and bubbled railing paint

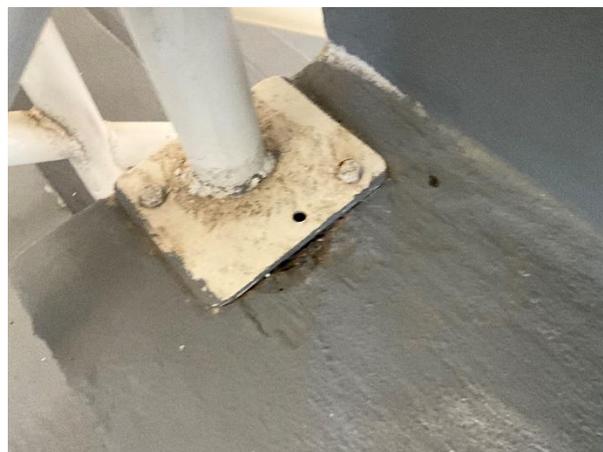
Photo 81
North Elevation – Common Walkways – Floor 2 – Isolated uncoated sealant.

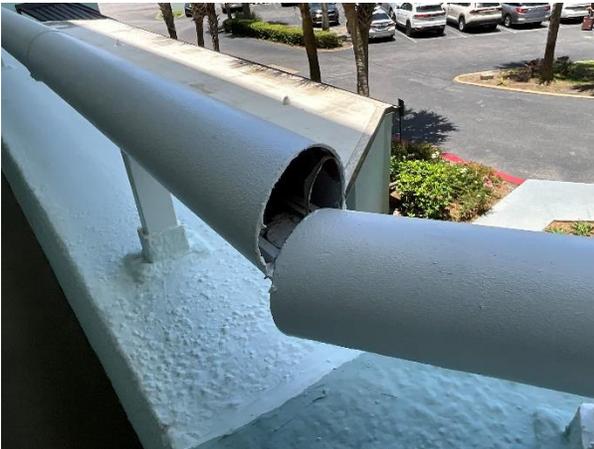
Photo 84
West Stairwell – Floor 11 – View of Stanchion Pockets unfilled and left under railings.

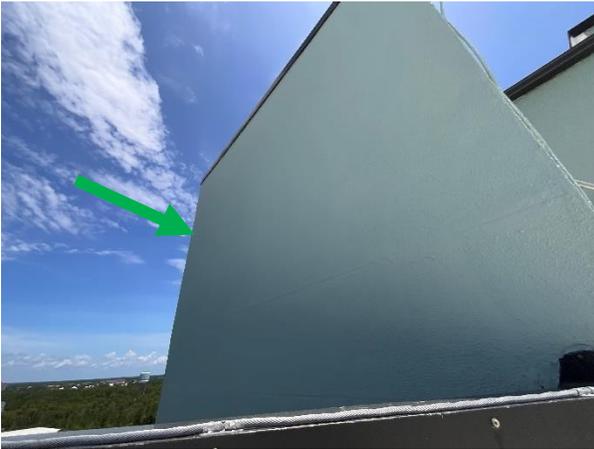
Photo 88
Low-Slope Roof – Coping in overall good condition.

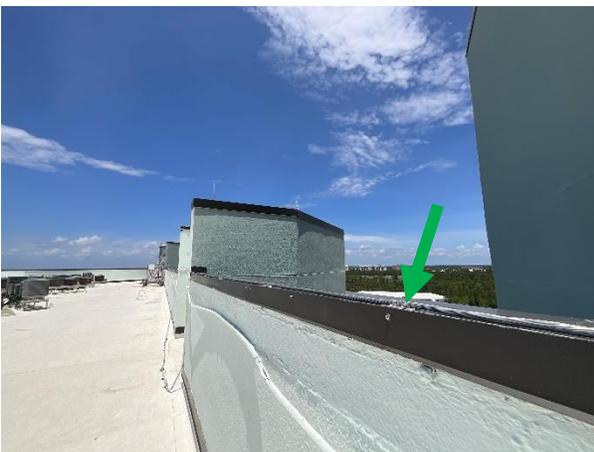
Photo 89
Low-Slope Roof – Parapet wall in overall good condition.

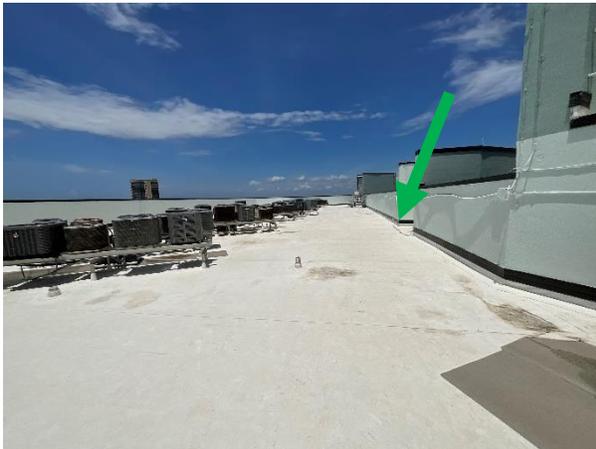
Photo 90
Low-Slope Roof – Single-ply membrane in overall good condition.

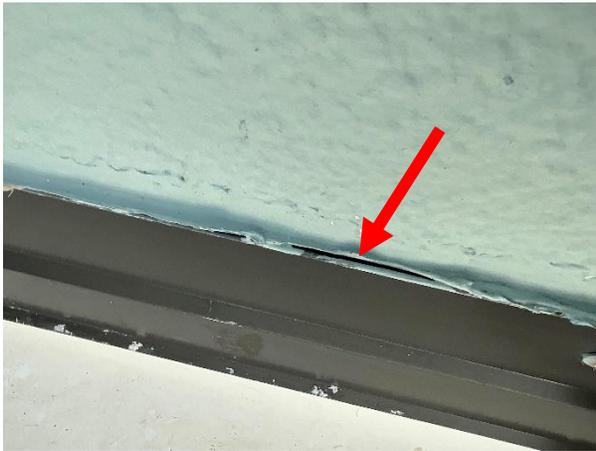
Photo 100
Low-Slope Roof – Missing sealant at metal flashing interface.

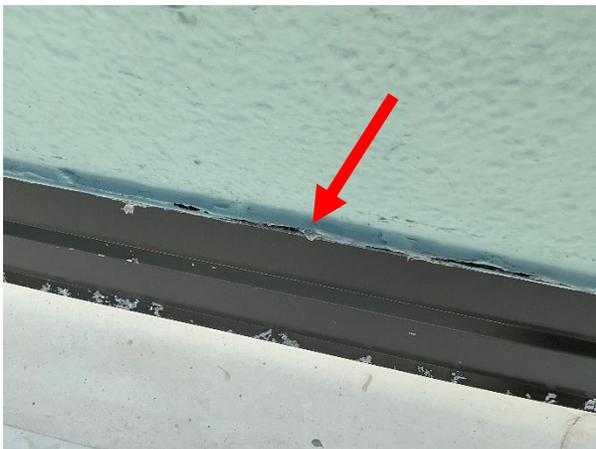
Photo 101
Low-Slope Roof – Missing sealant at metal flashing interface.

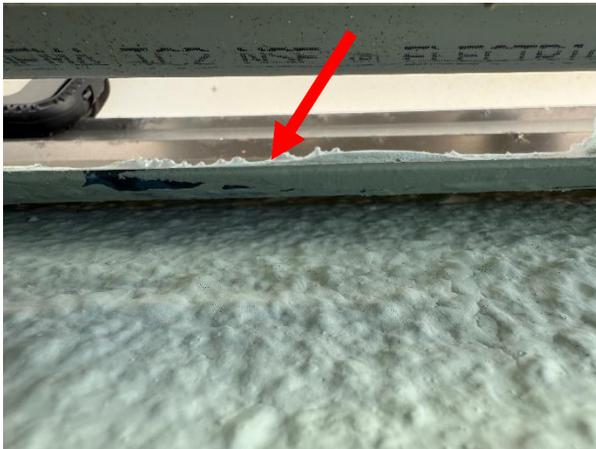
Photo 102
Low-Slope Roof – Missing sealant at metal flashing interface.

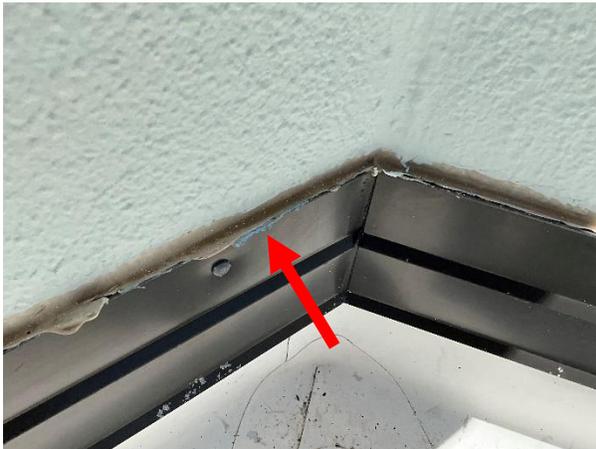
Photo 106
Low-Slope Roof – Sealant at metal flashing interface applied over exposed plastic film.

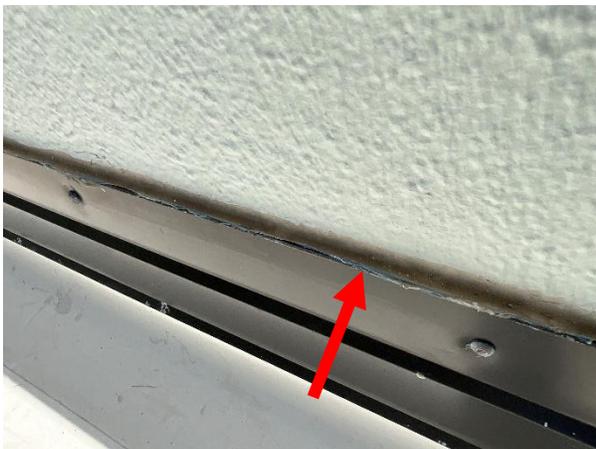
Photo 107
Low-Slope Roof – Hole present due to missing fastener.

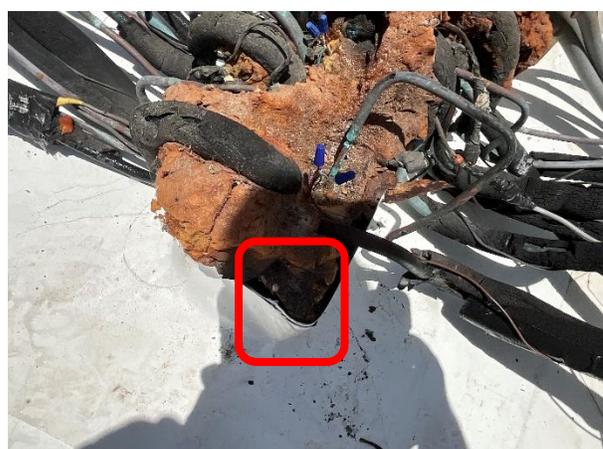
Photo 105
Low-Slope Roof – Sealant at metal flashing interface applied over exposed plastic film.

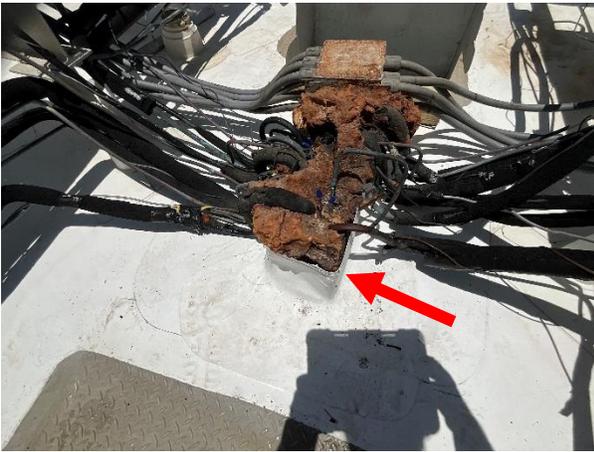
Photo 108
Low-Slope Roof – Typical void around AC conduit.

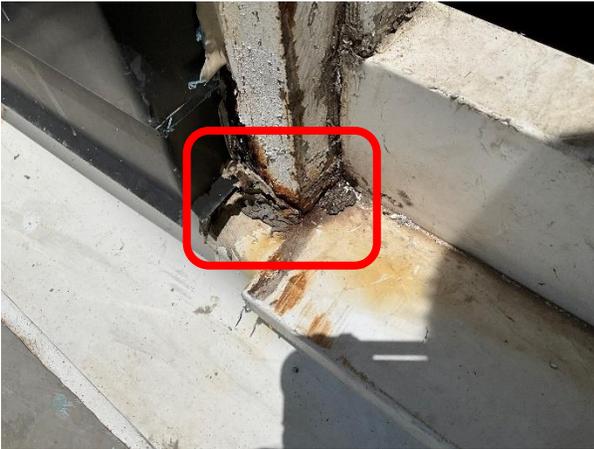
Photo 112
Low-Slope Roof – Loose and unbonded membrane at alcove.

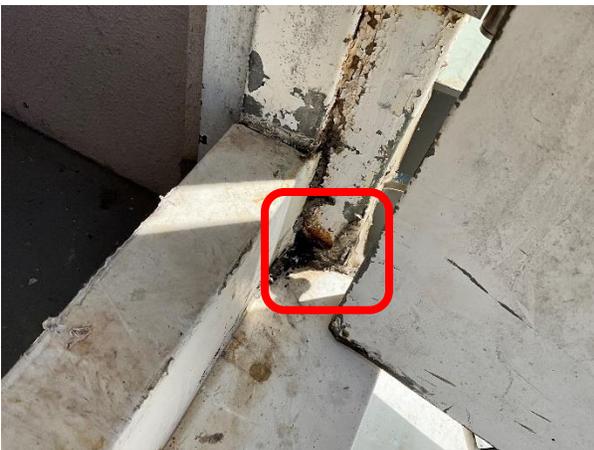
Photo 113
Low-Slope Roof – Loose and unbonded membrane at alcove.

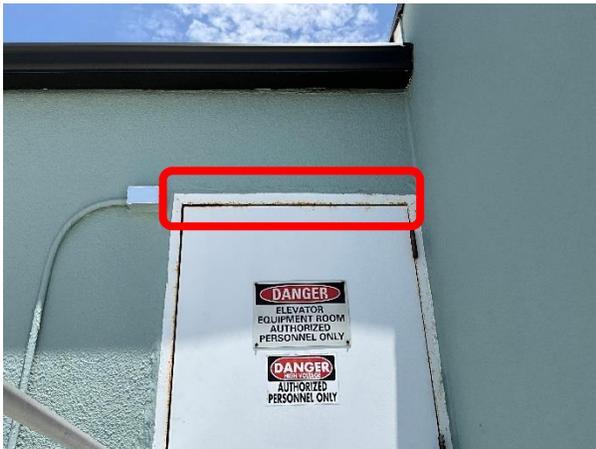
Metal Frames and Doors at Roof Level in poor condition with corrosion at the jambs and door panel.

Photo 118
Low-Slope Roof – Moderate corrosion on hardware of roof access door.

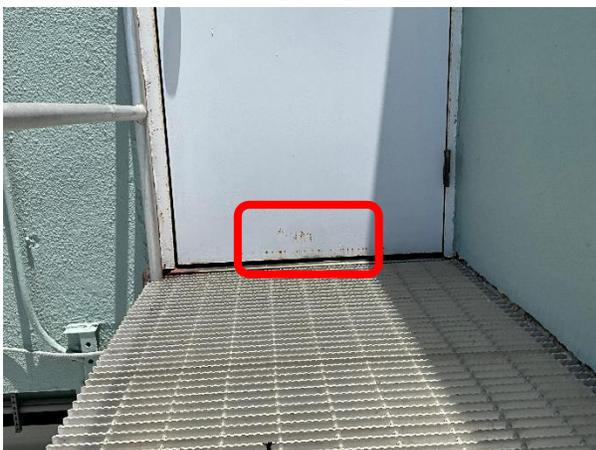
Photo 119
Low-Slope Roof – Minor corrosion on hardware of roof access door.
