BE-CI Annual Exterior Wall Survey Report

Project:
Perdido Sun Condominiums
13753 Perdido Key Dr.
Pensacola, FL 32507

REPORT YEAR: **2025**

CONSULTANT'S PROJECT NO: P01157

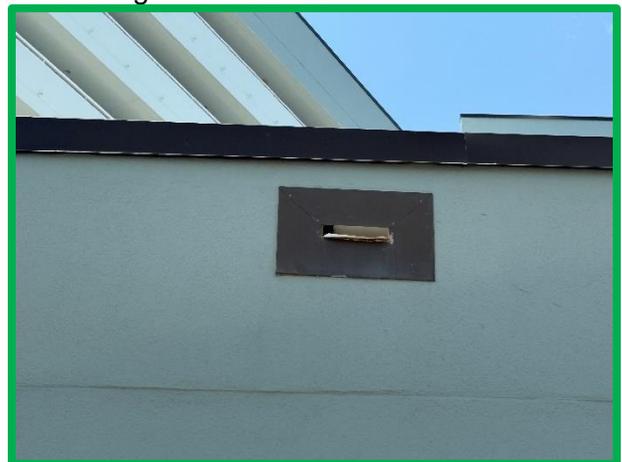
Photo 12
North Elevation – New coatings and windows in overall good condition.

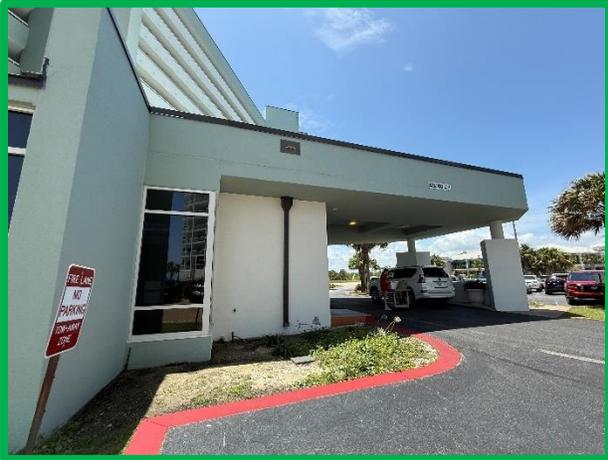
Photo 13
North Elevation – New coatings and windows in overall good condition.

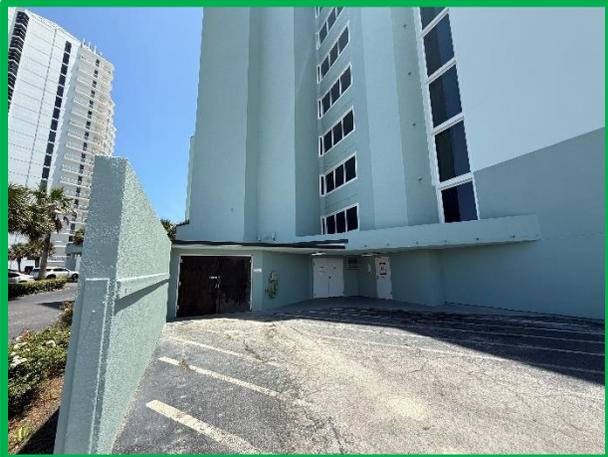
Photo 14
North Elevation – New coatings and windows in overall good condition.

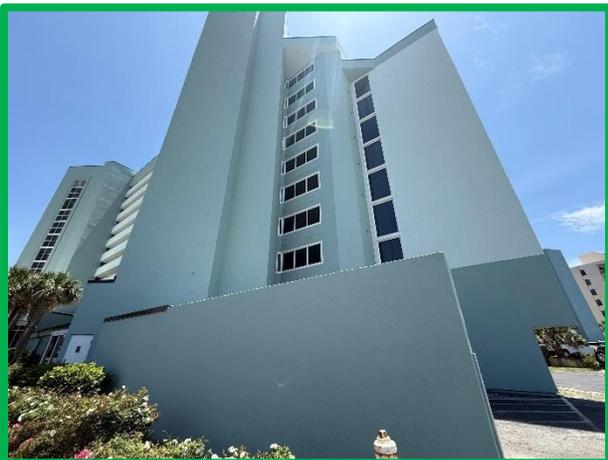
Photo 15
North Elevation – New coatings and windows in overall good condition.

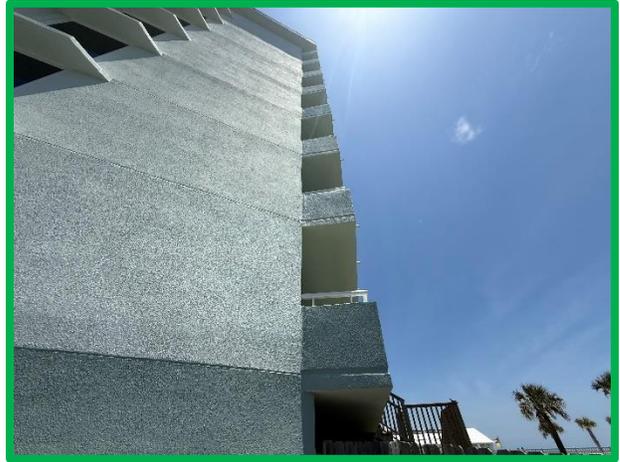
Photo 22
West Elevation – New coatings and windows in overall good condition.

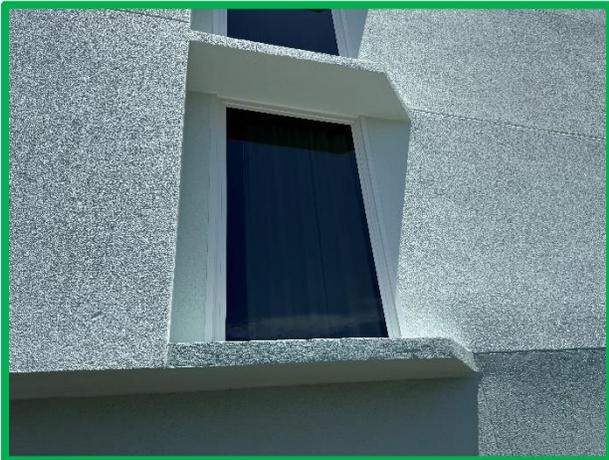
Photo 20
West Elevation – New coatings and windows in overall good condition.

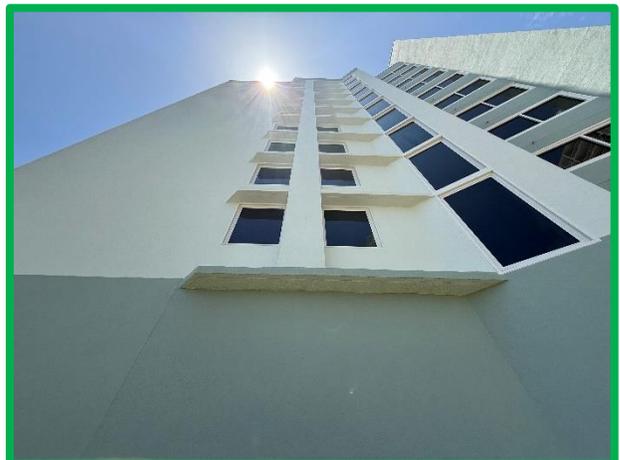
Photo 23
East Elevation – New coatings and windows in overall good condition.

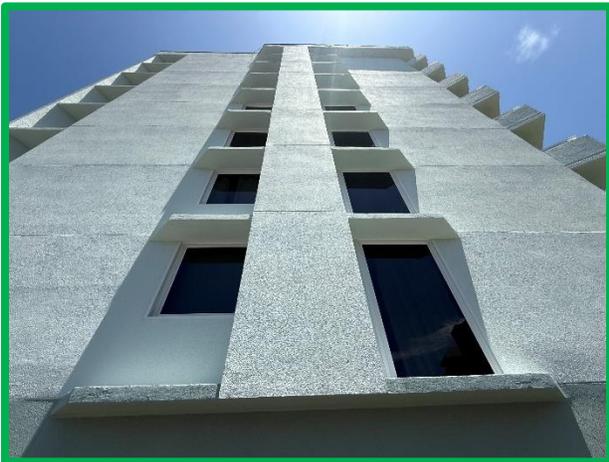
Photo 21
West Elevation – New coatings and windows in overall good condition.

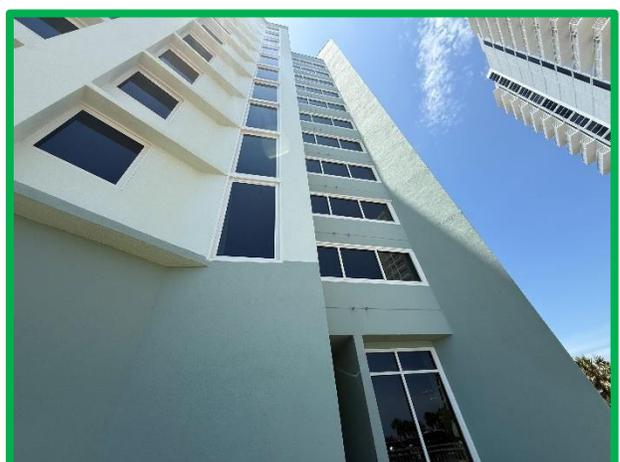
Photo 24
East Elevation – New coatings and windows in overall good condition.

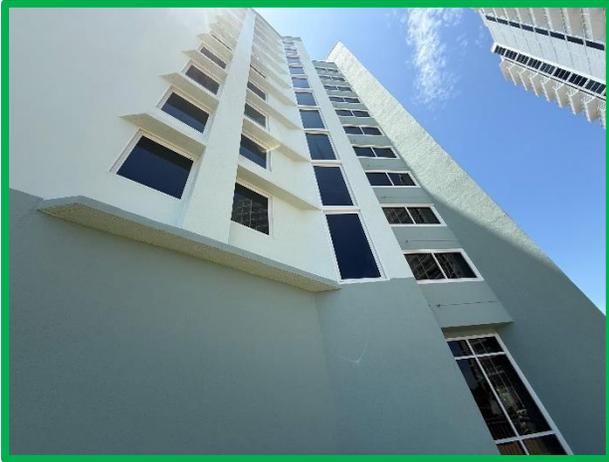
Photo 25
East Elevation – New coatings and windows in overall good condition

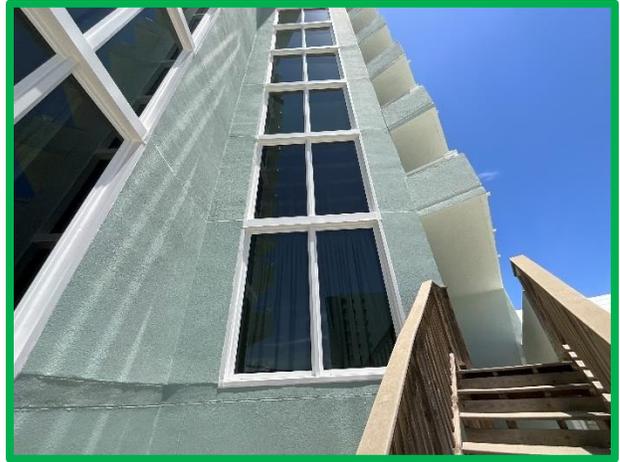
Photo 28
South Elevation – New coatings and windows in overall good condition.

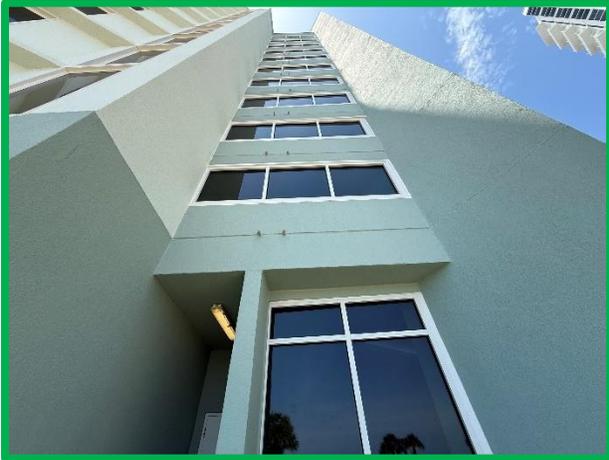
Photo 26
East Elevation – New coatings and windows in overall good condition

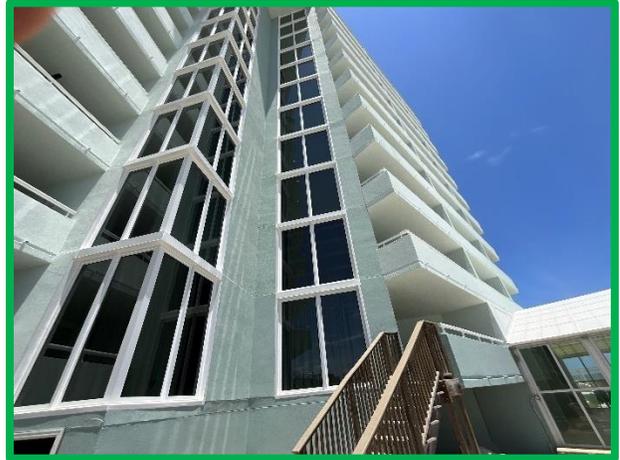
Photo 29
South Elevation – New coatings and windows in overall good condition.

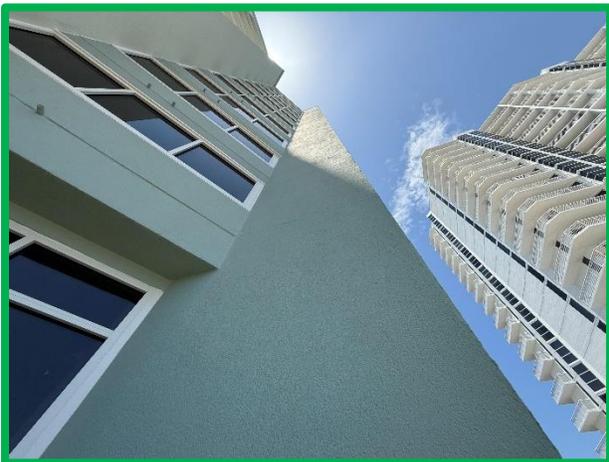
Photo 27
East Elevation – New coatings and windows in overall good condition

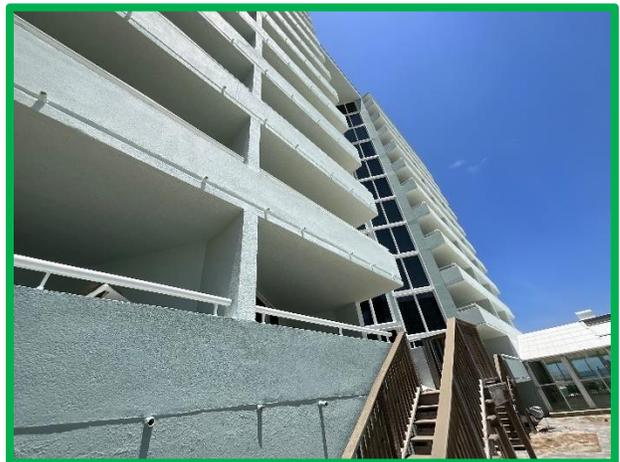
Photo 30
South Elevation – New coatings and windows in overall good condition.

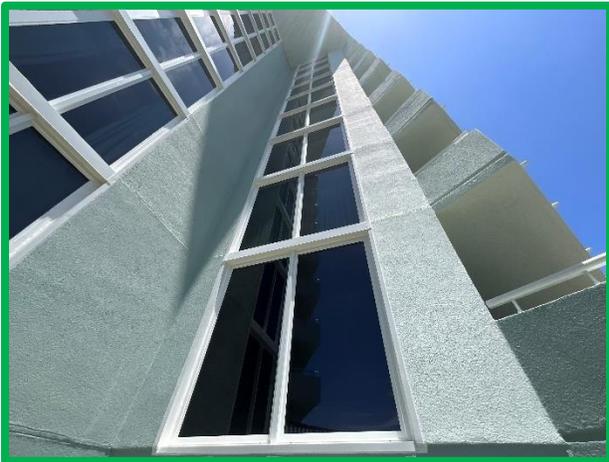
Photo 31
South Elevation – New coatings and windows in overall good condition.

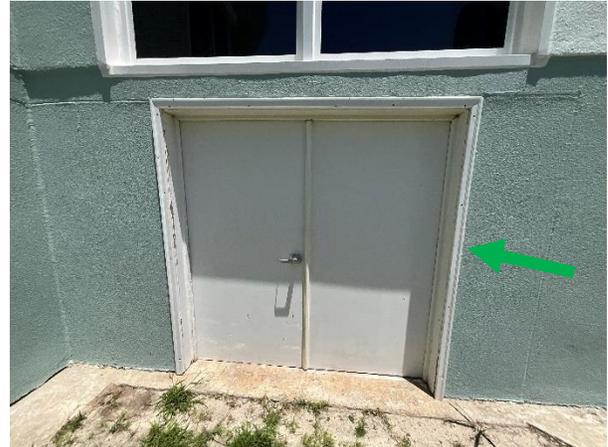
Photo 34
South Elevation – Perimeter sealant in good condition at door frame.

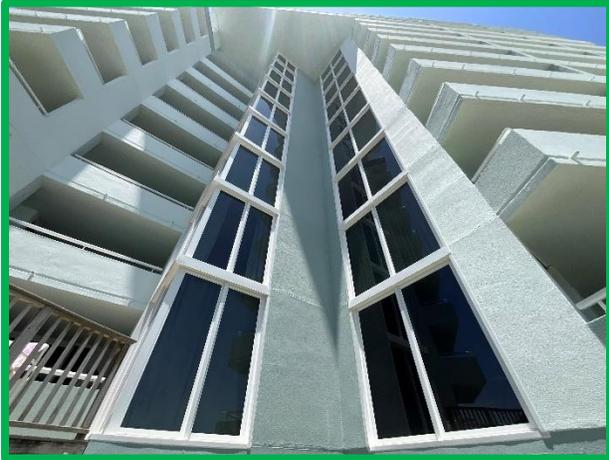
Photo 32
South Elevation – New coatings and windows in overall good condition.

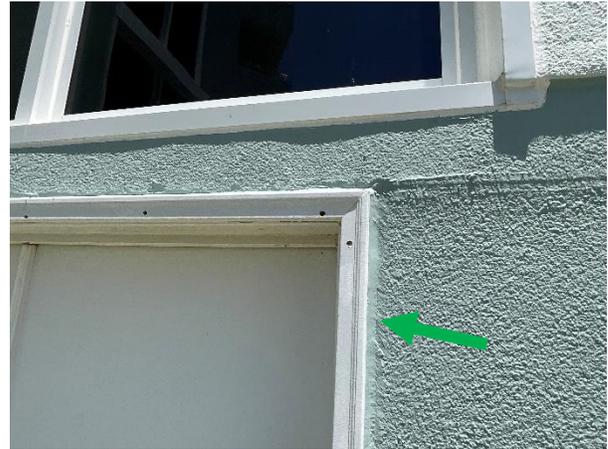
Photo 35
South Elevation – Perimeter sealant in good condition at door frame.

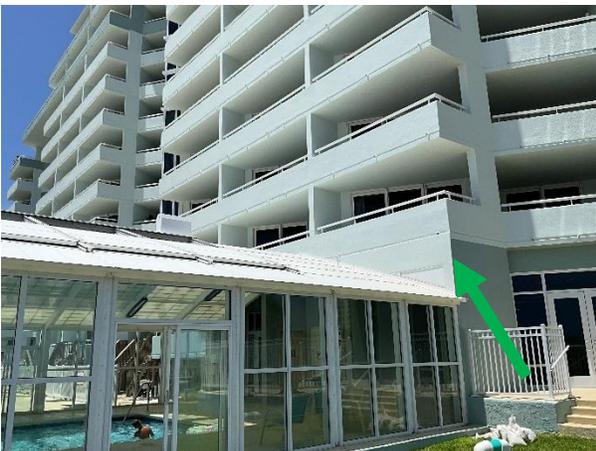
Photo 33
South Elevation – New coatings and windows in overall good condition.

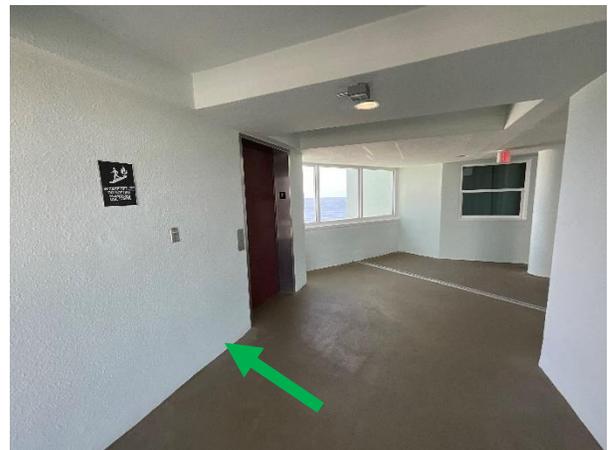
Photo 36
North Elevation – Common Walkways – Floor 11 – New coatings and windows in overall good condition.

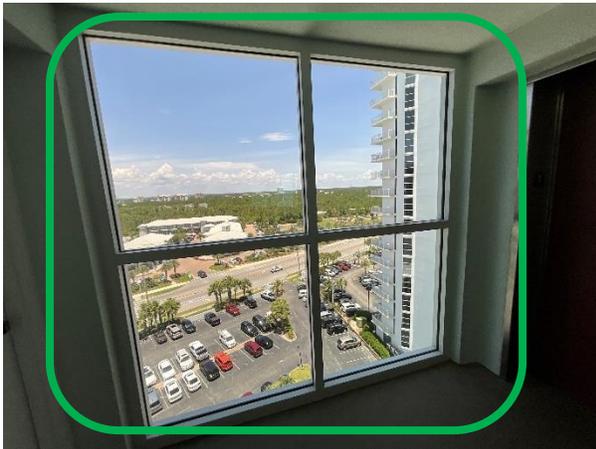
Photo 37
North Elevation – Common Walkways – Floor 11 – New window in overall good condition.

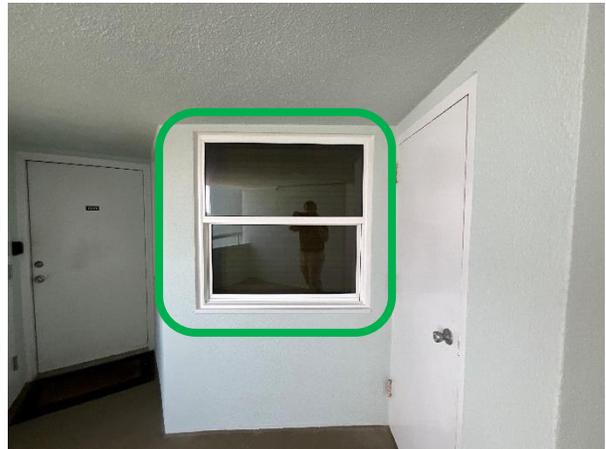
Photo 40
North Elevation – Common Walkways – Floor 10 – New window in overall good condition.

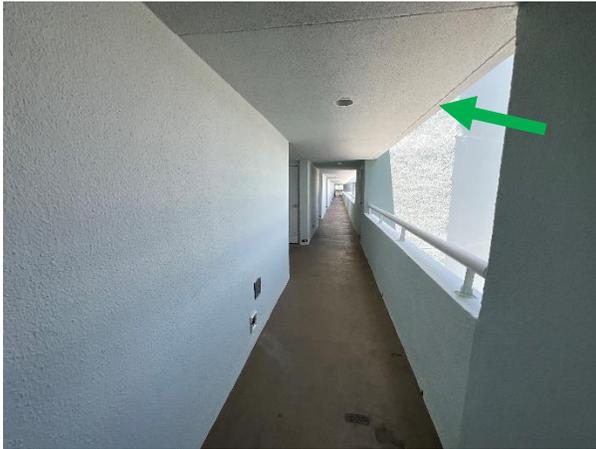
Photo 38
North Elevation – Common Walkways – Floor 11 – New coatings in overall good condition.

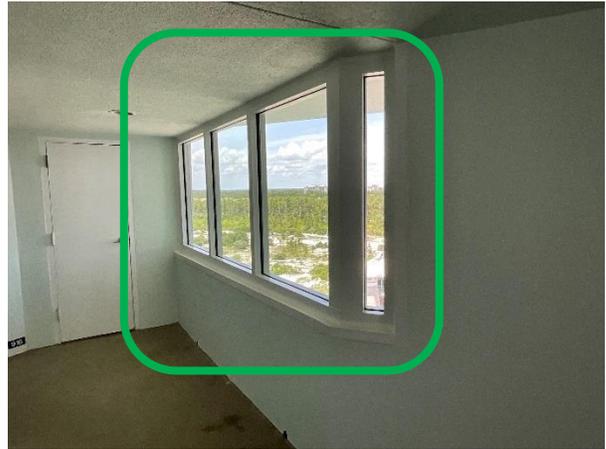
Photo 41
North Elevation – Common Walkways – Floor 9 – New window in overall good condition.

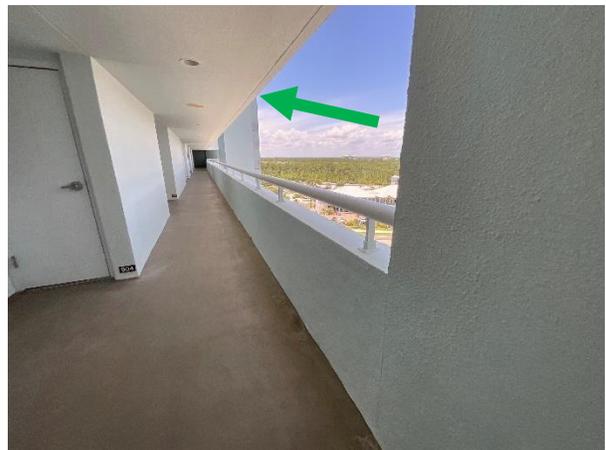
Photo 42
North Elevation – Common Walkways – Floor 9 – New coatings in overall good condition.

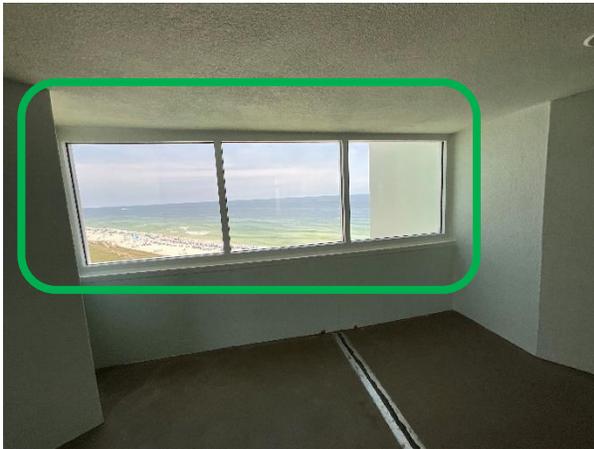
Photo 43
North Elevation – Common Walkways – Floor 9 – New window in overall good condition.

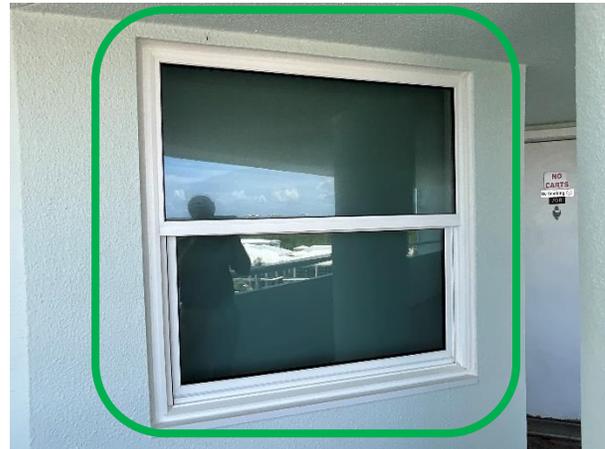
Photo 46
North Elevation – Common Walkways – Floor 7 – New window in overall good condition.

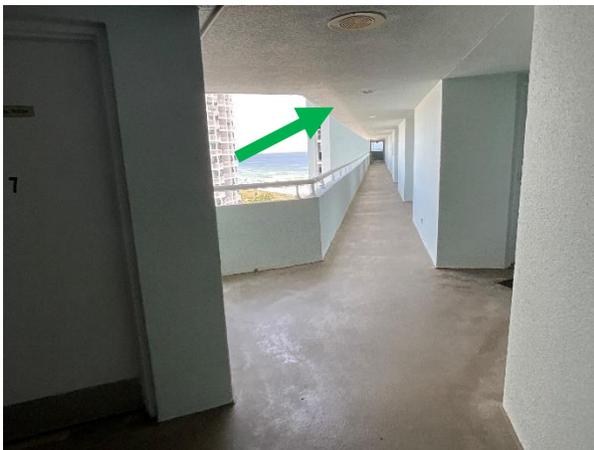
Photo 45
North Elevation – Common Walkways – Floor 7 – New coatings in overall good condition.

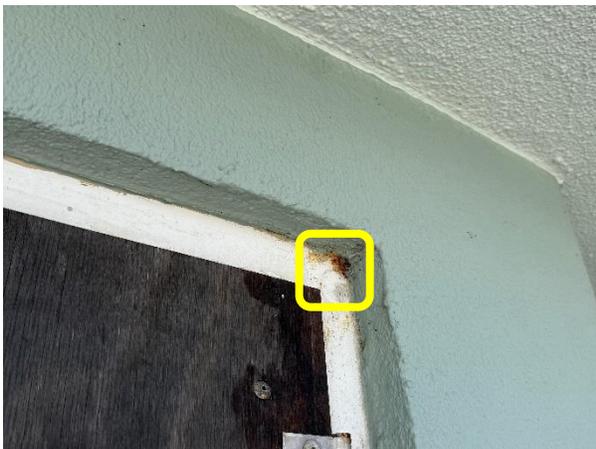
Photo 51
North Elevation – Moderate corrosion present on door frame.

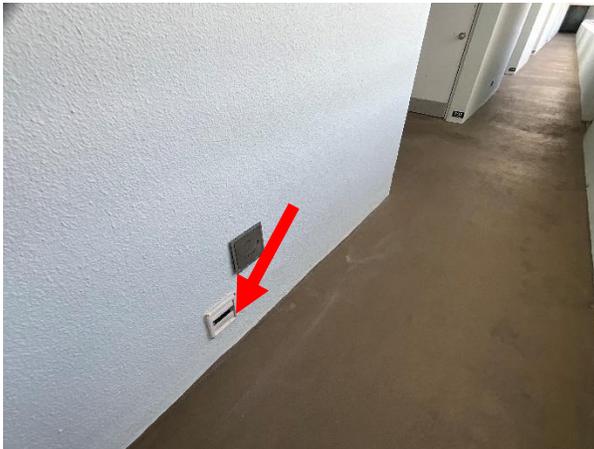
Photo 61
North Elevation – Common Walkways – Floor 7 – Unit 702 – Damaged dryer vent louver.

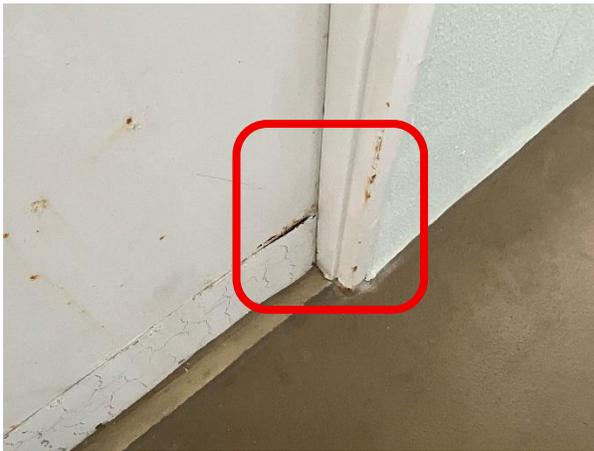
Photo 62
North Elevation – Common Walkways – Floor 11 – Corrosion present at door and frames.

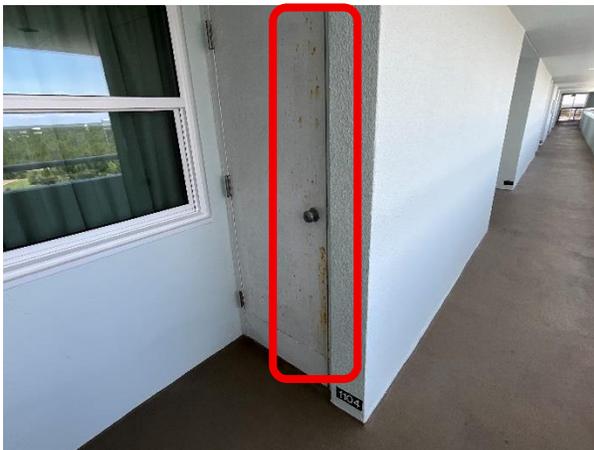
Photo 63
North Elevation – Common Walkways – Floor 11 – Corrosion present at door and frames.

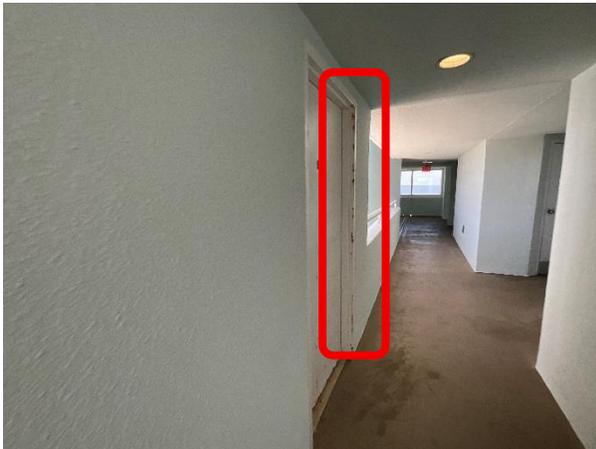
Photo 67
North Elevation – Common Walkways – Floor 7 – Corrosion present at door and frames.

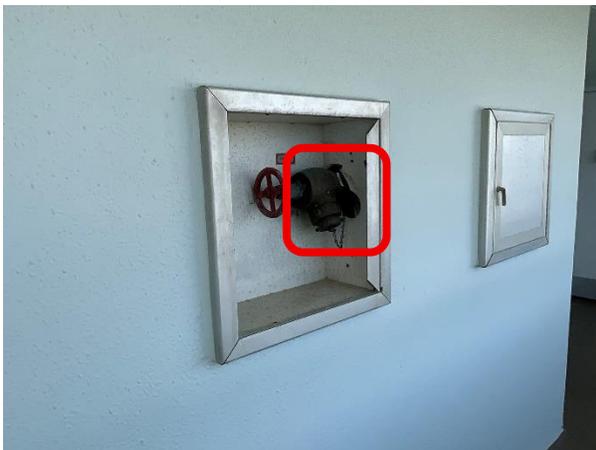
Photo 69
North Elevation – Common Walkways – Floor 11 – Opening in wall at fire wall penetration.

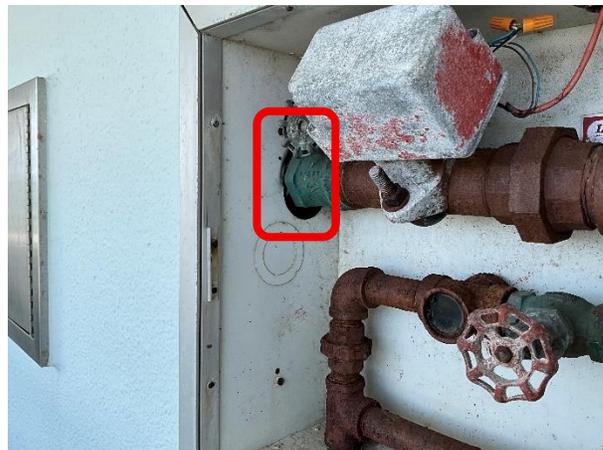
Photo 72
North Elevation – Common Walkways – Floor 10 – Opening in wall at fire wall penetration.

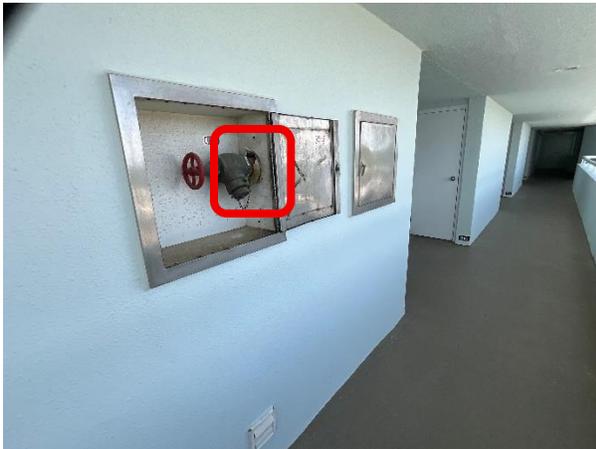
Photo 73
North Elevation – Common Walkways – Floor 9 – Opening in wall at fire wall penetration.

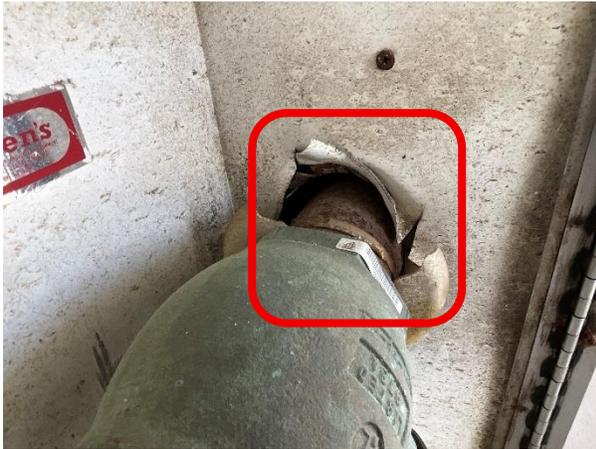
Photo 74
North Elevation – Common Walkways – Floor 9 – Opening in wall at fire wall penetration.

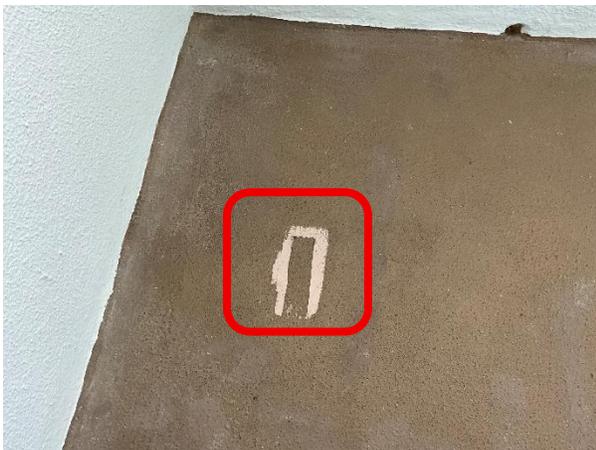
Photo 75
North Elevation – Common Walkways – Floor 11 – Isolated damaged deck coating.

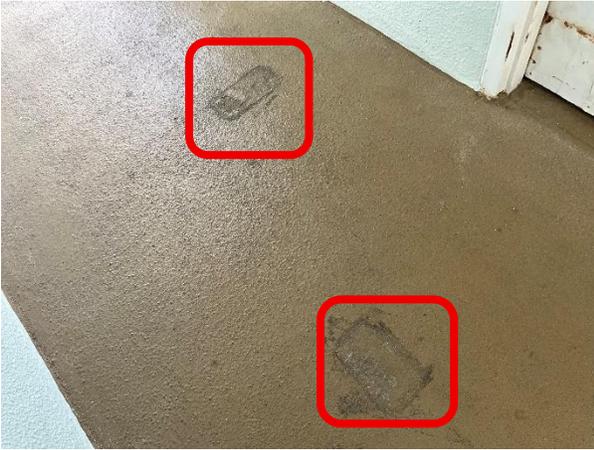
Photo 79
North Elevation – Common Walkways – Floor
4 – Isolated damaged deck coating.

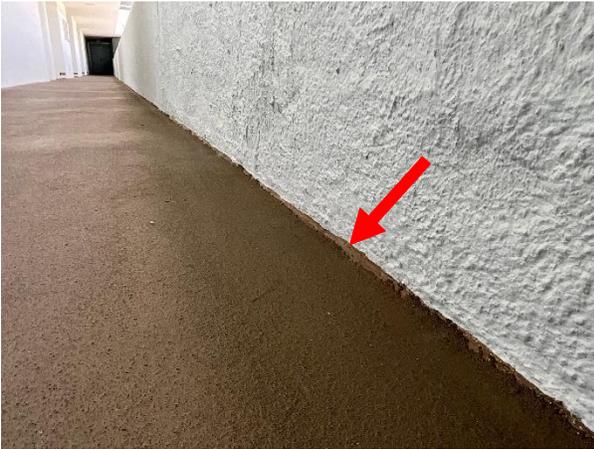
Photo 80
North Elevation – Common Walkways – Floor
2 – Isolated uncoated sealant.

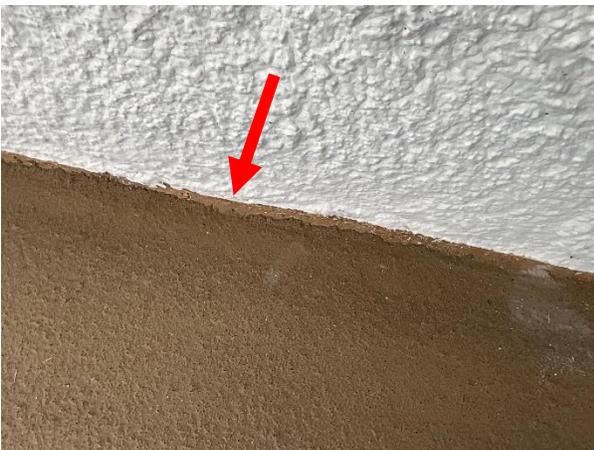
Photo 81
North Elevation – Common Walkways – Floor
2 – Isolated uncoated sealant.
